Watershed Emergency Response Team (WERT) 2024 Lake Fire

CA-LPF-001542 August 15, 2024

REPORT TITLE: Watershed Emergency Response Team (WERT) Evaluation – 2024 Lake Fire

Lake Fire – WERT REPORT EXECUTIVE SUMMARY

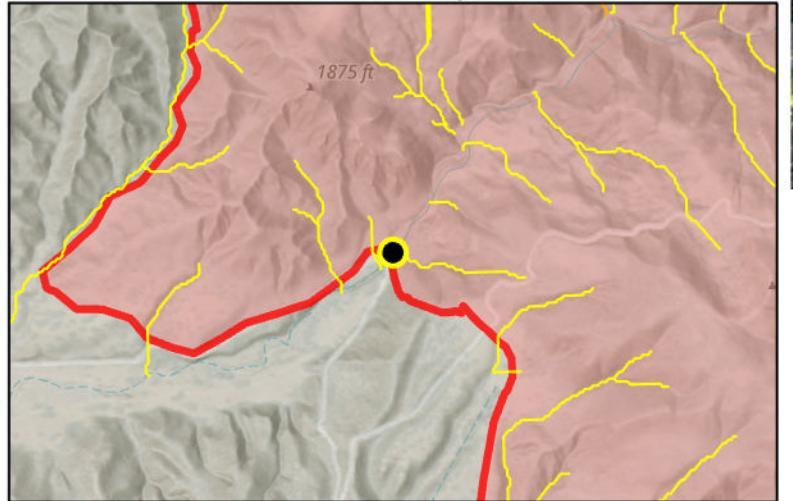
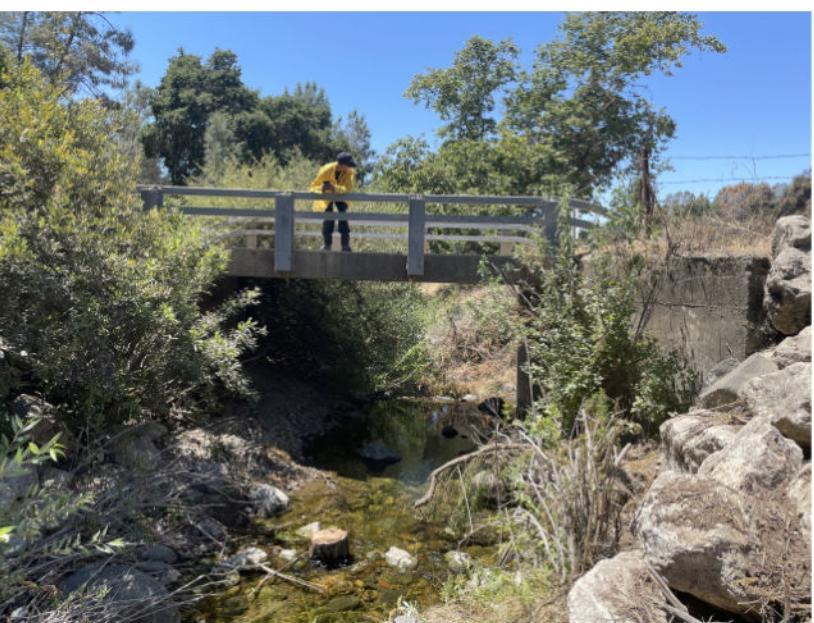
Field Observation Debris jam could impact bridge, causing loss of access. Little diversion potential. *or Potential Hazard:*

Description: Concrete bridge structure with a hydraulic area of 18'w x 8'h and a native substrate composed of cobble to boulders up to 2' diameter. Extensive vegetation (willow) along banks. Angled wingwall with sloped banks armored with riprap. Width of bridge normal to channel is approx 16'.

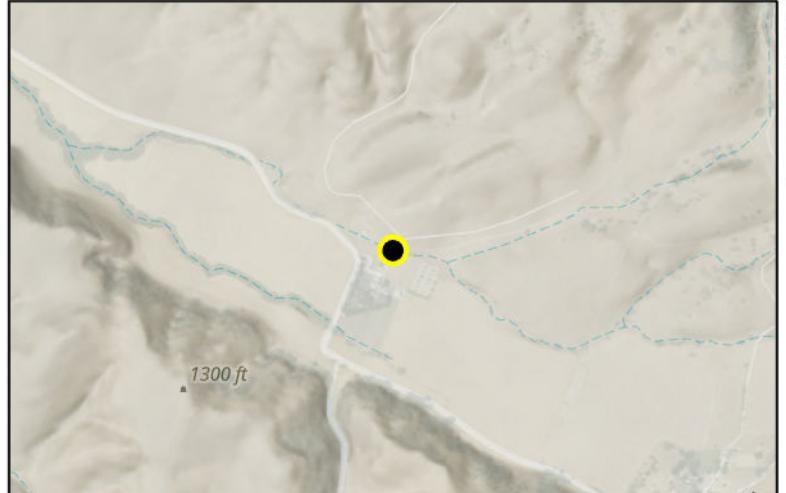
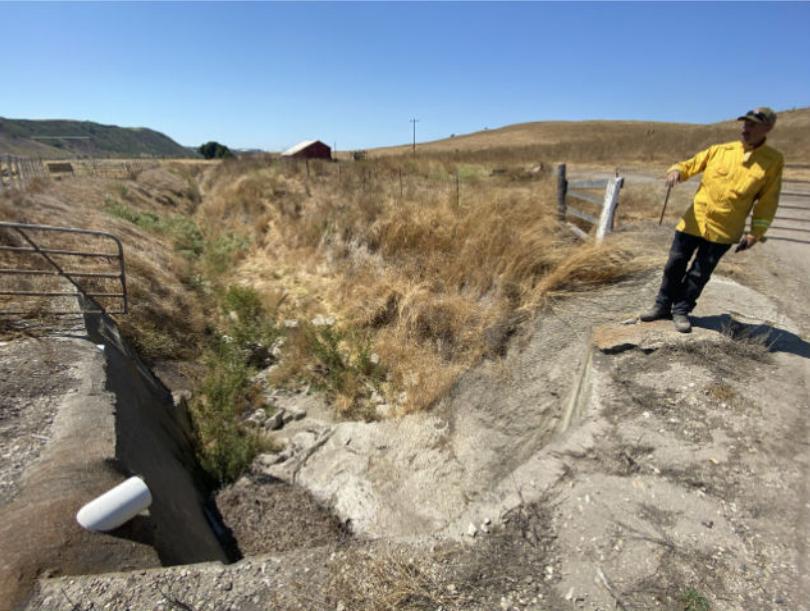
Field Observation Flooding of channel. Low potential of overbanking flow. *or Potential Hazard:*

Description: Box culvert that's also a bridge. 7ft deep and 5ft wide. Concrete head wall flared 30 degrees. Trapezoidal channel downstream. Barn and paddocks adjacent but elevated above channel. Flows may overtop and impact adjacent structures if jammed.

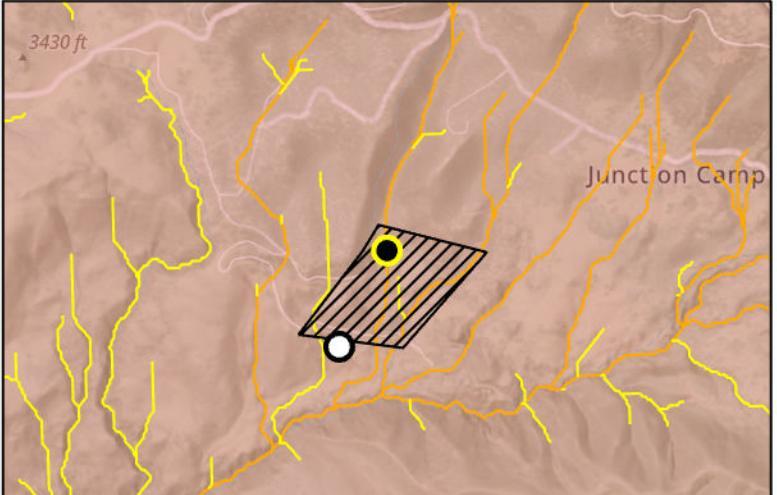
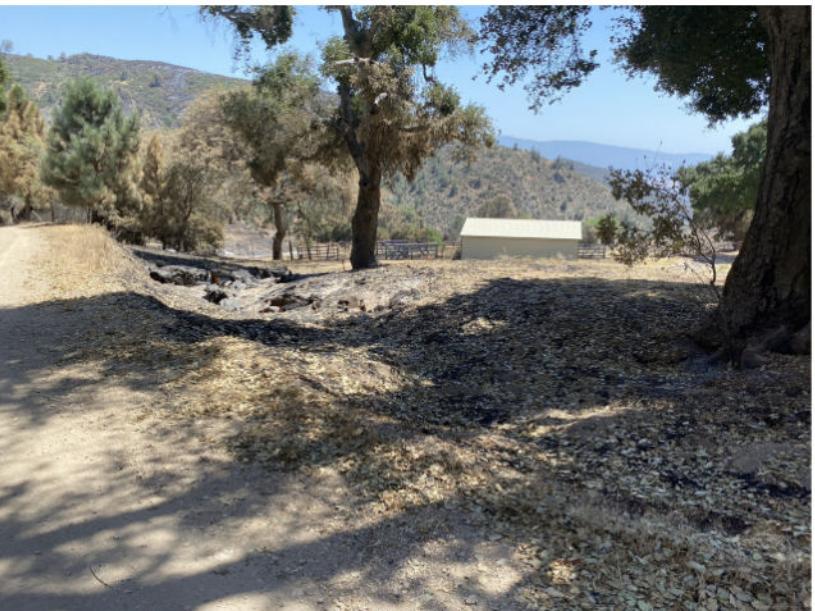
Field Observation Barn is located on a fan. Upstream basin area was burned mostly at moderate severity. Drainage does not *or Potential Hazard:* show evidence of recent incision near structure, but incision was present upstream at the Figueroa Mountain Rd.

Description: An unchannelized swale exists to the east of the animal barn and is likely to capture future flows. However, an unchannelized drainage upstream of the barn could route flow and sediment towards the barn during a large event.

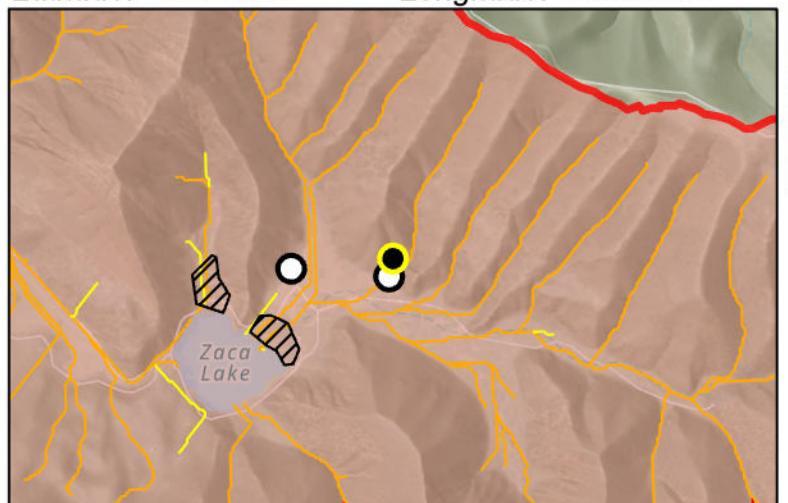
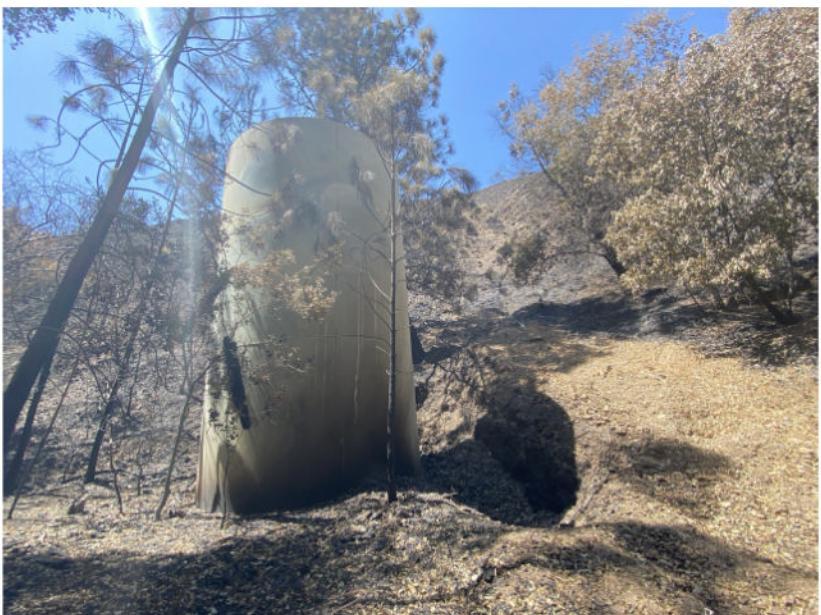
Field Observation Small, steep drainage with erodible material directly upslope of water tank. or Potential Hazard:

Description: Aggradation around base of water tank, but low risk/impact to overall tank structure. Inflow structure likely nearby the water tank but did not directly observe in the field.

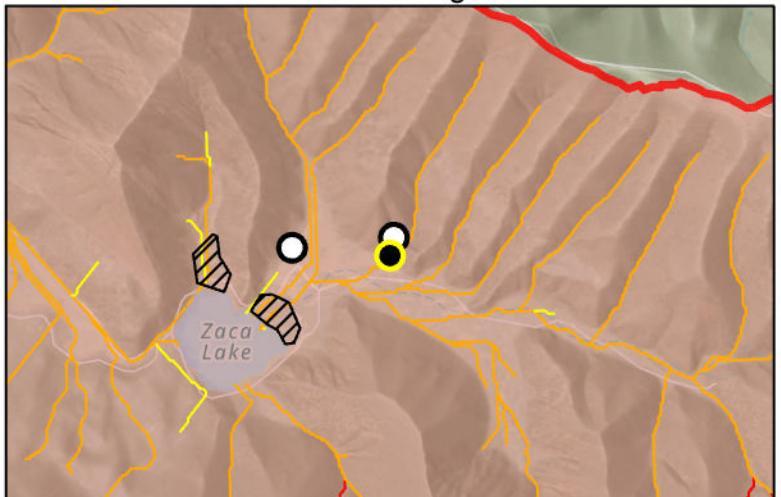
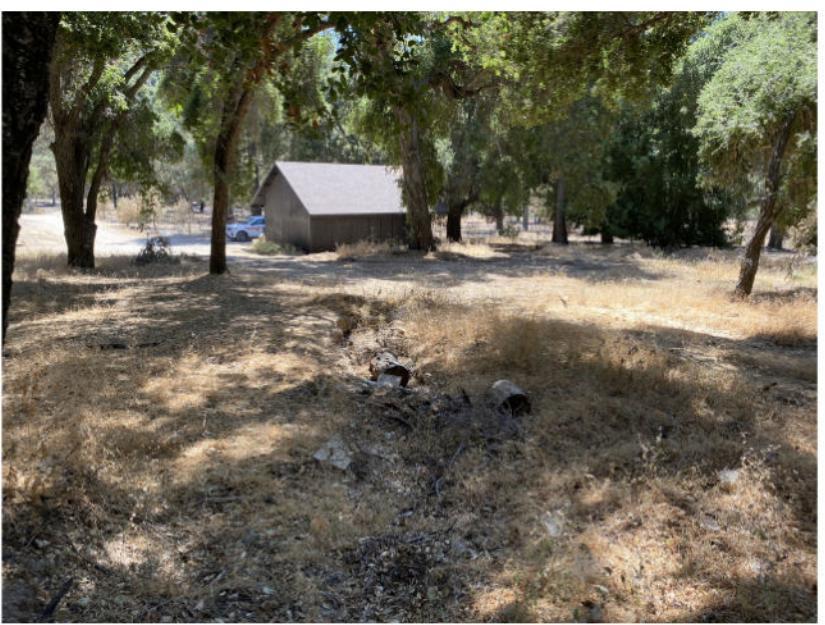
Field Observation Small basin with moderately incised channel upstream of structure. Channel has been filled near structure *or Potential Hazard*: which may increase likelihood of being impacted.

Description: Small shop at outlet of channel. The drainage is small but could easily be diverted towards structure.

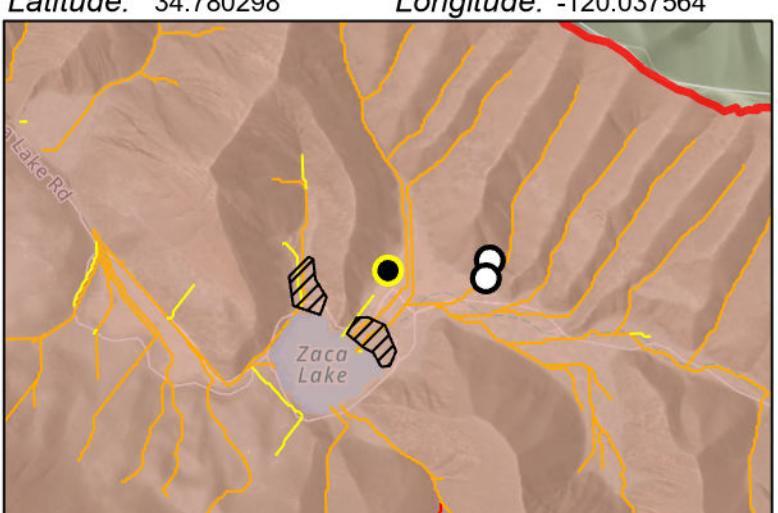
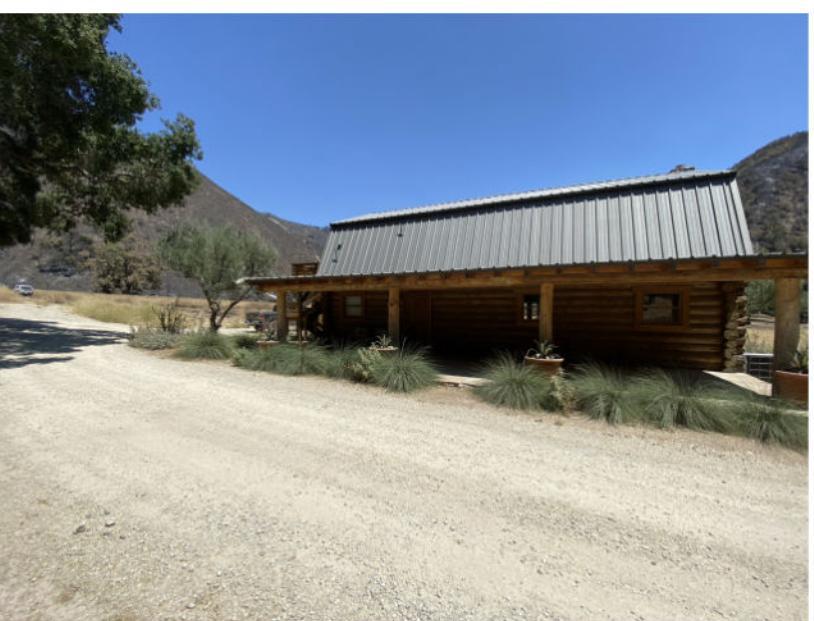
Field Observation Potential debris flood or nuisance flooding from primary basin. or Potential Hazard:

> Description: Small, steep northwest drainage with 30% surface cover. Minimal anticipated flows.

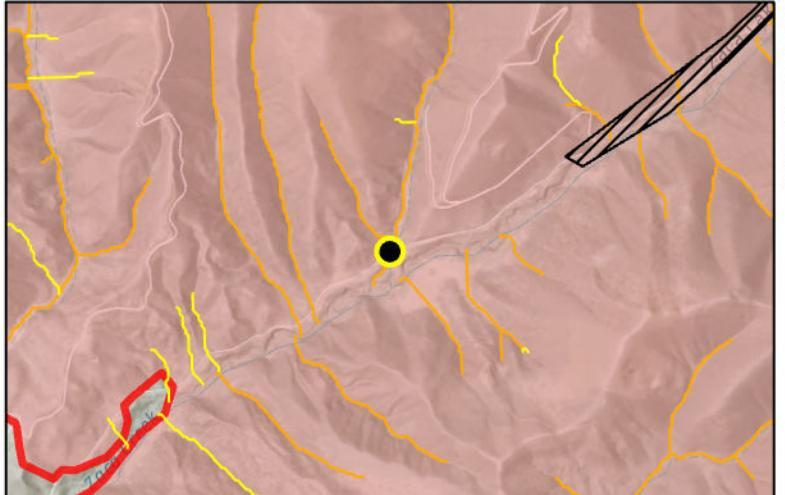
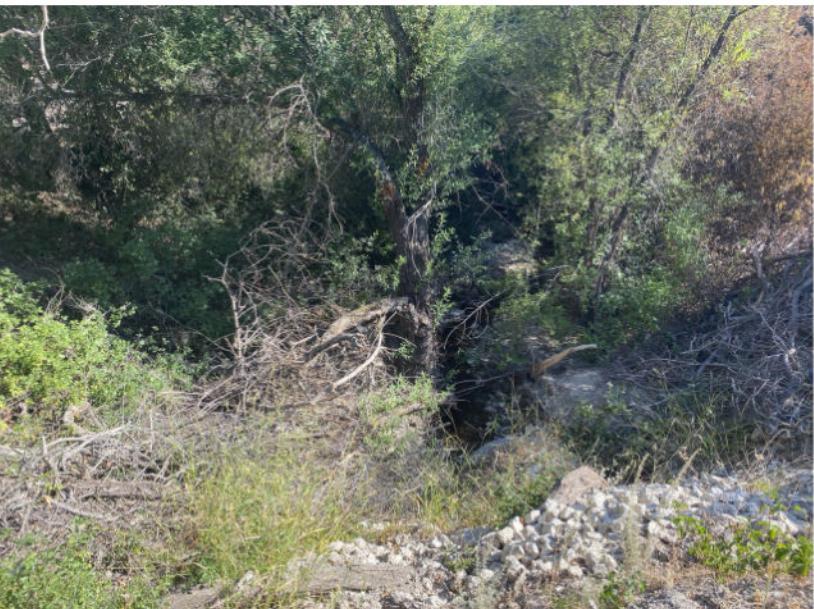
Field Observation Potential blockage of culvert could result in flooding along road. *or Potential Hazard:*

Description: Potential moderate impacts to culvert and road. Low traffic, private road, but people accessing road may be at moderate risk. 48 inch diameter, undersized culvert (CMP); large fill.

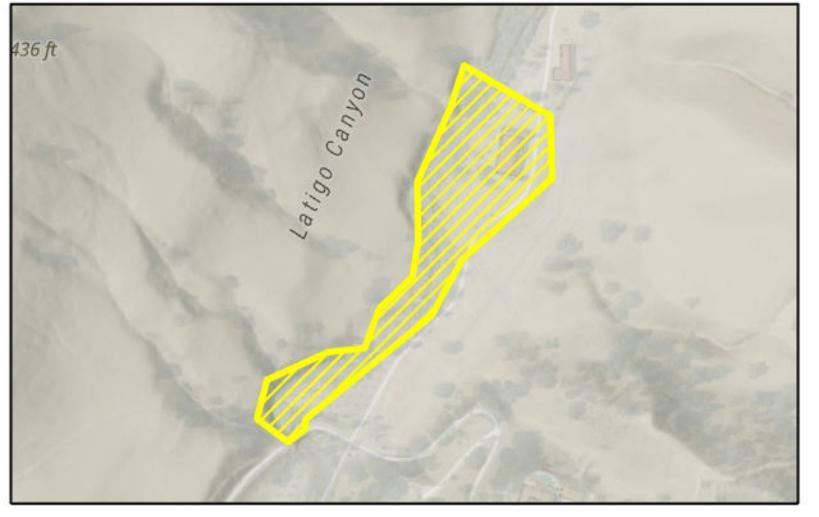
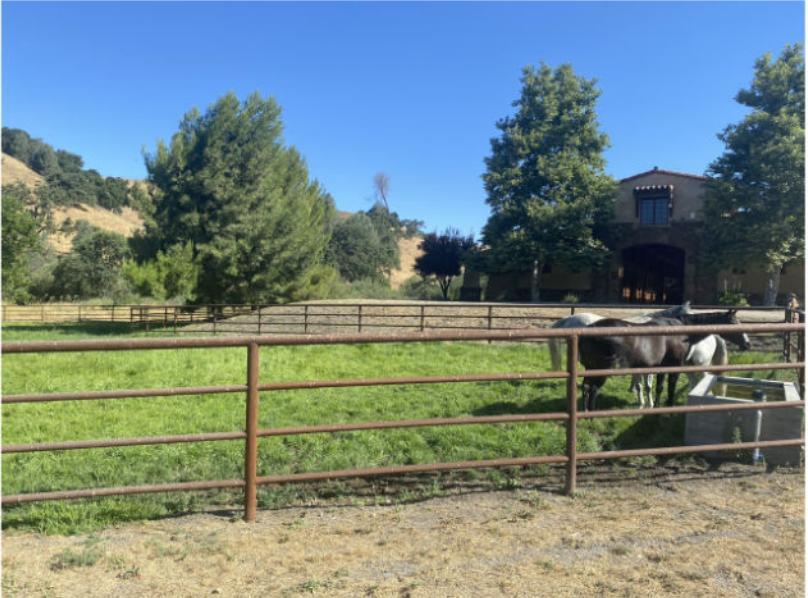
Field Observation Low potential for flooding or debris floods to barn and stream crossing. Channel is deeply incised (~10 ft) with *or Potential Hazard:* substantial floodplain on stream right for area upstream of barn. There is a large culvert at the stream crossing.

Description: In the unlikely event that the culvert is plugged, flooding on road will reenter channel immediately downstream.

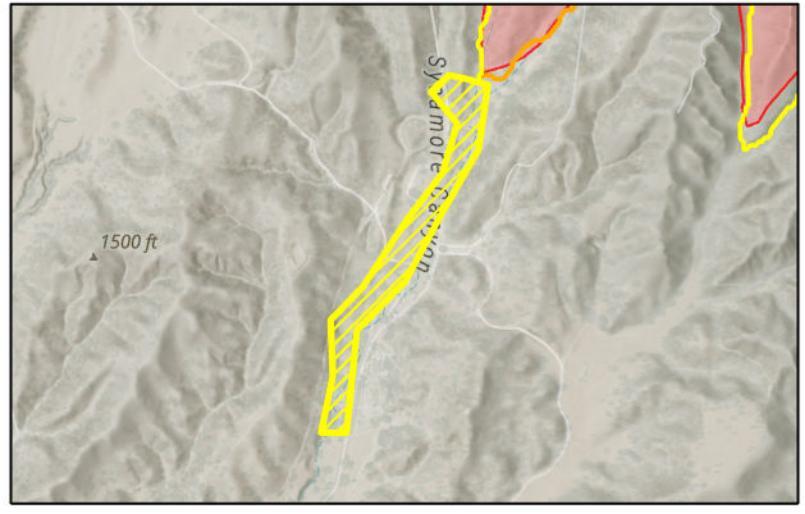
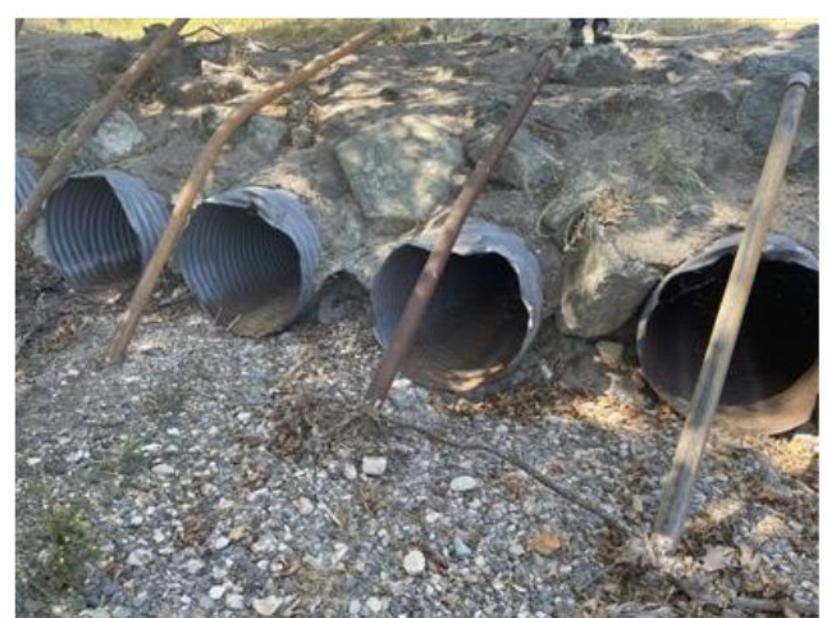
Field Observation An incised channel crosses the ranch and may flood multiple buildings during storms. *or Potential Hazard:*

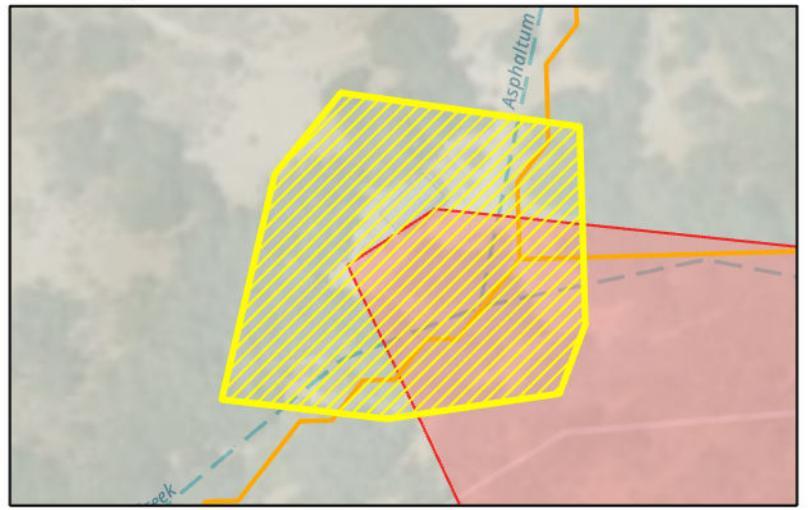
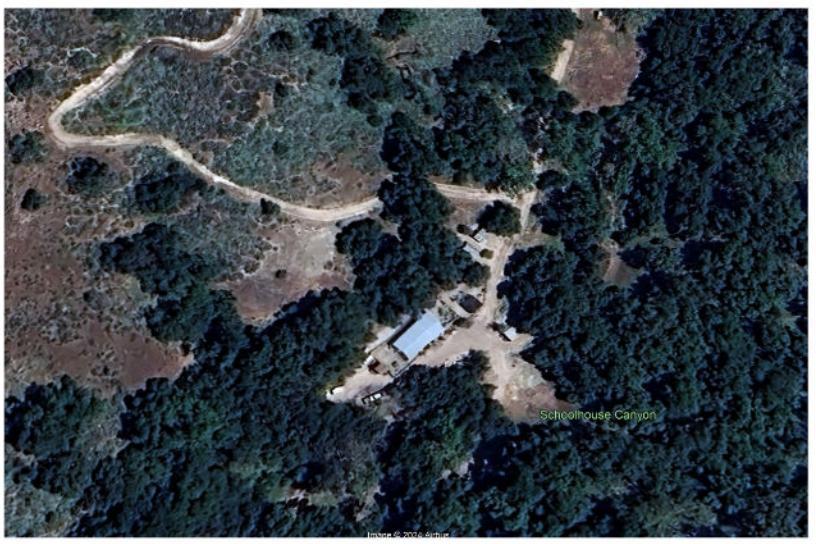
Field Observation Potential flooding to structure and crossings. Unable to access locked gate. *or Potential Hazard:*

Description: Assessment performed remotely.

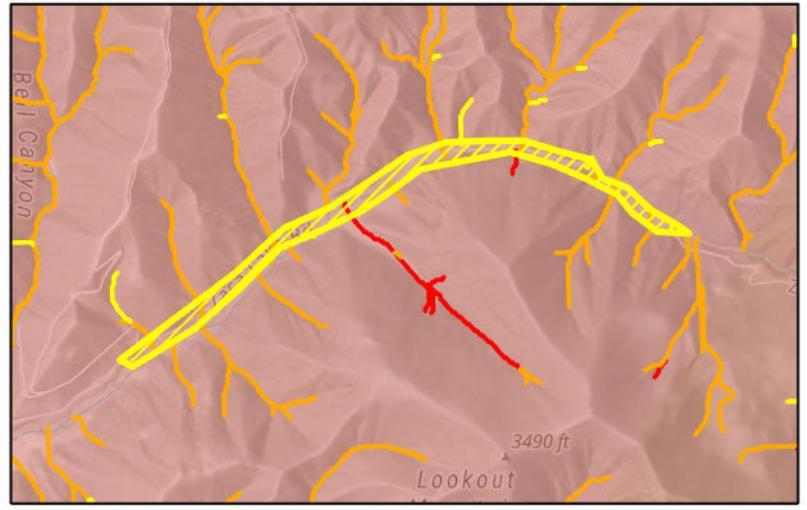
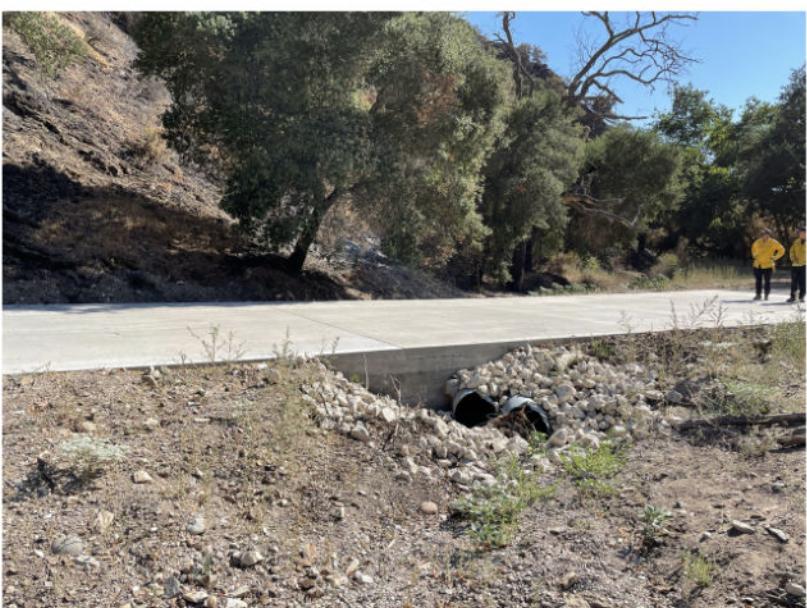
Description: Tributary drainages can deliver sediment and debris that can impact road.
