**CORRELATION BETWEEN RECORDED BUILDING
DATA AND NON-STRUCTURAL DAMAGE DURING
THE 1989 LOMA PRIETA EARTHQUAKE**

Data Utilization Report CSMIP/94-04

California Strong Motion Instrumentation Program

April 1994

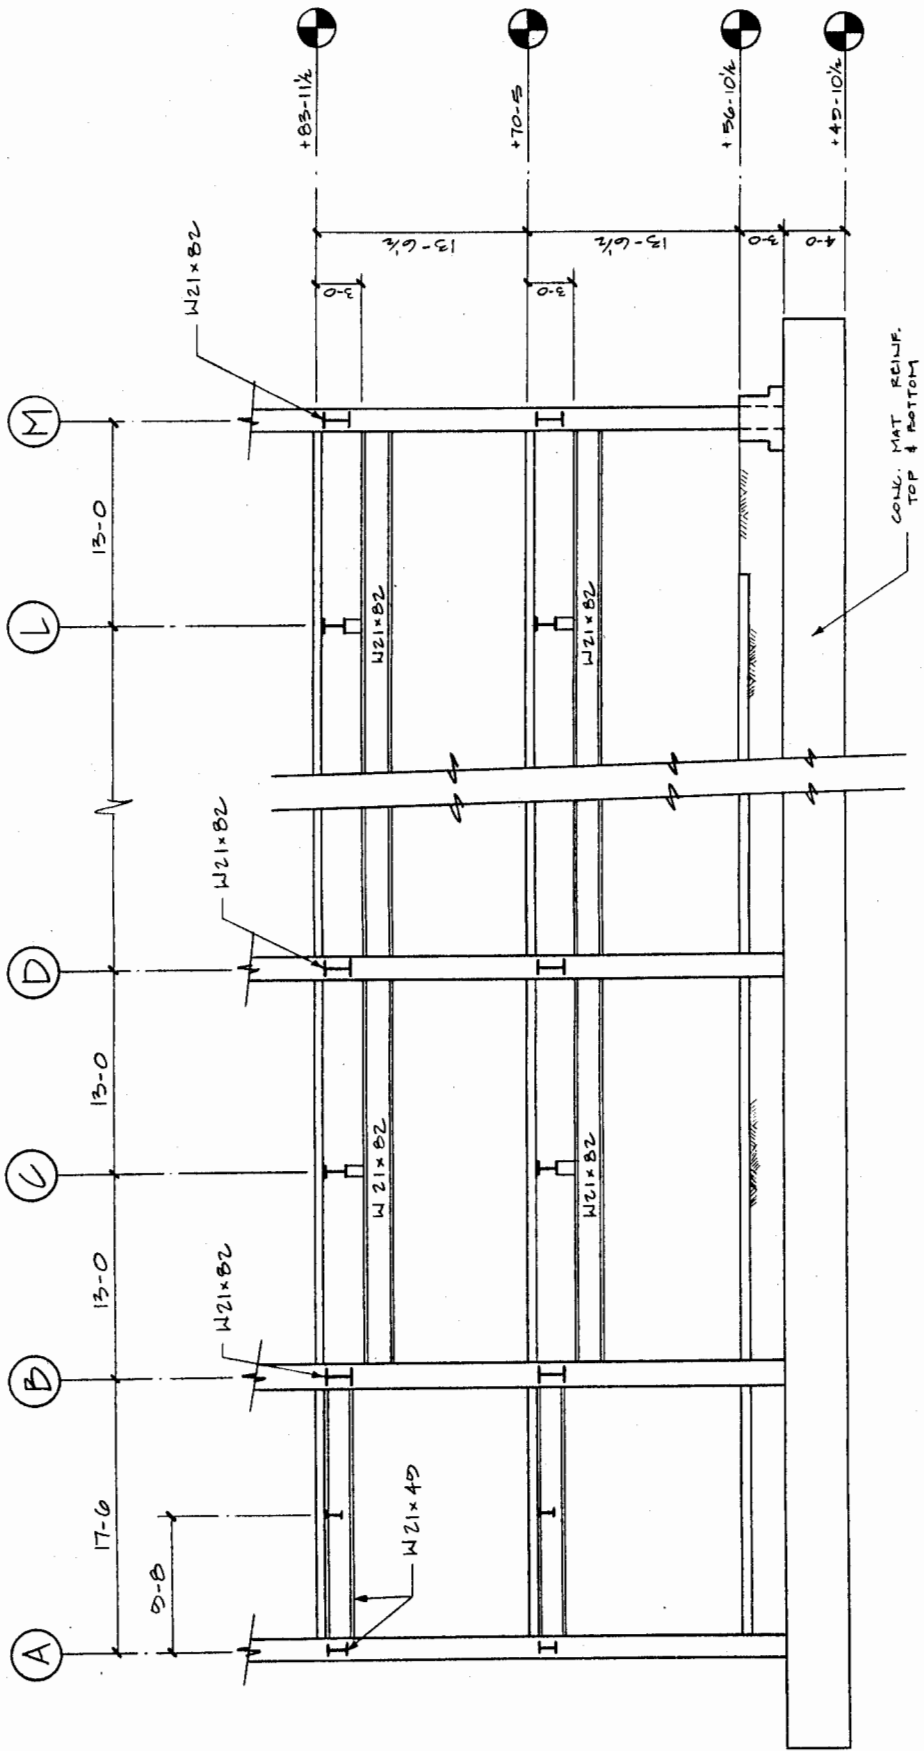
Figure 6: Santa Clara County Government Center - San Jose
Floor System - Details

An unusual and unique irregularity was found in the structural framing system. The girders (W21x82) that are part of the E-W moment-resisting rigid frames are offset from the nominal floor diaphragm level by 3'-0" as shown in Figure 6.

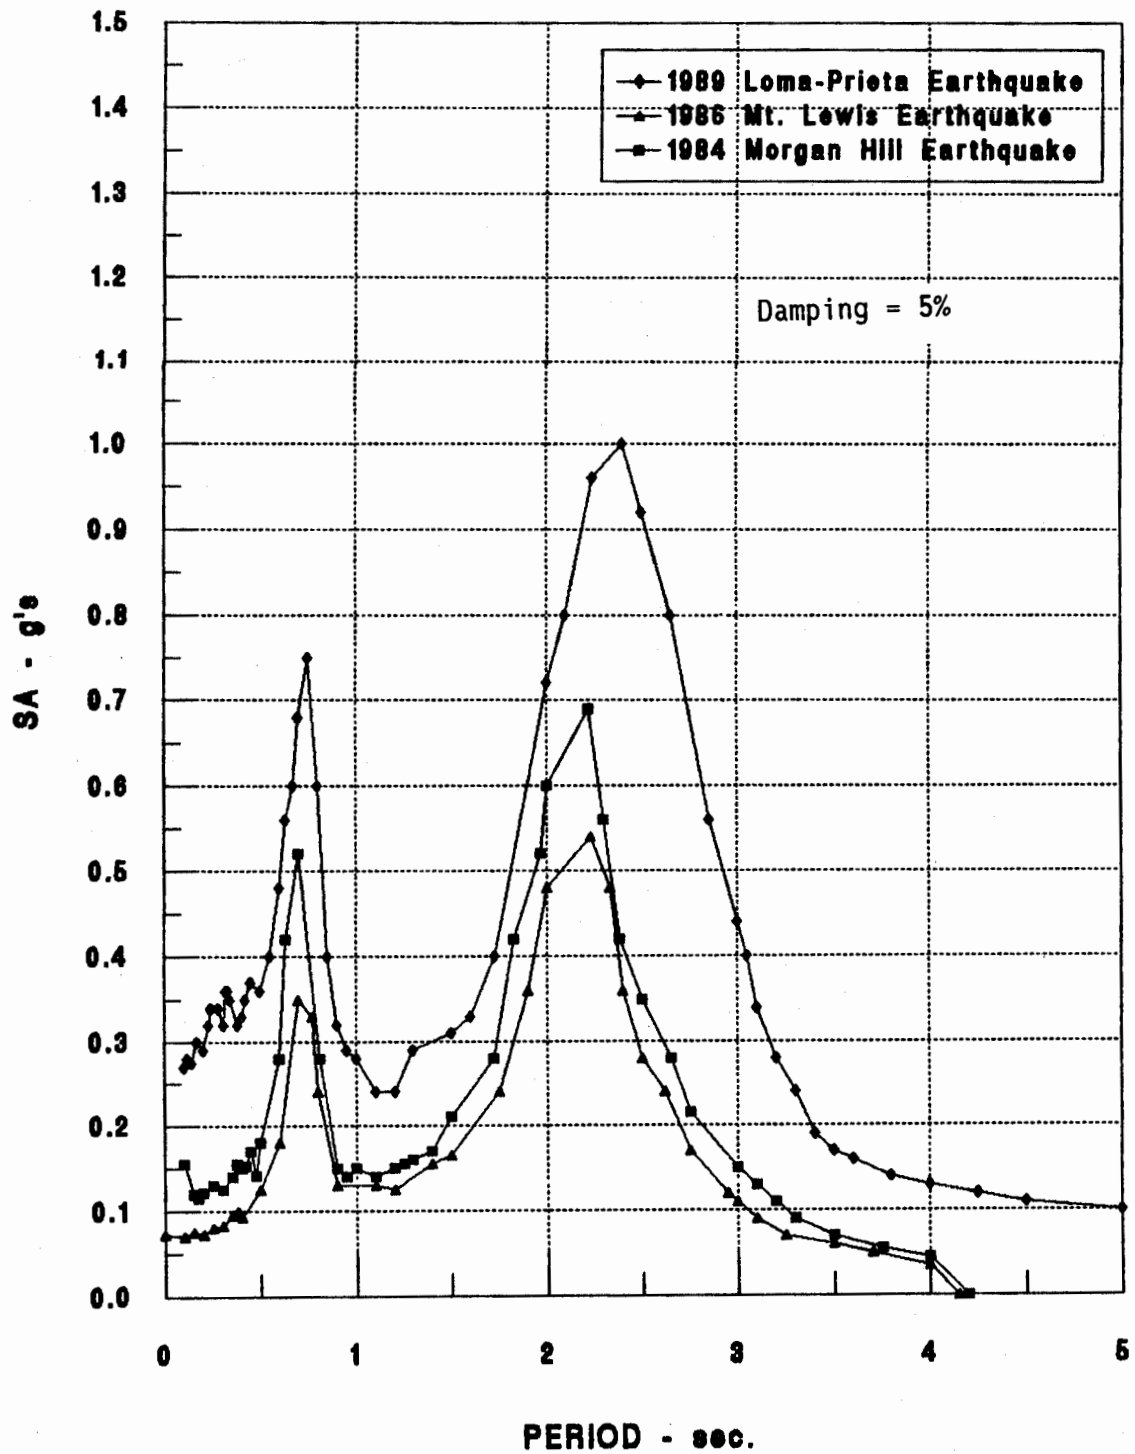
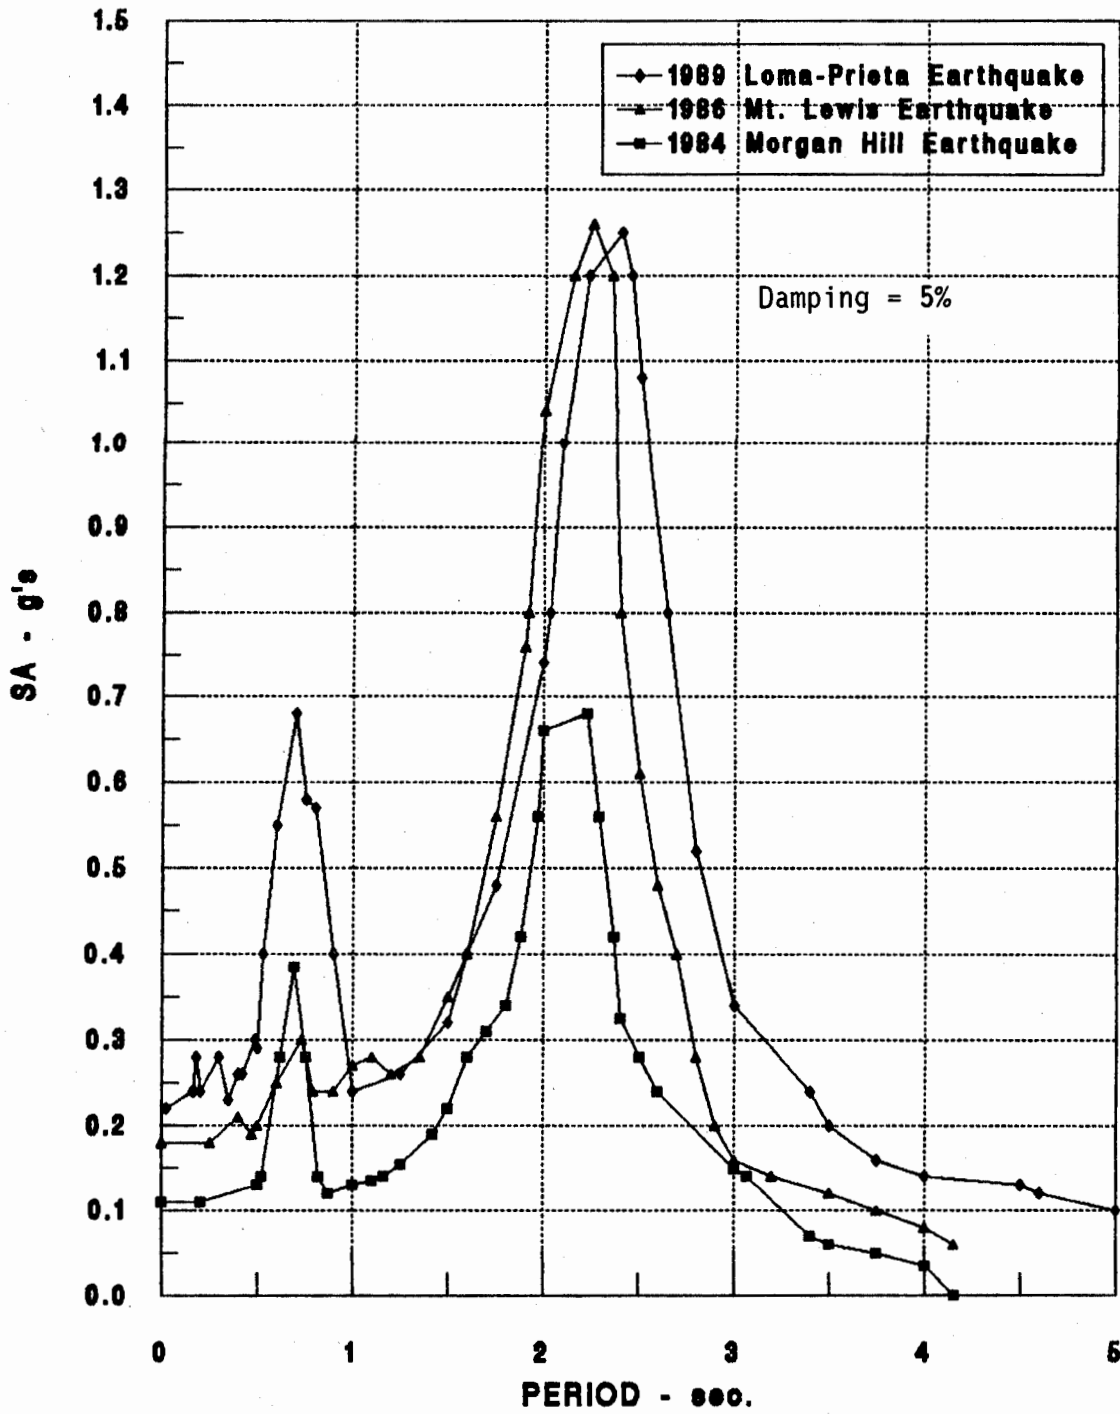
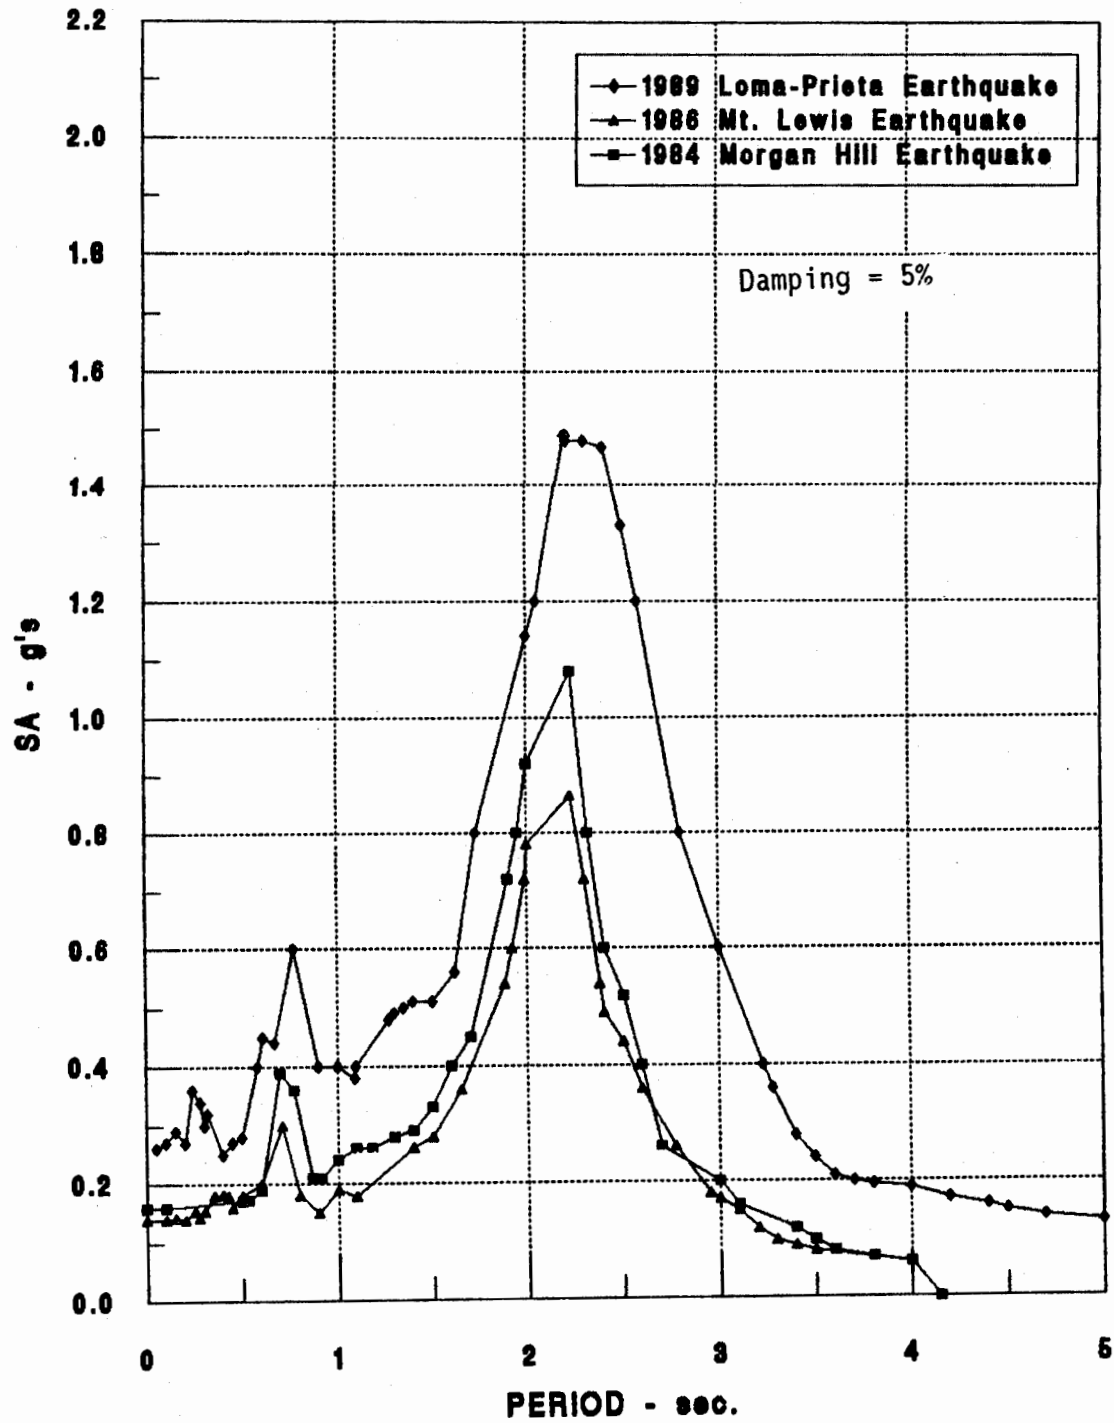
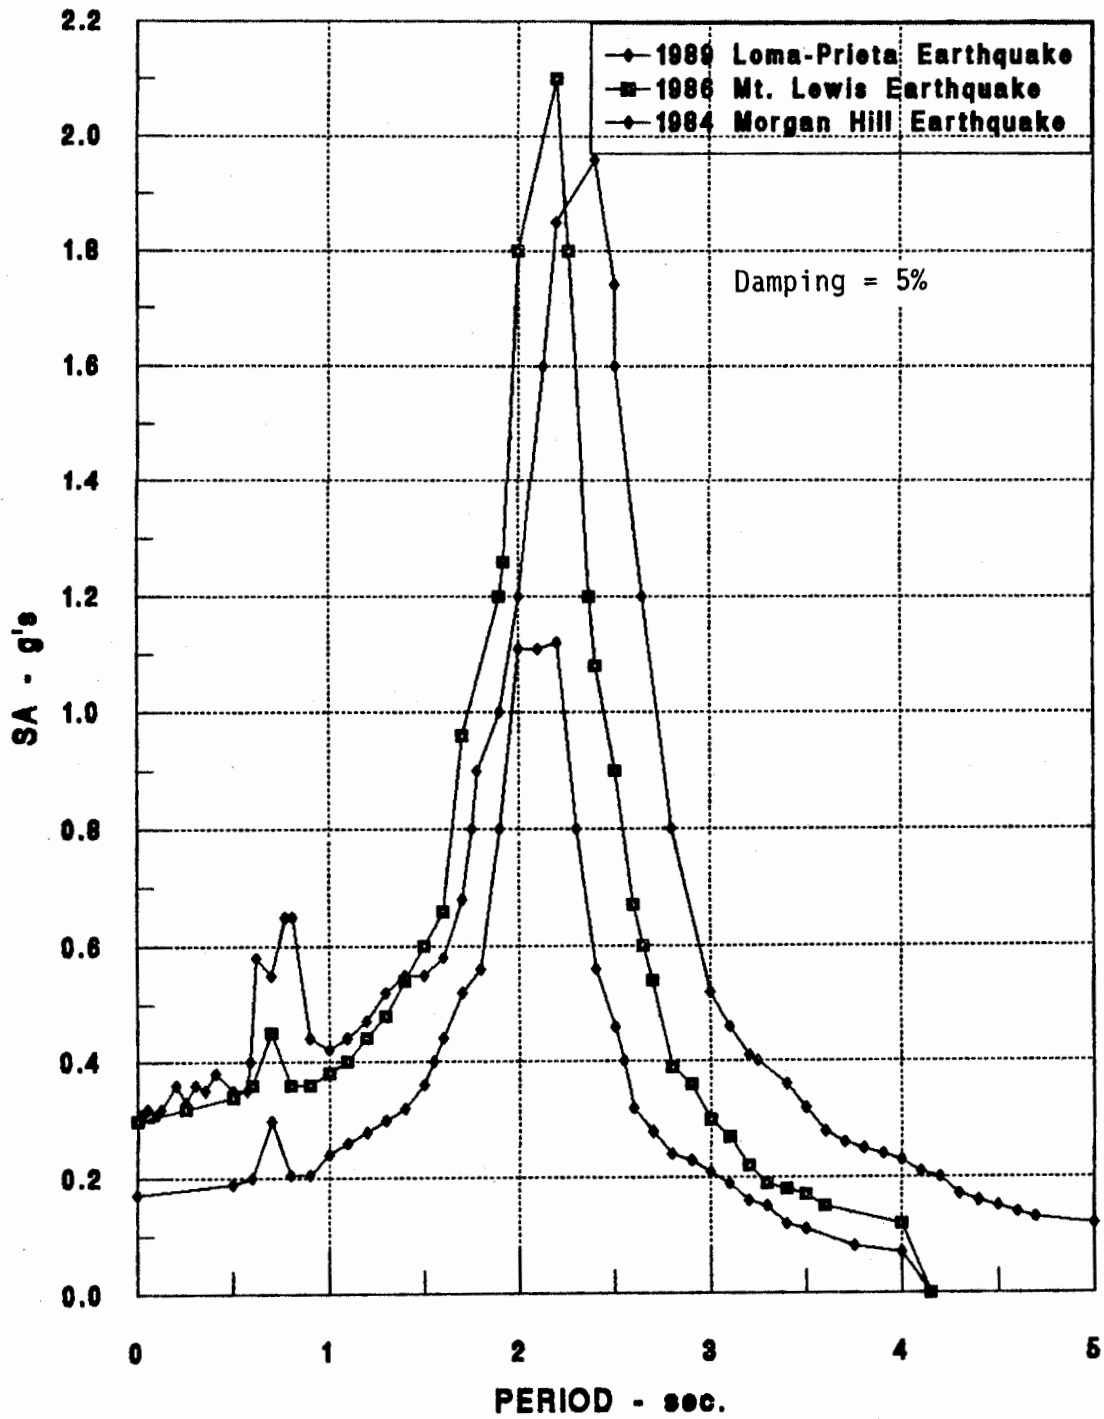
In an attempt to further determine threshold levels of nonstructural damage, recorded floor acceleration response spectra for the 7th floor and 12th floor (in E-W and N-S directions) were superimposed as shown in Figures 32-35. It is suggested that if

the fundamental dynamic properties, e.g., period and damping etc., of the non-structural components can be estimated, then the responses of non-structural components to floor motion could be evaluated and correlated with observed non-structural component damage.
