**OBSERVATIONS FROM THE APRIL 20, 2013 LUSHAN COUNTY,  
YA'AN CITY, SICHUAN PROVINCE, CHINA EARTHQUAKE**

Marshall Lew

AMEC Environment & Infrastructure, Inc.  
Los Angeles, California

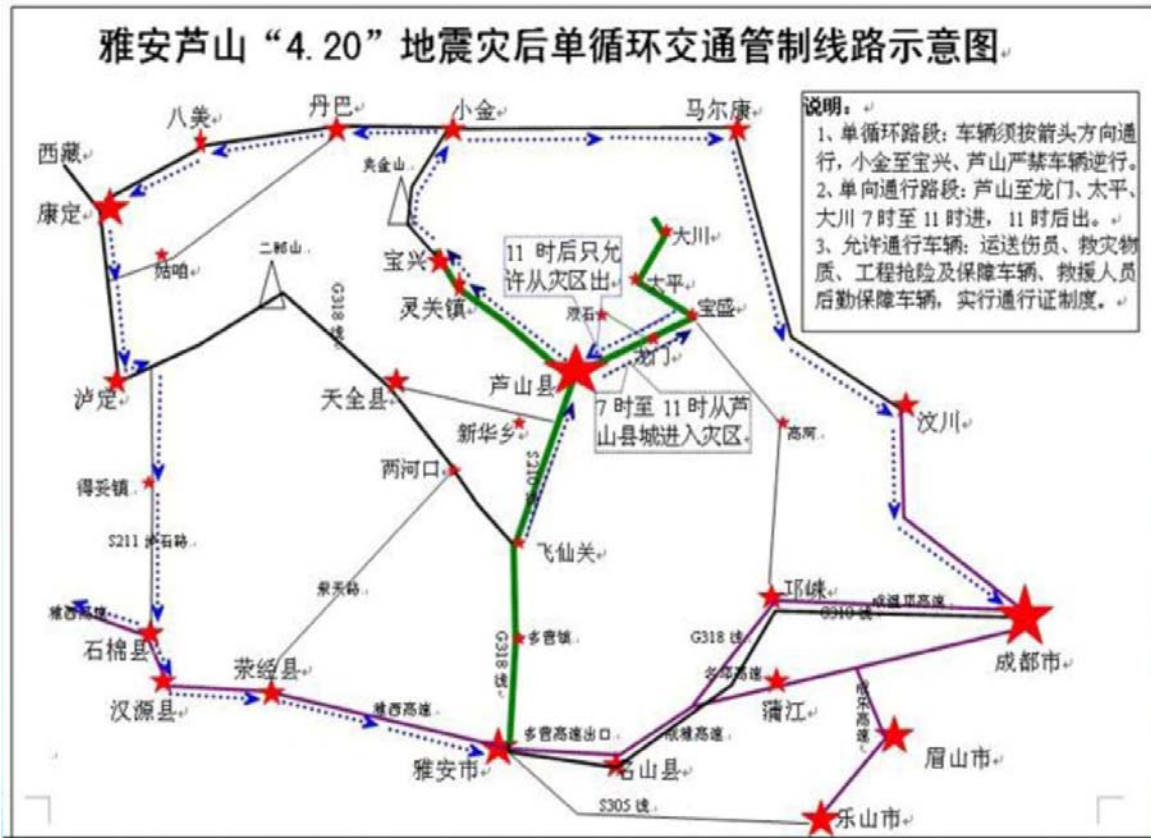
slopes. It was reported that portions of Baoxing, further into the mountains than Lushan, were isolated by landslides and rescue teams were unable to get there for 33 hours (Xinhuanet 2013). During the emergency and recovery period, traffic had to be regulated where most roads were restricted to one-way traffic only as shown on Figure 7; this resulted in long round-trips as circuitous routes were required to return to the starting point.

Fig. 7. Traffic control plan for Lushan area implemented after the earthquake due to landslides and rockslides (courtesy of Prof. Liu Aiwen).

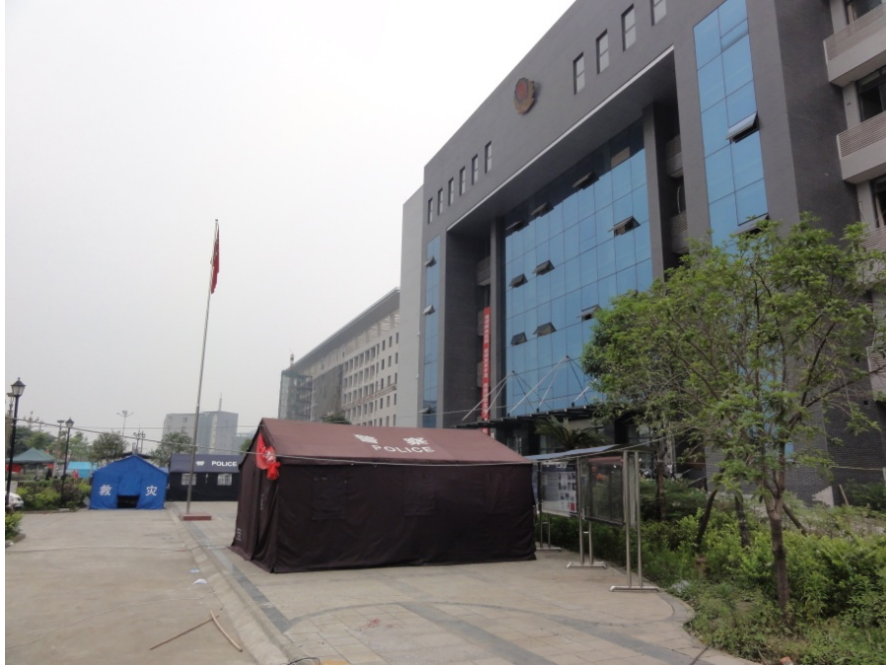
Fig. 13. Relatively new government building in New Lushan Town.

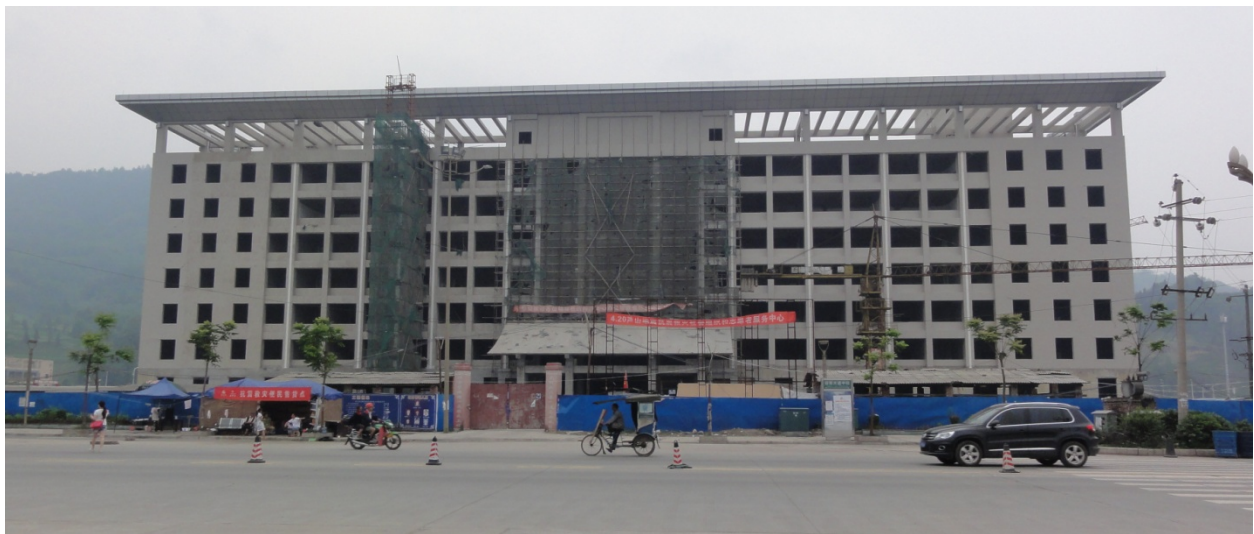
Fig. 14. Government building under construction in New Lushan Town.

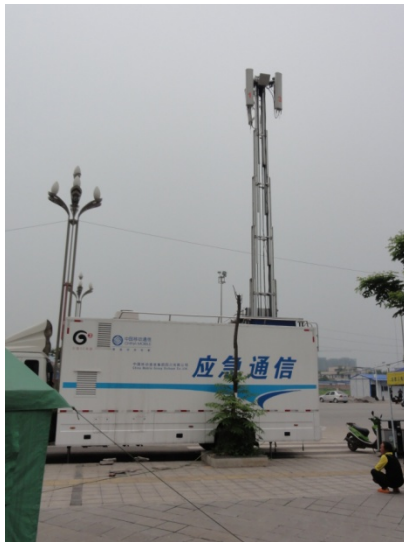
Fig. 25. COW in Lushan Town.

Mobile telephone service was disrupted by the earthquake. It is reported that China Telecom mobilized teams and equipment from Chongqing to provide service within a few days (Best-news.us, 2013c). As of May 28, mobile phone service in the affected region was still being provided with mobile cell towers, sometimes referred to as COWs or “cell on wheels” as shown in Figure 25.
