Evaluation of Code Accidental Torsional Provisions Using Strong Motion Records from Regular Buildings

ABSTRACT

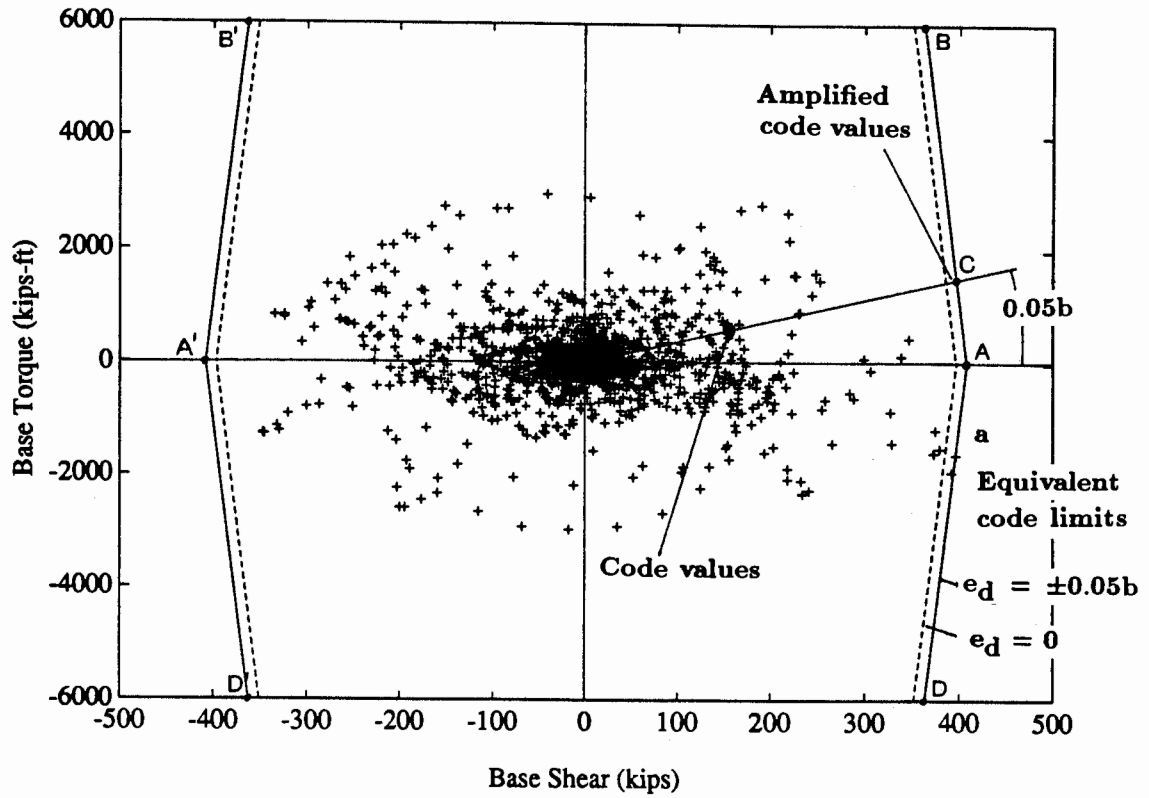
a)

Figure 7: Comparison of dynamic base shear and base torque with code values, and "equivalent" code limits

The base shears and torque at each instant of time are given by equations (3) to (5) with $j = 1$. These forces were computed for the selected building from its floor floor masses and the recorded accelerations (Figure 3). Each point in Figure 7a represents the values of V_{x1} and T_1 at a particular instant of time, similarly V_{y1} and T_1 values are presented in Figure 7b.

amplified code values are identified in Figure 7a. Each point on the straight line AB represents a combination of base shear and torque that produces the same member force as the amplified code combination, denoted by point C (Figure 7a). In particular, point A denotes the value of base shear alone (without any torque) that produces the same member force. For the selected building the straight lines AB and $A'D'$ denote combinations of base shear and torque which produce the same bending moment (and shear force) in column 4 (Figure 1) in the first story. This is the element with the largest bending moment (and shear force) under the forces corresponding to point C . Straight lines $A'B'$ and AD denote combinations of base shear and torque which produce the same bending moment (and shear force) in column 22 (Figure 1) at the first story. The straight lines AB , AD , $A'B'$ and $A'D'$ represent "equivalent" code limits. The corresponding results for analysis in the Y -direction are presented in Figure 7b.

At a particular time instant the base shear and torque computed from the recorded motions (equations (3) to (5)), represents a point on the base shear-torque diagram. A point outside the "equivalent" code region represents a combination of base shear and torque which, together with the code specified heightwise distribution of lateral forces, produces member forces in the first story column 4 which exceed the amplified code forces associated with point C . Such a condition would suggest that the accidental eccentricities should be increased beyond the code specified value of $0.05b$. For the selected building and recorded motions all combinations of $V_{y1} - T_1$ and $V_{x1} - T_1$, except the one denoted by a , fall within the "equivalent" code limits (Figures 7a and 7b). This one point falls only slightly outside the "equivalent" code limit indicating that the accidental eccentricity of $0.05b$ seems satisfactory.

For the particular recorded response of this building during the Loma Prieta earthquake, the torsional effects are so small that it may not be necessary to consider accidental eccentricity at all. Figure 7 indicates that only a couple of points fall outside the "equivalent" code limit with zero accidental eccentricity.

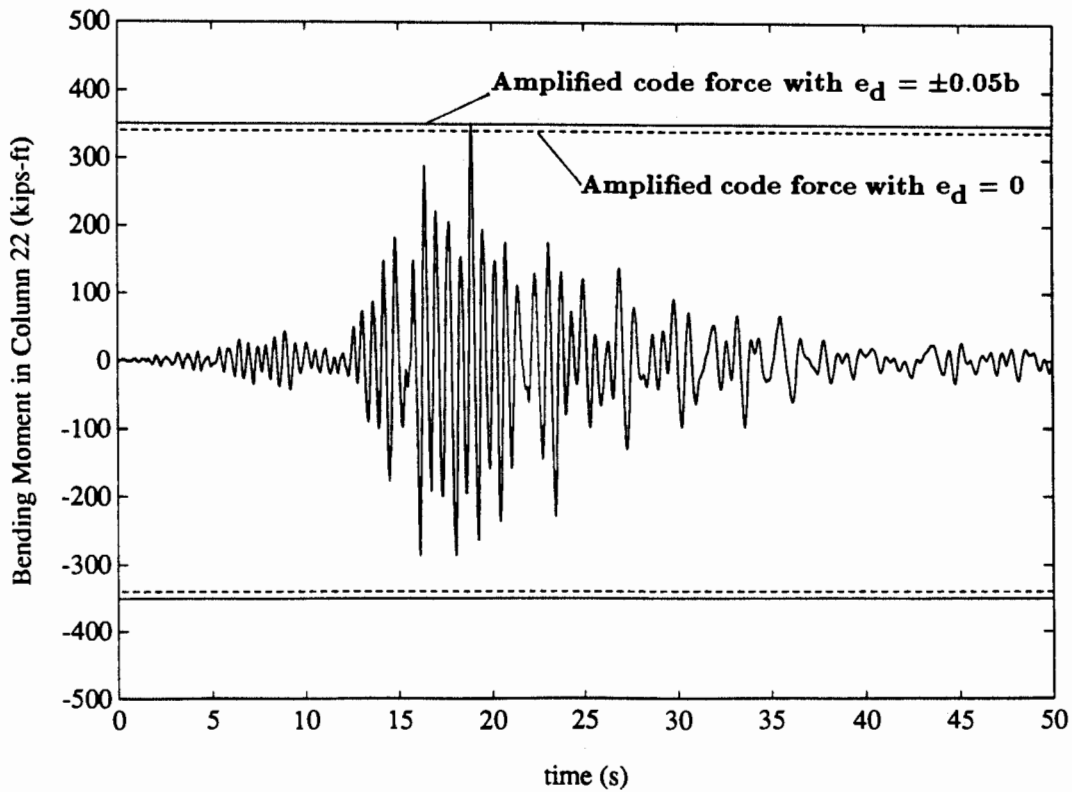
Figure 9: Comparison of earthquake-induced forces in column 22 with amplified code values

Additionally, the member forces associated with the recorded motions can be compared with those resulting from the amplified code forces defined earlier. At each time instant during the earthquake, the member forces are determined by static analysis of the building, using the ETABS computer program, subjected to the floor inertia forces $m_j a_{xj}(t)$, $m_j a_{yj}(t)$ and $I_{pj} a_{\theta j}(t)$. The results of such static analyses are plotted in Figures 8 and 9, where the shear force and bending moment in the first story columns 22 and 18 are presented. Also shown is the member force associated with the amplified code forces defined by the base shear-torque combination of point C in Figure 7. It is seen that the column 18 forces during the earthquake remain below the amplified code values. The same is true for column 22 forces, except for one peak (This peak corresponds to point a in Figure 7). Even at this peak the actual member force exceeds the amplified code value only slightly. Thus the accidental eccentricity of $0.05b$ seems to be satisfactory in representing the torsional response of the building during the Loma Prieta earthquake.

Also shown in Figures 8 and 9, are the member forces associated with the amplified code forces modified for zero accidental eccentricity. These lower values are slightly exceeded for both columns only by a single peak, suggesting that the torsional response of this building during the Loma Prieta earthquake is so small that it may not be necessary to consider accidental eccentricity at all.
