SPECIAL REPORT 185

**LANDSLIDES IN THE HIGHWAY 1 CORRIDOR:  
GEOLOGY AND SLOPE STABILITY ALONG  
THE BIG SUR COAST BETWEEN POINT LOBOS  
AND SAN CARPOFORO CREEK, MONTEREY AND  
SAN LUIS OBISPO COUNTIES, CALIFORNIA**

Prepared for the  
COAST HIGHWAY MANAGEMENT PLAN

In cooperation with  
CALIFORNIA DEPARTMENT OF TRANSPORTATION  
NEW TECHNOLOGY AND RESEARCH PROGRAM  
OFFICE OF INFRASTRUCTURE RESEARCH  
Project F99TL34

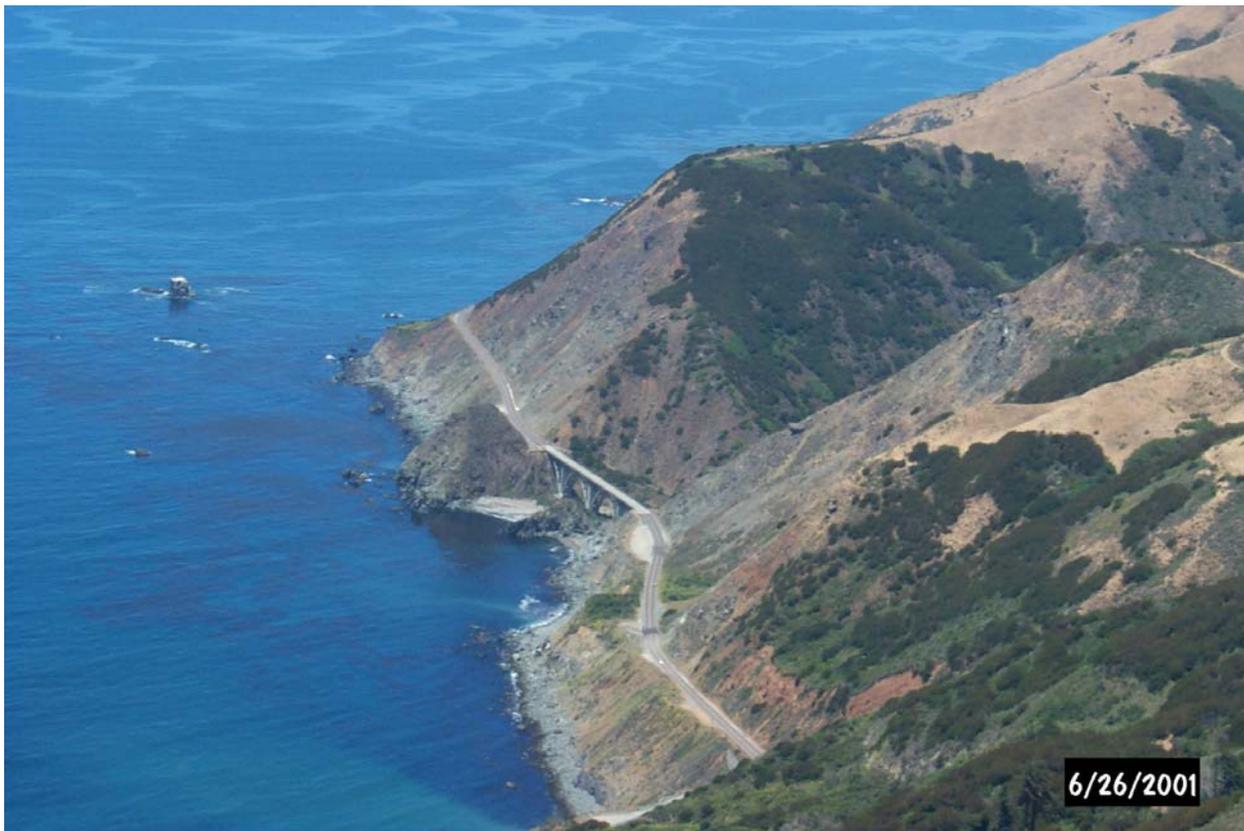
**Figure 1. View of Highway 1 at the mouth of Big Creek, where the road crosses several extensive landslide areas south of the bridge and a large area of rock fall and debris slides north of the bridge. View looking Northwest. Photo by C.J. Wills.**

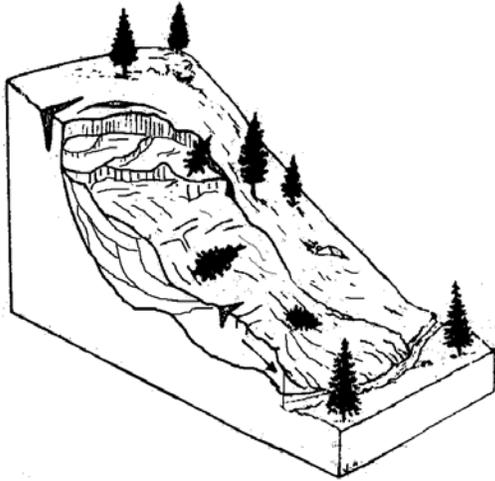
diagram by J. Appleby, R. Kilbourne, and C. Wills after Varnes, 1978

**EARTH FLOW:** A landslide composed of mixture of fine grained soil, consisting of surficial deposits and deeply weathered, disrupted bedrock. The material strength is low through much of the slide mass, and movement occurs on many discontinuous shear surfaces throughout the landslide mass. Although the landslide may have a main slide plane at the base, many internal slide planes disrupt the landslide mass leading to movement that resembles the flow of a viscous liquid.

commonly from 10% to as steep as 30%, although steeper slopes may be found in headscarp areas and where landslide toes are being eroded. Movement of a slide mass along numerous curved failure surfaces leads to an irregular steep headscarp at the upper boundary of the slide. Immediately below the headscarp is a series of blocks that are commonly rotated so they are less steep than the surrounding hill slopes. Below the bench, the slide mass is made up of many smaller masses which may move as intact masses for a time then break up into smaller masses and flow on a multitude of failure surfaces. The flowage of weak material with blocks of relatively intact material leads to a lumpy "hummocky" slope that is typical of large earth flow areas. The lower parts of the slopes usually bulge outward and are steeper than the surrounding slopes.

The rotation of the blocks that typically occurs in the upper part of an earthflow leads to a less steep slope which sometimes holds closed depressions. These areas may accumulate and hold water more than the surrounding slopes. Recognition of landslides is aided if the accumulated water leads to significantly different vegetation, especially phreatophytic (water loving) vegetation. The water retention of these areas also decreases the overall stability of the slide mass by allowing more time for water to infiltrate the slide.

Earthflows are sensitive to conditions that affect the entire slope and to disturbances to any part of the slope. A rise in the water table that may occur in high rainfall years may decrease the overall stability. High water pore pressures, typically following a sustained period of heavy rains, may trigger earth flows, which then may continue to move for a period of days to weeks. Undercutting of the base of slope or addition of fill to the upper slope also tends to destabilize an existing slide. Because the slide mass is weak and contains slide planes throughout, cuts or fills on the slide mass may destabilize a part of the slide. Movement may occur for years as creep of the surficial soil as it shrinks in dry seasons and swells in wet seasons. Movement of the entire mass is more common in years of higher than normal rainfall. Movement is generally slow, in the millimeters or centimeters per day range, but can accelerate to as fast as meters per day in exceptional circumstances.

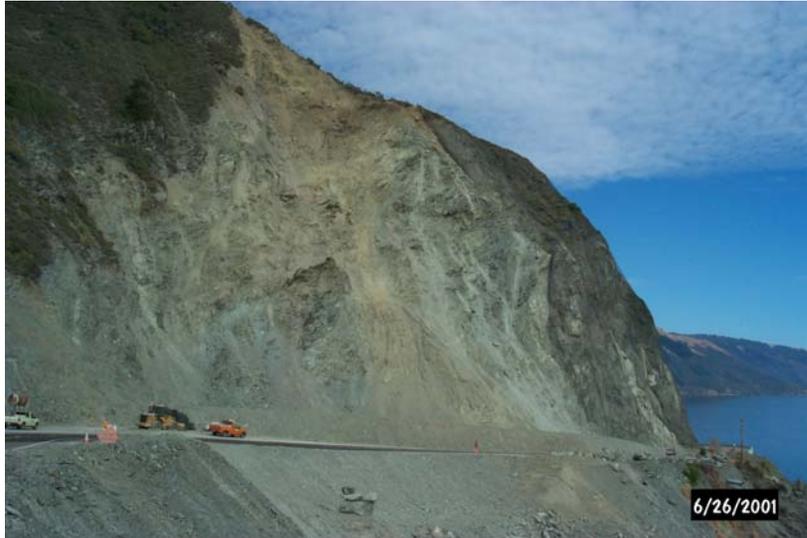
**Figure 4, Debris slides above the highway at "Pitkin's Curve" may have formed due to retrogressive failure starting in a road cut.**

Even when blasting was not used during construction, creating a cut slope in marginally stable material can trigger small slides. If an extensive area of weak rock or soil extends upward from the cut, small slides in the cut can reduce the stability of somewhat larger areas on the adjacent slopes. If the larger areas fail, that can reduce the stability of larger adjacent areas. This form of landslide, which develops from a small failure in a cut slope to a much larger failure in slopes that are largely natural, is called a retrogressive landslide failure. This type of sliding was probably extensive in the 10 to 20 years after construction of the highway. More recently, repairs and maintenance have led to similar failures. One example of a retrogressive failure related to highway maintenance may have occurred at "Pitkin's Curve" (P.M. 21.5) where a landslide below the highway led Caltrans to move the highway to the southeast, off of the slide. A cut slope was required to move the highway inland. That cut slope in weak, loose debris and weathered rock rapidly failed, leading to retrogressive failure of the entire slope above the cut to the ridge crest (Figure 4)

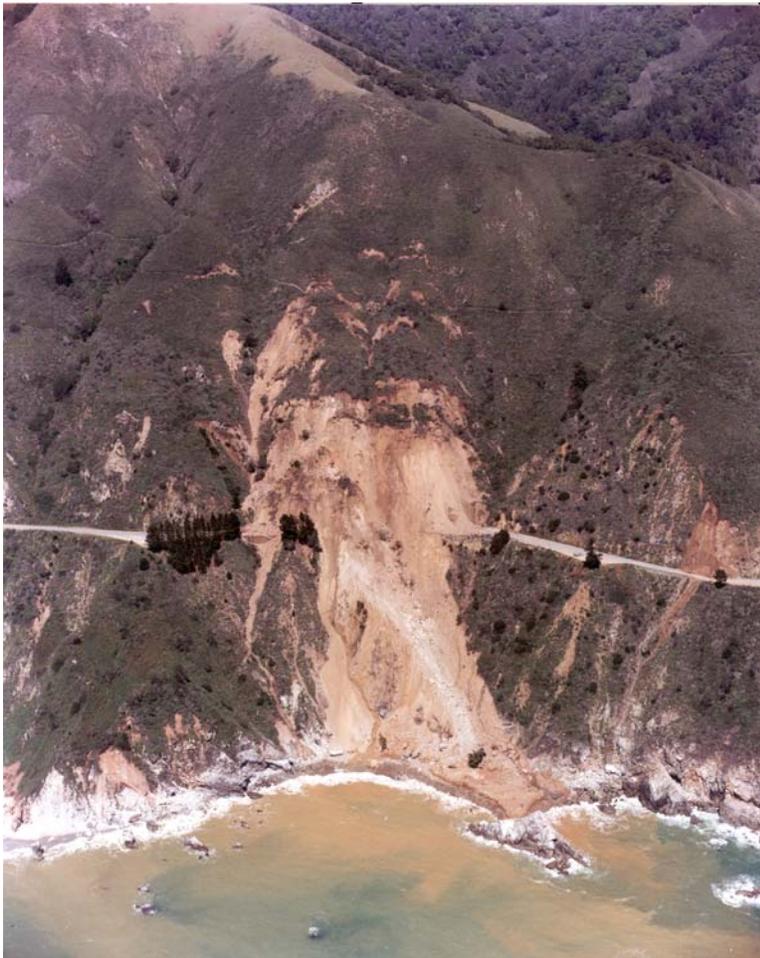
Figure 6. Aerial view of the McWay slide of 1983. Photo by Lynn Harrison, Caltrans

Overall, this segment has a moderate potential for landslides, largely related to small rockfalls and debris slides, but there are zones of weakness in the tonalite, and major landslides have occurred in exceptional circumstances. The heavy rainfall in the winter of 1983 was one such circumstance, because it triggered not only the largest slide on this segment, the McWay (or J.P. Burns) slide at P.M. 36.25 (Works, 1984; Figure 6), but also a similar slide at Sycamore Draw.
