CORRELATION BETWEEN RECORDED BUILDING DATA AND NON-STRUCTURAL DAMAGE DURING THE LOMA PRIETA EARTHQUAKE

Dr. Satwant S. Rihal
Professor, Architectural Engineering Department
Cal Poly State University, San Luis Obispo, CA 93407

INSTRUMENTED BUILDING CASE-STUDY SANTA CLARA COUNTY SERVICES BUILDING - SAN JOSE

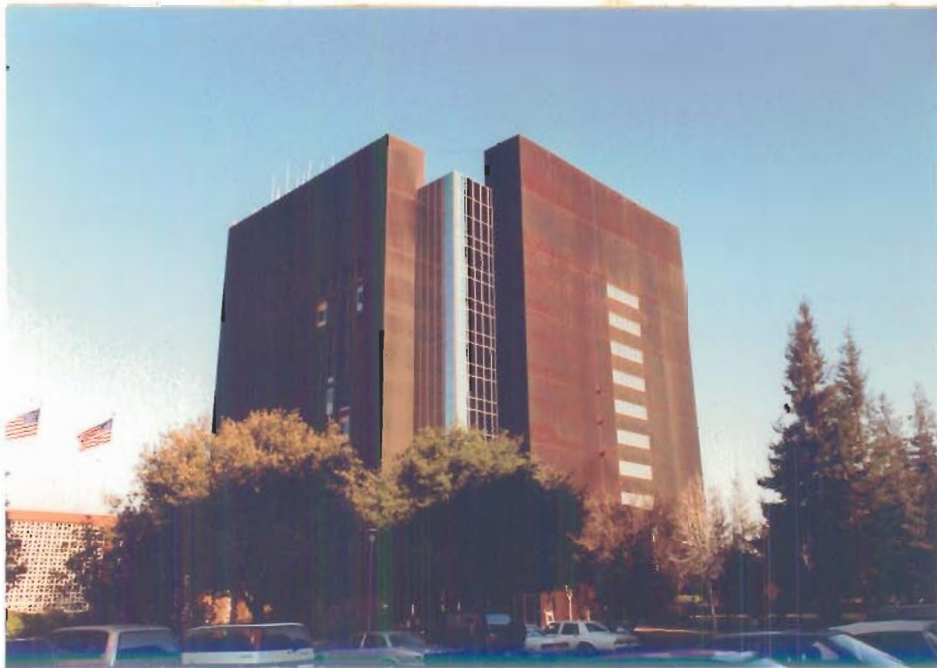
Figure 1. Santa Clara County Government Center - San Jose
Overall View from South-West

After initial study it was decided to lead this research project with a case-study of the Santa Clara County Government Center Building located in downtown San Jose. This building has been the source of recorded data from two previous earthquakes in 1984 and 1986, and has been the subject of studies during these previous earthquakes. The overall view of this case-study building is presented in Figures 1 and 2.

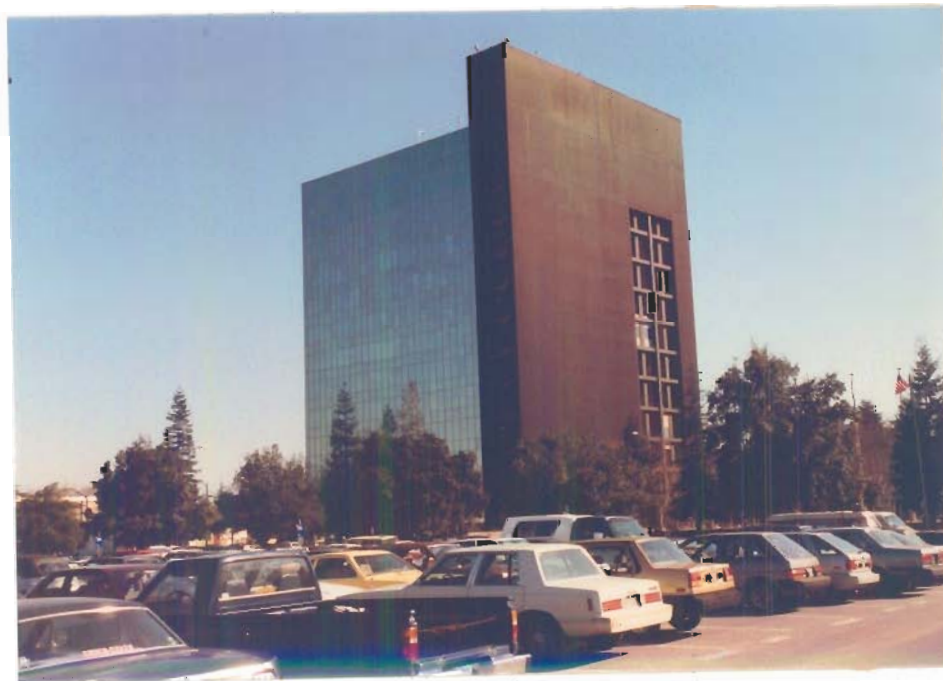
Figure 2. Santa Clara County Government Center - San Jose
Overall View from the North-West

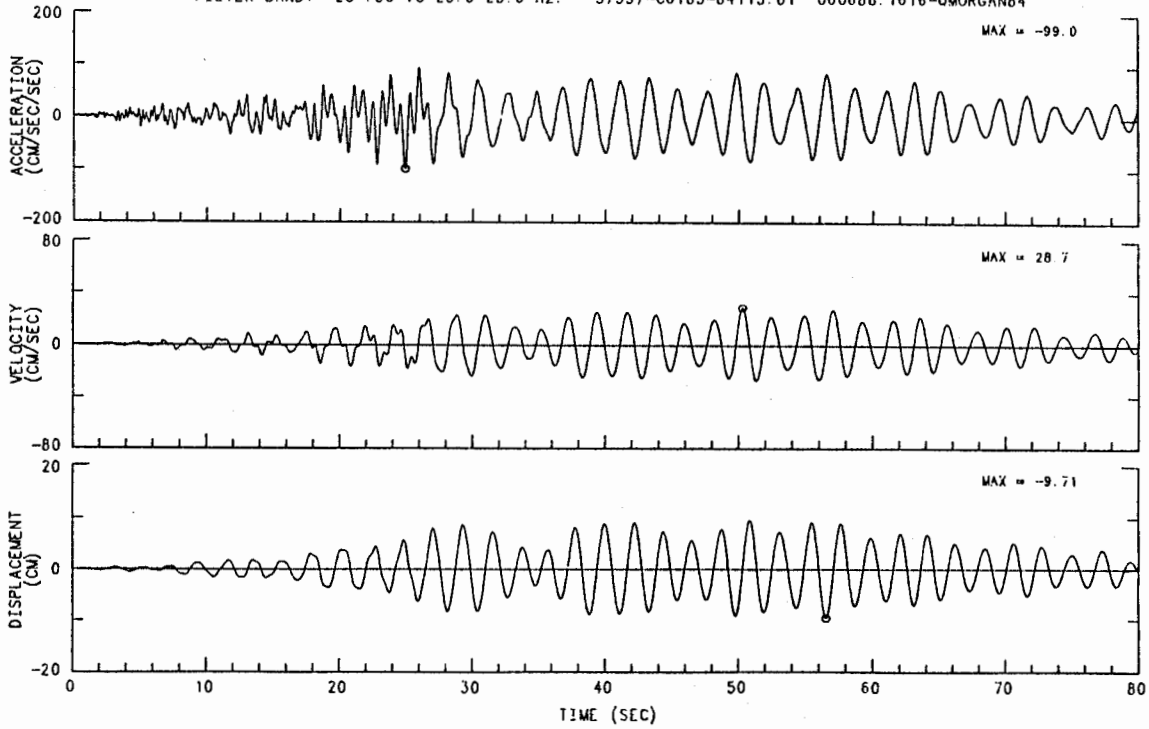
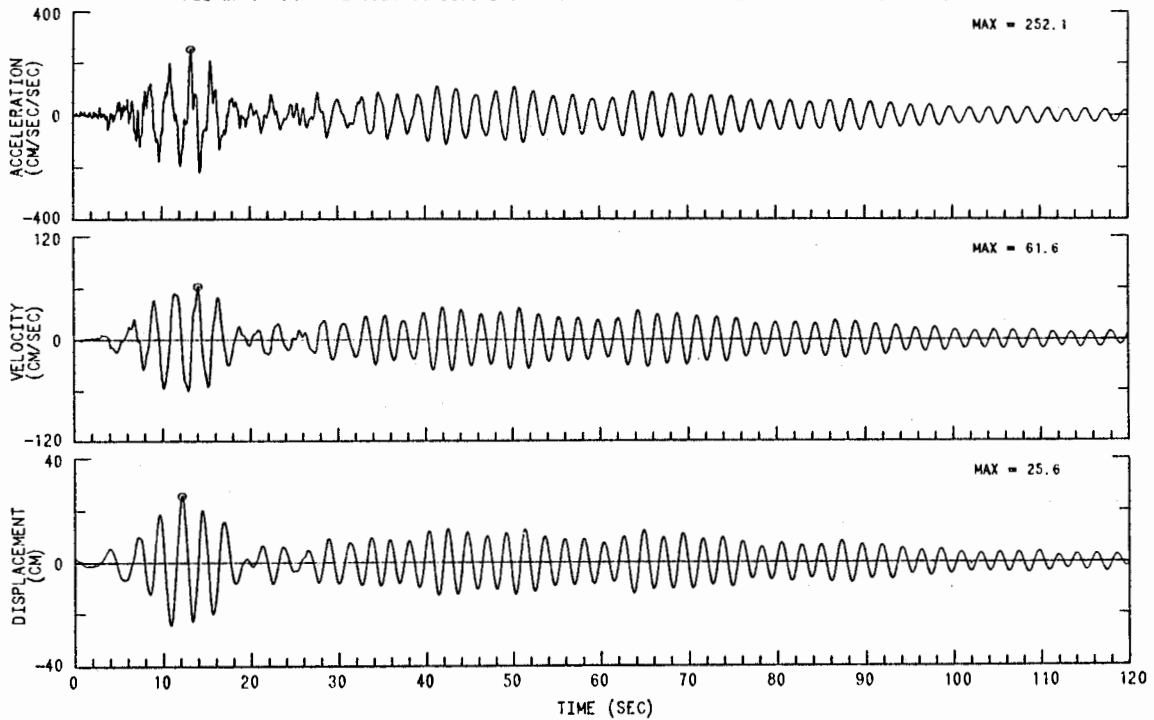
Figure 6
Source: Ref. [3], [4]

MORGAN HILL EARTHQUAKE APRIL 24, 1984 13:15 PST
SAN JOSE - SANTA CLARA CO. BLDG. CHN 12: 90 DEG (7TH FLOOR, NORTHWEST CORNER)
INSTRUMENT-CORRECTED AND BANDPASS-FILTERED ACCELERATION, VELOCITY AND DISPLACEMENT
FILTER BAND: 20-30 TO 23.0-25.0 HZ. 57357-C0185-84115.01 060688.1616-QMORGAN84

SANTA CRUZ MTNS (LOMA PRIETA) EARTHQUAKE OCTOBER 17, 1989 17:04 PDT
SAN JOSE - 13-STORY GOVT. OFFICE BLDG. CHN 12: 90 DEG (7TH FLOOR, NW CORNER)
INSTRUMENT-CORRECTED AND BANDPASS-FILTERED ACCELERATION, VELOCITY AND DISPLACEMENT
FILTER BAND: 0.12-0.24 TO 23.0-25.0 HZ. 57357-C0185-89291.03 032191.1634-QL89A357A

The typical recorded and processed data obtained from the strong motion instruments in the Santa Clara County Services Building, as provided by the CSMIP program [4] is shown in Figure 6.

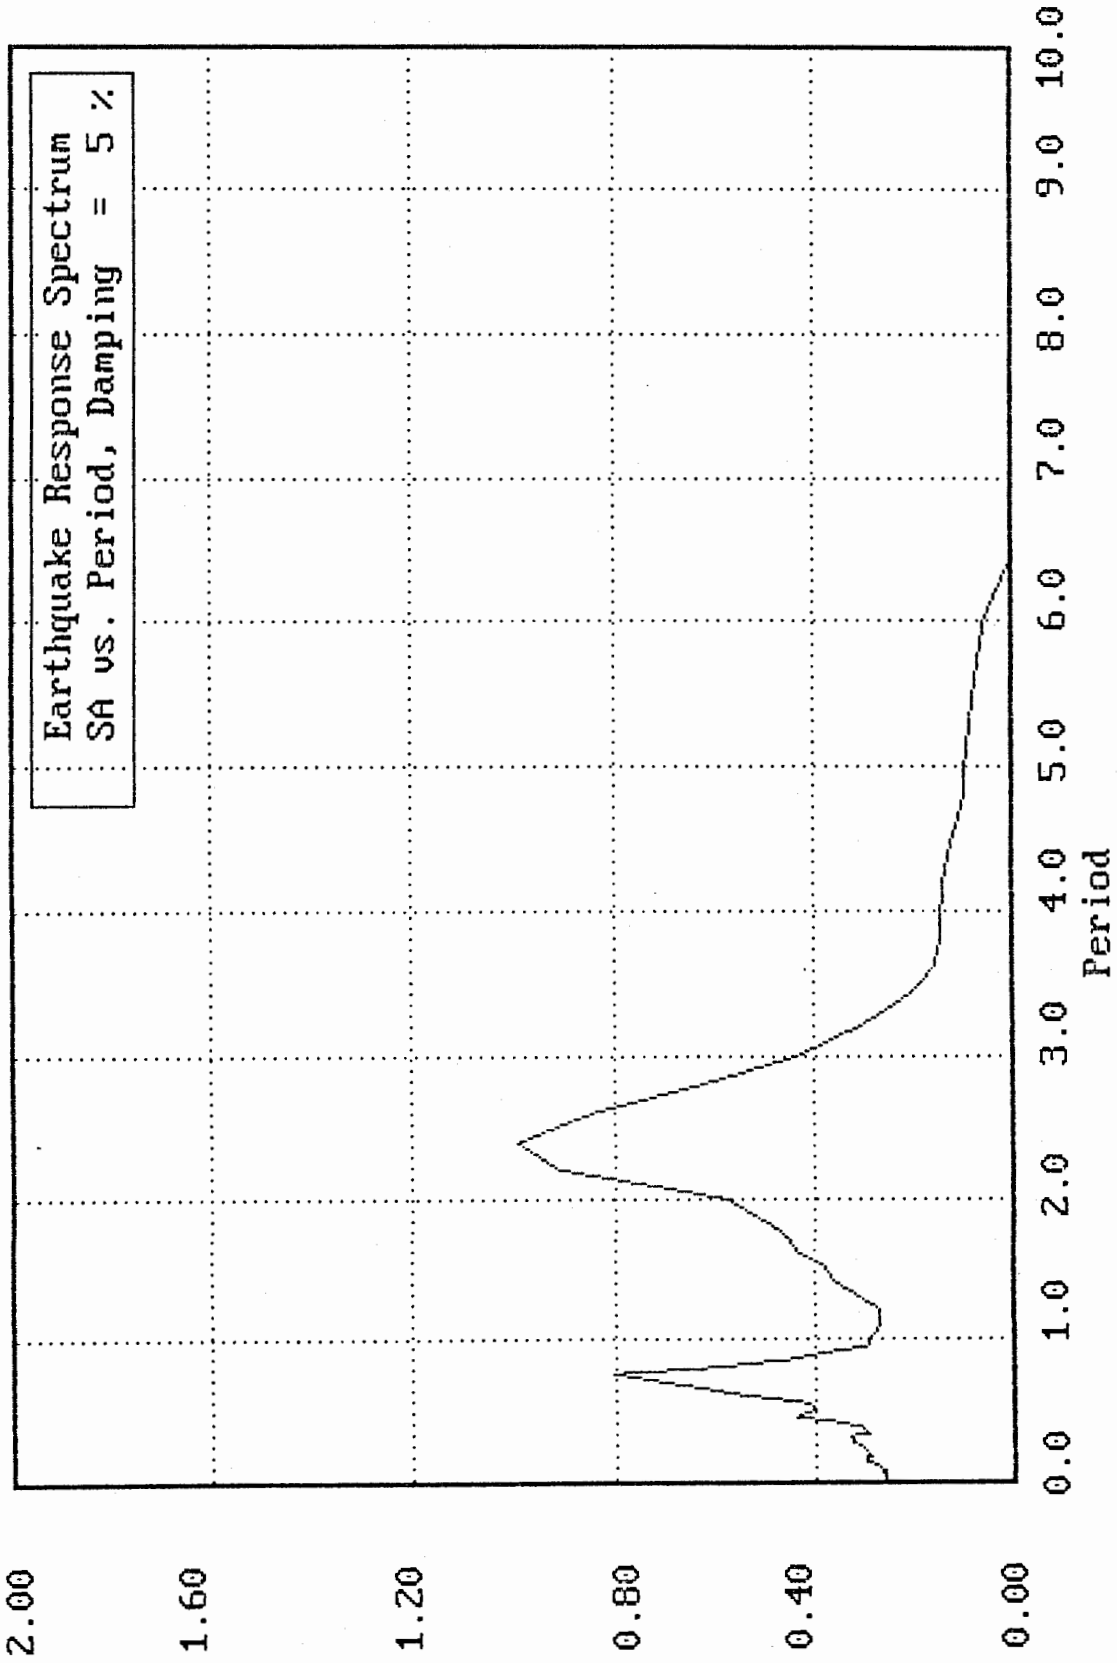
Figure 7

SANTA CRUZ MTNS (LOMA PRIETA) EARTHQUAKE OCTOBER 17, 1989 17:04 PDT
 SAN JOSE - 13-STORY GOVT. OFFICE BLDG.

CHAN 12: 90 DEG (STA CHN: 12) LOCATION: 7TH FLOOR, NW CORNER

A typical floor acceleration response spectrum for the 7th floor (NW corner) based on CSMIP vol. 3 [4] data for this building is presented in Figure 7.
