SMIP91 Seminar Proceedings

Degradation of Plywood Roof Diaphragms under Multiple Earthquake Loading

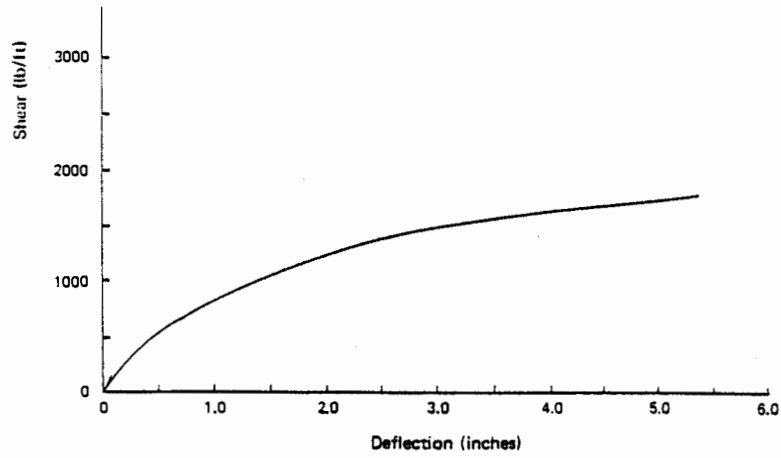
Figure 6. Shear-Deflection Plot for 1/2 inch Plywood Diaphragm. (APA)

Comparing the plots of the acceleration FFT's for the Morgan Hill and Hollister earthquakes with the plot for the Loma Prieta earthquake, a shift in the predominant frequency of the roof diaphragm is noted. This indicates a softening of the diaphragm stiffness. The magnitude of change in predominant frequency and the associated changes in the relative diaphragm stiffness between the three earthquakes is presented in Table 3. This degradation or softening of plywood diaphragms under high loads has been previously noted in static tests⁸. Non-cyclical tests of plywood diaphragms have shown them to be highly non-linear. A substantial portion of this non-linearity can be attributed to nail slip, a progressive and degenerative process. A representative load-deflection curve of test on a full size 1/2 inch plywood diaphragm, showing degradation of diaphragm stiffness with increasing load is shown in Figure 6.

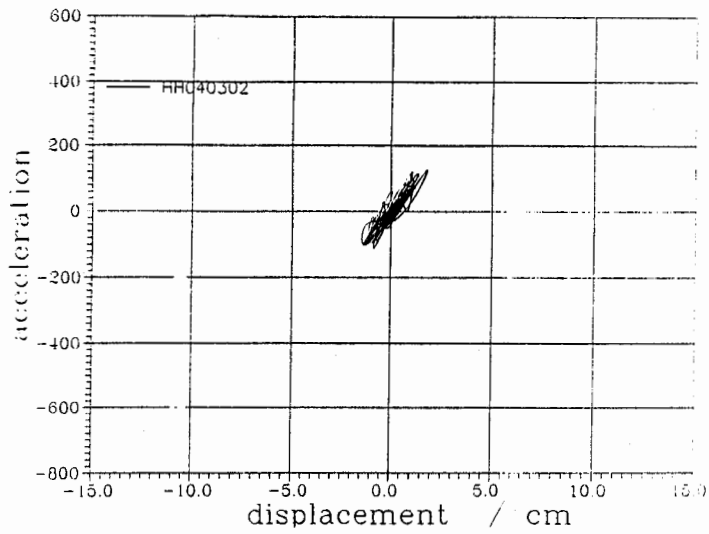
Figure 7. Acceleration vs. Displacement Hollister earthquake, January 26, 1986.

Plots of acceleration versus displacement at the center of the roof (channel 4) for the Hollister and Loma Prieta earthquakes are shown in Figures 7 and 8. The acceleration versus displacement plot for the Hollister earthquake (Figure 7) is generally linear, indicating that the diaphragm remained essentially elastic and suffered no apparent degradation in stiffness due to the earthquake. This correlates well with the computed D/C_v of 0.93. The plot for the Loma Prieta earthquake (Figure 8) shows considerable softening of the diaphragm, as evidenced by the trend towards decreasing slope in the acceleration versus displacement plot. The magnitude of the change in diaphragm stiffness is in good agreement with the change in stiffness predicted by the period shifts observed using the FFT.
