CALIFORNIA DEPARTMENT OF CONSERVATION DIVISION OF MINES AND GEOLOGY

SPECIAL PUBLICATION 115

PLANNING SCENARIO IN HUMBOLDT AND DEL NORTE COUNTIES, CALIFORNIA FOR A GREAT EARTHQUAKE ON THE CASCADIA SUBDUCTION ZONE

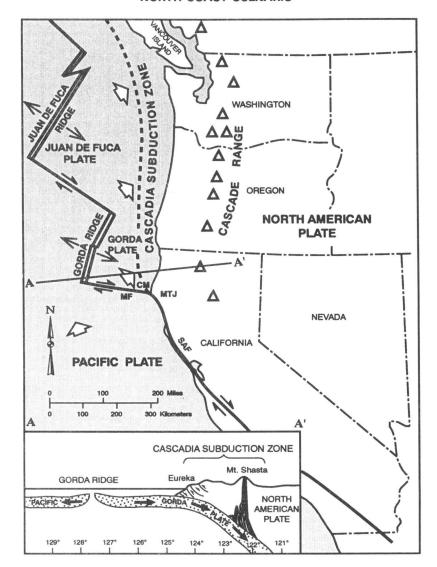
Figure S-1 Simplified map of northwestern California regional tectonics. To the south of the Mendocino triple junction (MTJ), the San Andreas fault system (SAF) is the transform (strike-slip) boundary between the Pacific and North American plates. North of Cape Mendocino (CM), the Juan de Fuca and Gorda plates are converging with the North American plate along the Cascadia subduction zone. West of Cape Mendocino, the Mendocino fault (MF) is the transform boundary between the Pacific plate and the Gorda plate. White arrows denote plate motion relative to North America; black arrows denote relative plate motion at plate boundaries. The inset is a simplified cross section of the southern Gorda plate being subducted beneath the North American plate in northern California. Reproduced from Dengler and others, 1992.

The CSZ is a 750 mile (1,200 km) long thrust fault extending offshore from northern California to southern Canada, and dipping gently eastward beneath North America (Figure S-1). On the south end, the CSZ intersects both the Mendocino fault and the San Andreas fault at the Mendocino triple junction. To the north, the fault zone intersects the Queen Charlotte fault, off the shore of British Columbia. The CSZ contains several plate segments that are subducting or thrusting beneath North America, as shown in Figure S-1. The southernmost segment is the 150 mile (240 km) long Gorda plate, which extends from Cape Mendocino to southernmost Oregon.

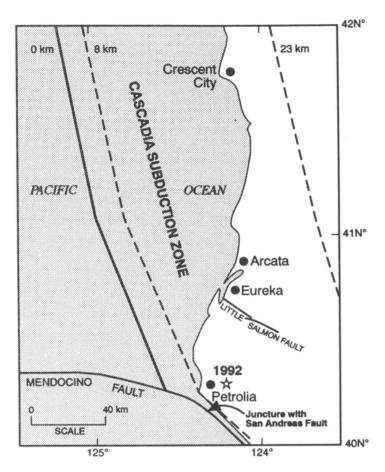
Figure S-2 The Gorda segment of the Cascadia Subduction zone (CSZ). The southern terminus is at the triple junction where it meets the Mendocino fault and the San Andreas, near the epicenter (star) of the 1992 Petrolia earthquake. The CSZ dips gently beneath Humboldt and Del Norte counties. It surfaces in the ocean bottom, indicated by 0 km. The earthquake-producing portion is between depths of 8 km and 23 km.

Little is known about the possible independent seismic activity of the Gorda segment of the CSZ. Offshore reflection and refraction data indicate that the CSZ crops out some 40 miles (60 km) west of Eureka in water 1.5 miles (2.5 km) deep (Greene and Kennedy, 1989). Clarke (1992) indicates that the earthquake-producing or seismogenic portion of the subducting plate may be distinguished by faults and folded sediments in the overriding plate that trend nearly normal to the direction of plate convergence. The seismogenic zone may also be distinguished by seismicity having compressional mechanisms. He suggests that the interface dips easterly at about 11 degrees, and that the seismogenic zone extends from about 12 miles (20 km) eastward of the surface trace of the CSZ at a depth of 5 miles (8 km) for about 50 miles (80 km), to a depth of about 14 miles (23 km), as indicated in Figure S-2.

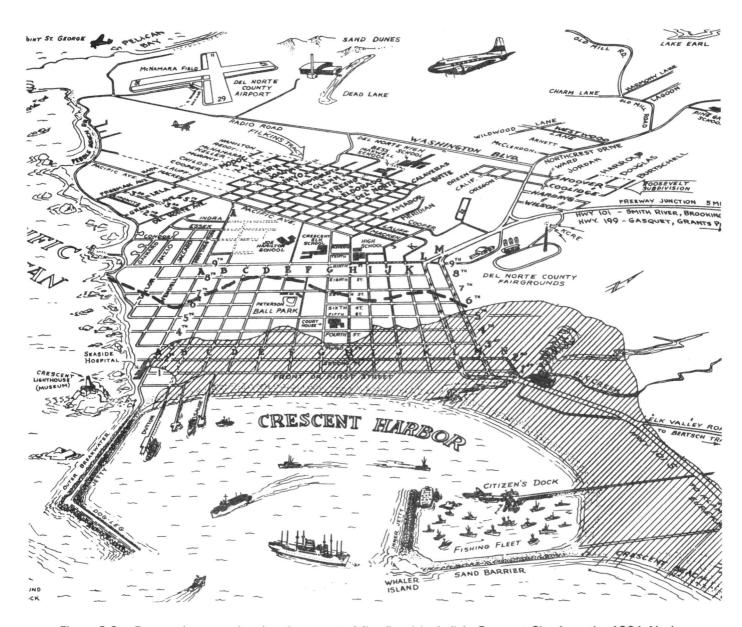
Figure S-3 Perspective map showing the extent of flooding (shaded) in Crescent City from the 1964 Alaska earthquake tsunami. Reproduced with permission of W.H. Griffin, Crescent City Printing Co., Inc. The postulated extent of flooding from the scenario event is dashed for comparison.

At Crescent City the tsunami destruction will exceed that which occurred from the 1964 Alaska tsunami. Figure S-3 shows that the 1964 run-up reached 4th Street, while this scenario postulates tsunami run-up reaching 8th Street. Crescent City experienced ten fatalities and over \$7 million in damage from the tsunami caused by the 1964 Great Alaska earthquake (M9.2). Serious damage can be expected to the part of the city and the unincorporated area of Del Norte County that lies to the southeast of Front and M streets along the shoreline, as happened in 1964. This area consists of hotels, motels, restaurants, marinas, commercial establishments, and some residences. In addition to the force of the wave, damage will result from water driven debris, such as logs, small boats, building materials, vehicles, etc. The following accounts from Crescent City of the 1964 tsunami are instructive:

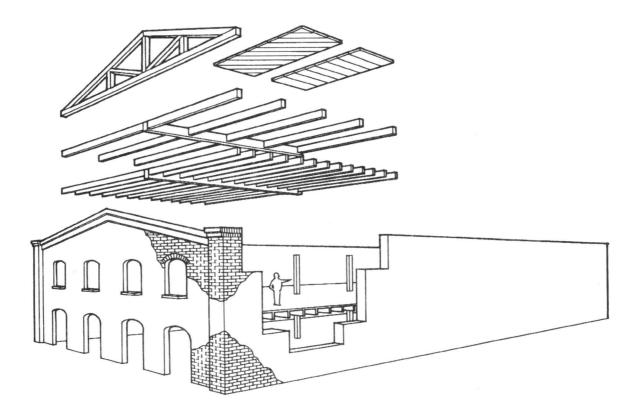
Figure B-1 Typical unreinforced masonry bearing wall building (URM). From Lagorio and others (1986).

These are old brick buildings (Figure B-1) built in the 1930s or before. Some are historic structures. URM structures, particularly bearing-wall structures, are classified as one of the more hazardous

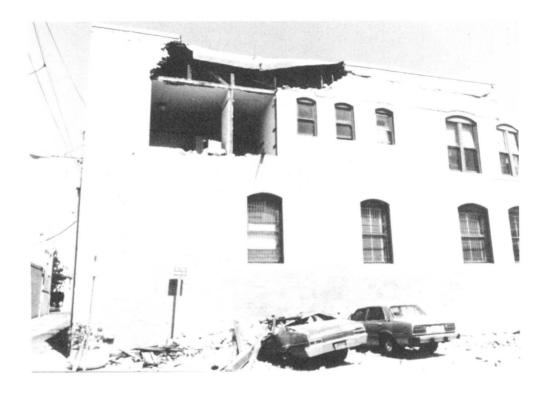
Photo B-1 Unreinforced brick buildings frequently lose parts of walls in earthquakes. Falling brick is a major life-safety concern. This structure was damaged in the 1987 Whittier earthquake. Photo by Ronald Gallagher.

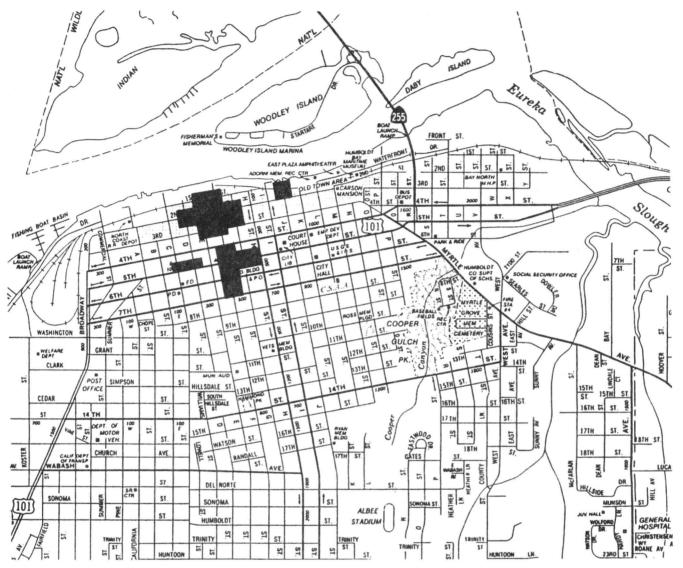
Figure B-2 Schematic distribution of URMs in Eureka.

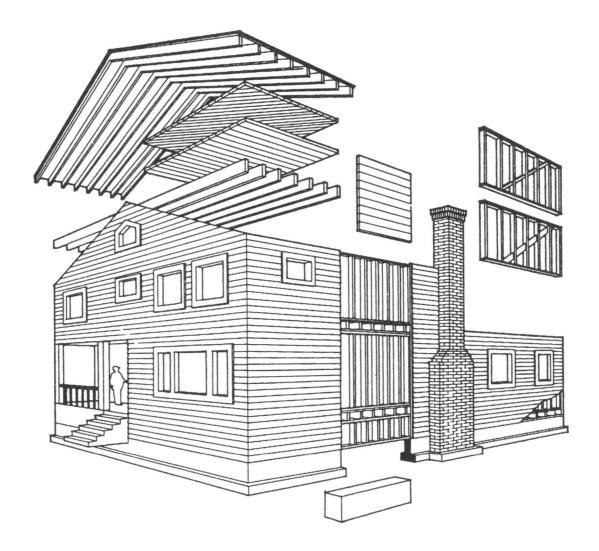
Figure B-3 Typical pre-1940 wood frame building. *Lagorio and others, 1986*.

NOTE: Foundations are commonly post and pier in Humboldt and Del Norte counties.

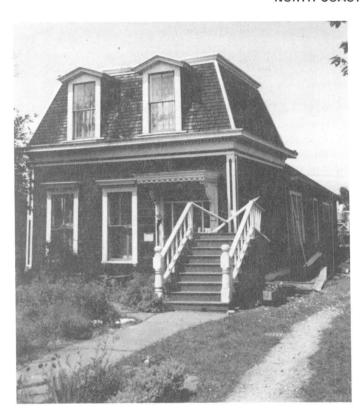
Photo B-2

The front door was at the top of the stairs before this Ferndale house was shaken off its foundation. *Photo by Kevin Bayliss.*

Elevated unbraced foundations collapsed on more than a dozen Ferndale houses (Photo B-2). While much of this damage was repairable, some houses were a total loss. This damage imposed an added burden on the community of finding shelter for the inhabitants at a time when community resources were already severely taxed.

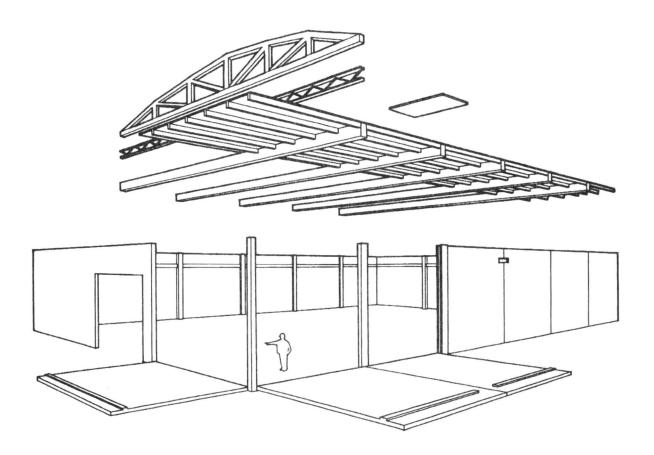
Figure B-4 Typical pre-1973 tilt-up construction. From Lagorio and others, 1986.

Earthquake problems associated with <u>tilt-up construction</u> can be significant. Probably the most common cause of severe damage has been separation between the concrete tilt-up wall panels and the roof (Figure B-4). Many tilt-up buildings constructed before the mid-1970s have weak connections between walls and roof and between walls and floors. This can lead to collapse of the roof and floors and cause the wall panels to fall outward. The consequence of tilt-up building failure are both life-safety and economic. These buildings are often found in industrial parks, or are used as warehouses or even office buildings, and even one or two-wall failures can shut down entire buildings. A great many tilt-up buildings failed during the 1971 San Fernando earthquake.

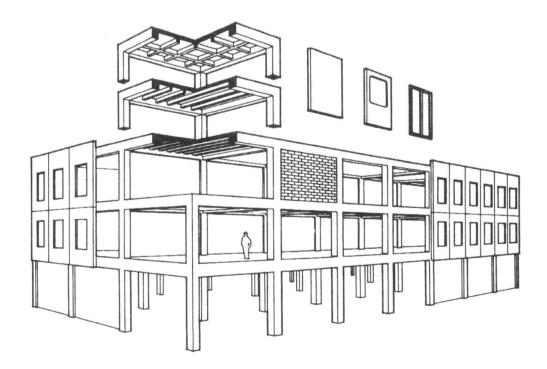
Figure B-5 Typical non-ductile concrete frame. From Lagorio and others, 1986.

Structures with <u>non-ductile concrete</u> frames (Figure B-5) may collapse. These are typically old reinforced concrete frame structures without modern standards for detailing reinforcement in columns, beams, and joints. The strength and stiffness of these structures can degrade rapidly in an earthquake, causing serious damage or collapse (Photos B-4 and B-5). The Cypress viaduct, which collapsed in Oakland during the Loma Prieta earthquake with a loss of 42 lives, is an example of a non-ductile concrete structure which met code requirements when it was built (Photo H-1).

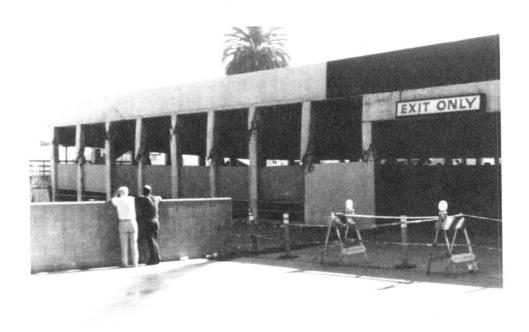
Photo B-4 This non-ductile concrete parking structure suffered severe damage and partially collapsed in the 1987 Whittier earthquake. This type of construction is a collapse hazard under strong shaking. *Photo by Ronald Gallagher.*

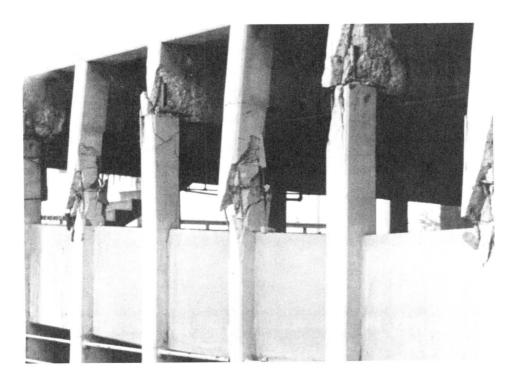
Photo B-5 Close-up of the parking structure showing structural failure of the non-ductile concrete columns. *Photo by Ronald Gallagher*.

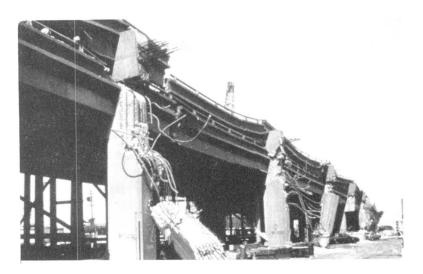
Photo H-1

Collapsed steel rebar and concrete columns of the Cypress I-880 freeway structure, Oakland, California. A 1-mile lenght of this double-decked reinforced-concrete viaduct collapsed onto commuter traffic during the Loma Prieta earthquake. The failed column in the foreground supported the top deck. Built in the 1950s, the columns had vertical steel reinforcing rods but lacked the spiral reinforcing rods used in modern construction. Photo by Michael Rymer, courtesy of the U.S. Geological Survey.

We reviewed the general characteristics of the structures in light of their historic failure mechanisms. In particular, the damage patterns witnessed during the Loma Prieta earthquake were used for many of the predictions in this scenario. In some instances damage can occur in MMI VII zones far from the epicenter, when soil conditions and the period of a long structure lead to resonant amplification. Collapse of the Cypress Structure during the Loma Prieta earthquake is the classic example (Photo H-1).

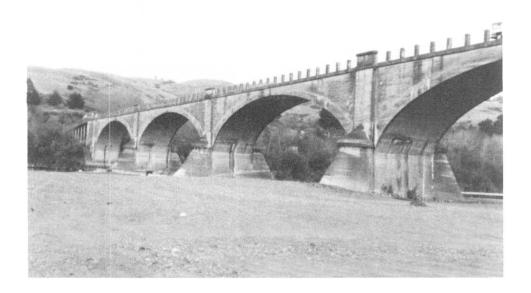
Photo H-2 The old bridge across the Eel River at Fernbridge.

This route will have moderate structure damage and pavement separation and settlement problems will develop due to liquefaction. The old bridge over the Eel River (Photo H-2) will be severely damaged.

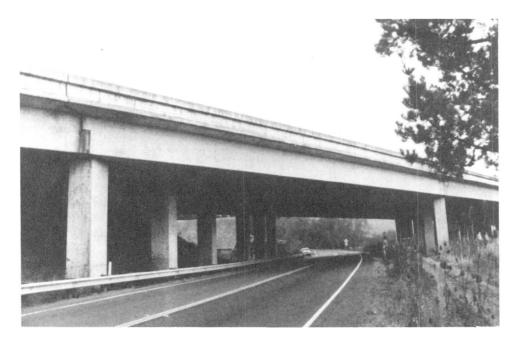
Photo H-3 Route 101 Fields Landing Overhead.

Two of the four spans of the Fields Landing Overhead (locally known as Tompkins Hill Road Overpass) collapsed in the 1980 M7.0 earthquake (Semans and Zelinski, 1980, photos 1 to 38; Kilbourne and Saucedo, 1981, photos 2 to 3). The two spans were replaced more or less according to the original design (Photo H-3) and both the old and the new spans were retrofitted with hinge restrainers to prevent future support failures.

The superstructure has undergone up to 2 inches of progressive lateral movement between 1965 and 1980 (Semans and Zelinski, 1980, p. 2). Caltrans now expects this structure to perform much better and only suffer minor damage. In 1980, however, the intensity was only VII at Fields Landing (Kilbourne and Saucedo, 1981), whereas the scenario event will produce MMI IX with a shaking duration many times what it was in 1980. The bridge is founded in soft, saturated, sandy sediments and the scenario event will produce liquefaction and subsidence of many of the supports. The Little Salmon fault traverses the northern approach of the overhead (refer to Wills, 1990 for details). Slip along this fault will produce up to 12 feet (4 m) of thrust movement across a zone tens of feet wide (Carver, 1993).

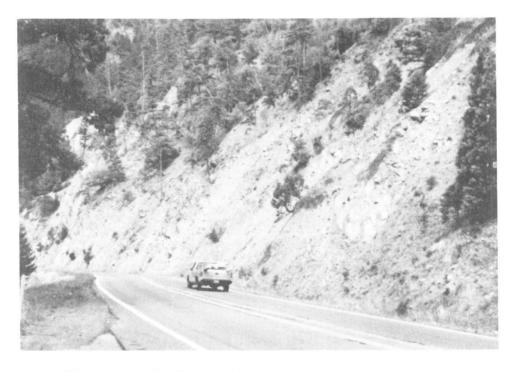
Photo H-4 Route 199 between Cedar Springs and Washington Flat.

This is one of only two roads leading into the study area from the north. The route has very steep slopes with numerous perched rocks above the roadway (Photo H-4).

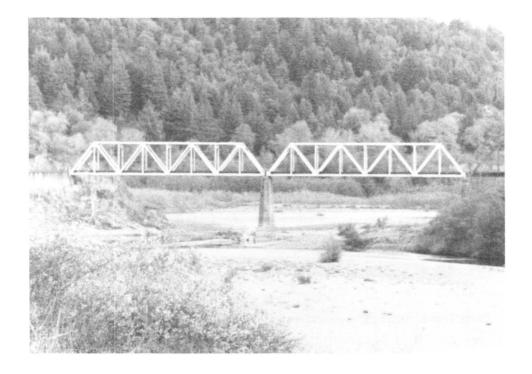
Photo R-1 Railroad bridge across South Fork Eel River at Scotia.

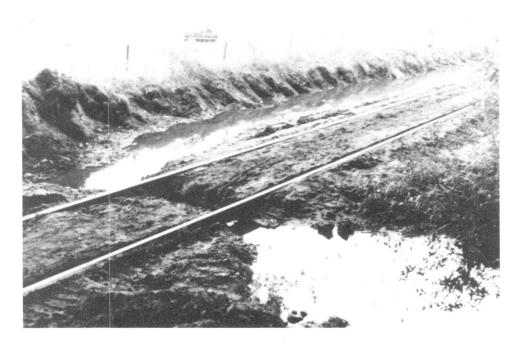
Photo R-2 Railroad tracks beneath Fields Landing overpass.

The overpass on Route 101 could fall onto the tracks as occurred in 1980. Beneath the overpass the railroad tracks cross a drainage area underlain by fine sand which is subject to liquefaction (Photo R-2). Either or both situations will stop service on this segment.

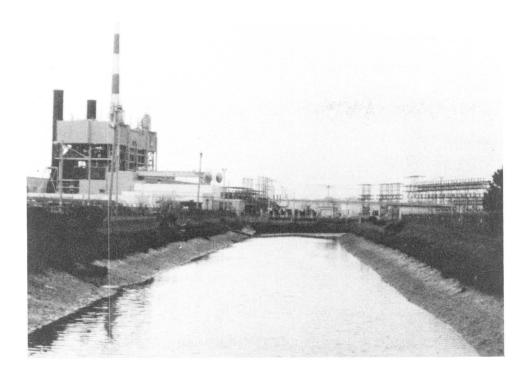
Photo E-1 Humboldt Bay Power Plant, cooling water channel and substation.

Photo E-1 shows the power plant and part of the substation, and the cooling water channel which will be a free face during liquefaction. Damage to the equipment at the Humboldt Bay Power Plant substation will be substantial in this scenario earthquake.

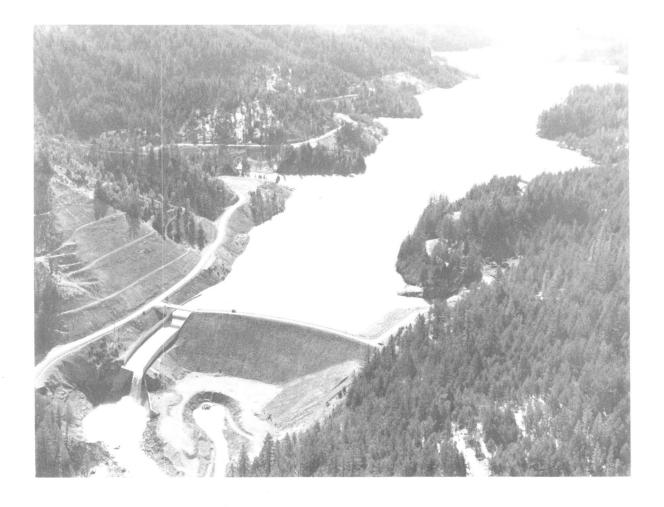
Photo W-1 Matthews Dam and Ruth Lake.
