# EARTHQUAKE PLANNING SCENARIO

FOR A MAGNITUDE 7.5 EARTHQUAKE  
ON THE HAYWARD FAULT IN THE  
SAN FRANCISCO BAY AREA

CALIFORNIA DEPARTMENT  
OF CONSERVATION

SPECIAL PUBLICATION 78

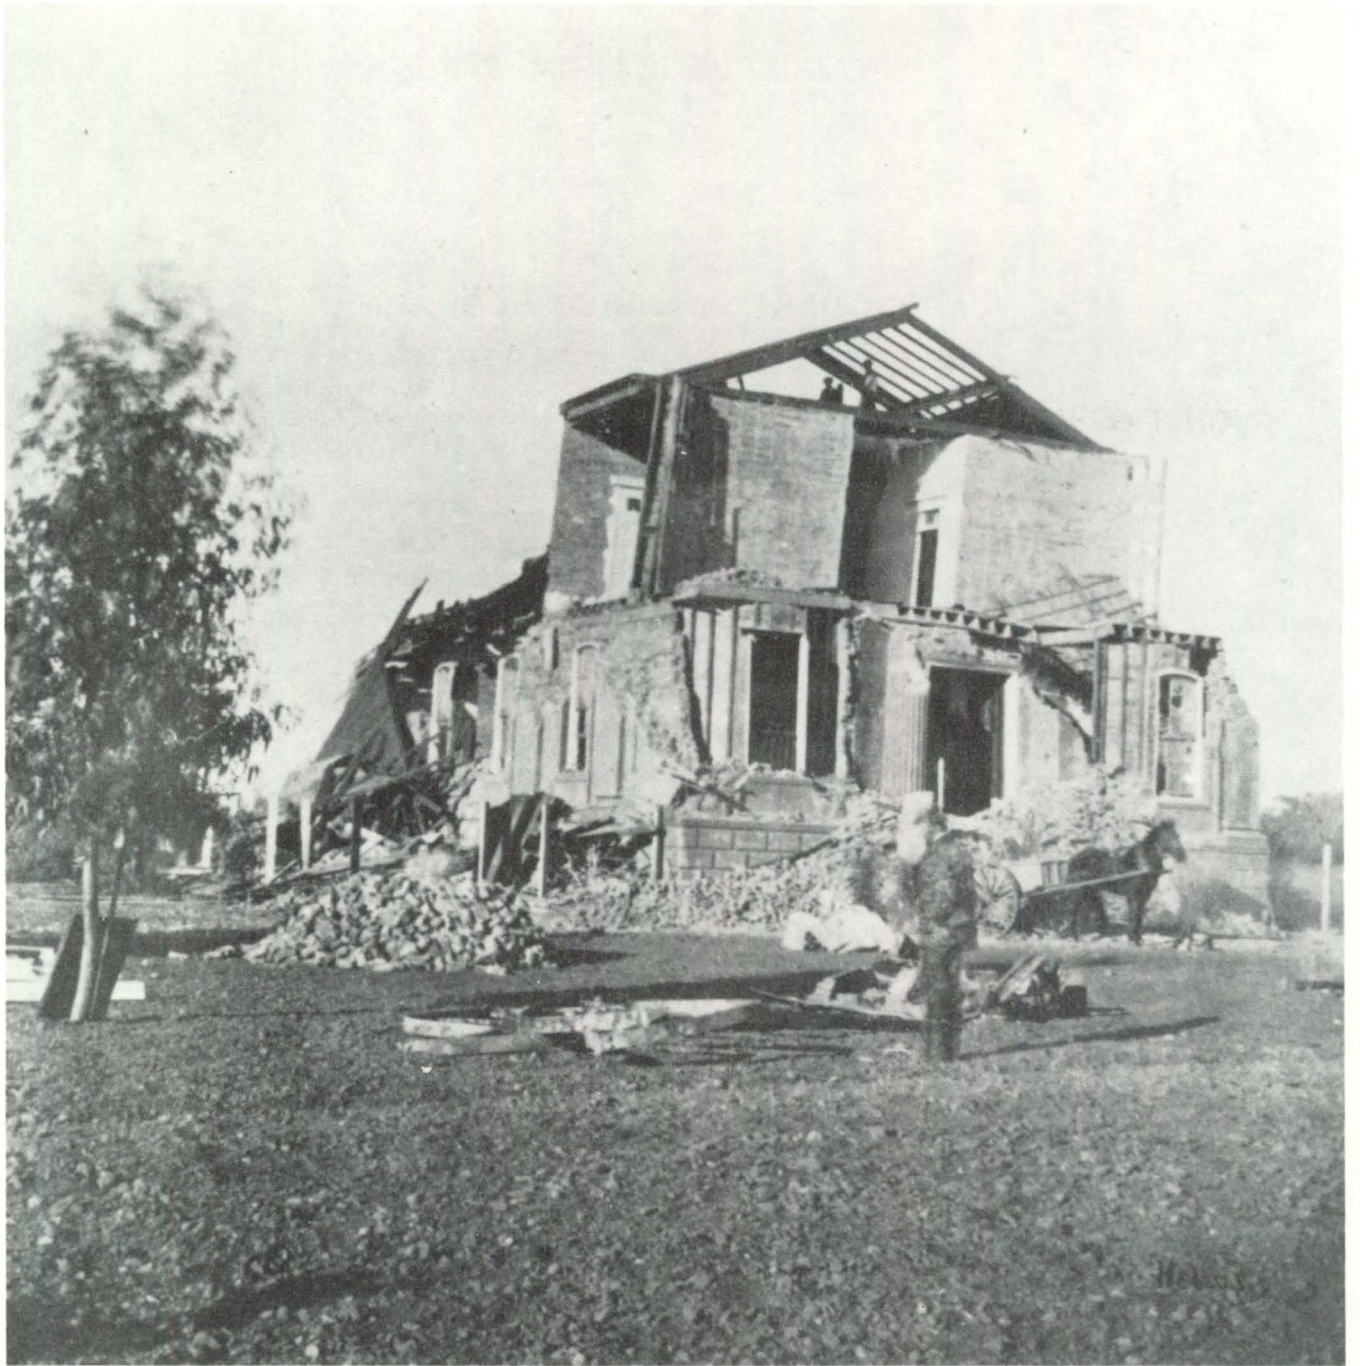
Courthouse at San Leandro after the Hayward earthquake of October 21, 1868.

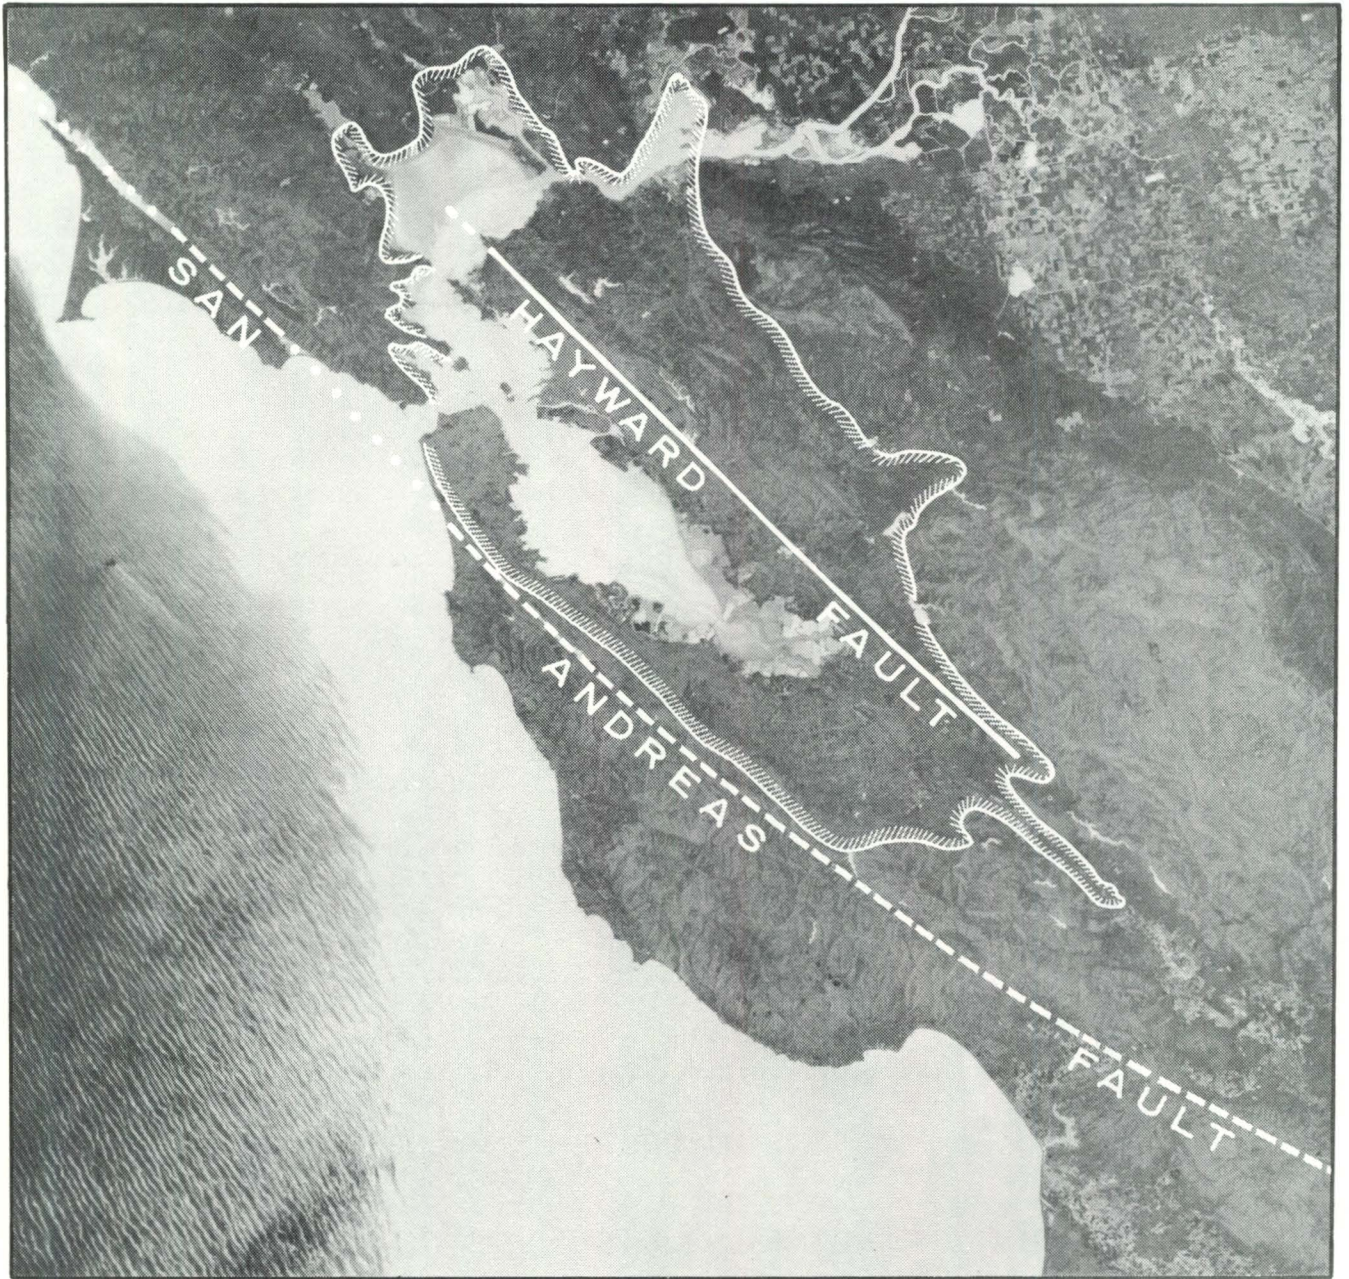
Figure 1. Landsat image of the San Francisco Bay area. The magnitude 7.5 scenario earthquake is the result of rupture of the entire 100-kilometer (62-mile) length of the Hayward fault. Prolonged strong shaking sufficient to cause significant structural damage (Modified Mercalli intensity VIII and greater) would occur throughout the area outlined. Note that downtown San Francisco is about equidistant from the Hayward and San Andreas faults and, therefore, vulnerable to a major earthquake originating on either fault.

Downtown San Francisco is situated about 10 miles east of the San Andreas fault and 10 miles west of the Hayward fault (Figure 1). Consequently, ground shaking in the downtown area resulting from a M7.5 event on the Hayward fault would be essentially the same as the shaking from a M<sup>~</sup>8 event on the San Andreas fault. This is because most of the strong ground motion at any given location is contributed by the 100-km length (approximately) of the causative fault that is nearest to that location (in this case, downtown San Francisco). In a M<sup>~</sup>8 San Andreas earthquake, faulting that occurs along the coast of Sonoma and Mendocino Counties north of the Bay area would generate destructive strong ground motion at Santa Rosa and Ukiah, but its contribution at San Francisco would be only to the long-period shaking affecting structures higher than about 10 stories. Communities further south on the San Francisco Peninsula are closer to the San Andreas fault and would, therefore, be more strongly affected by a large earthquake originating on that fault than by one originating on the Hayward fault.

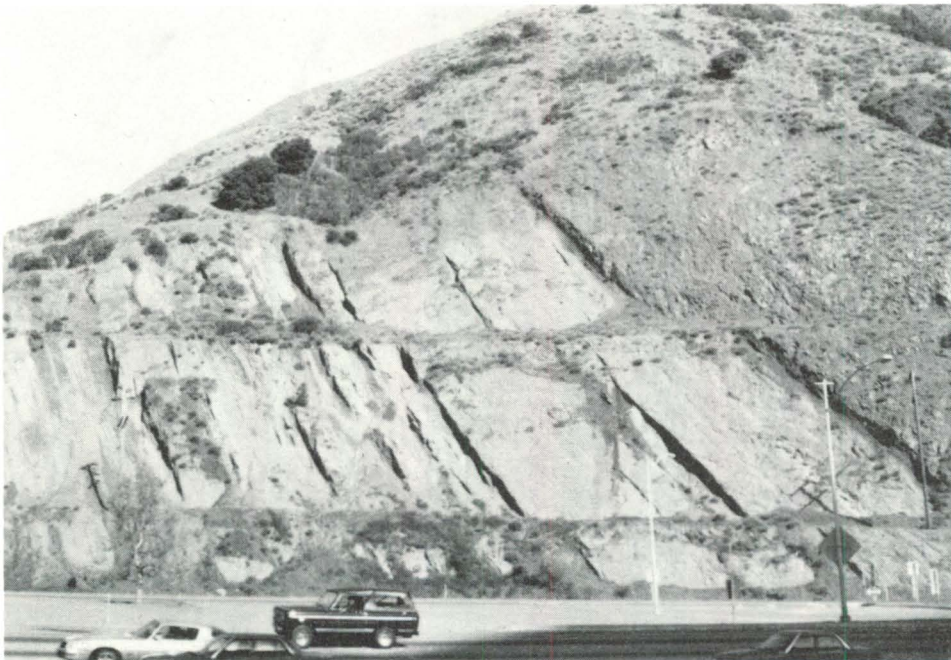
Former flatlying sediments stand almost vertical in this roadcut along Route 24 east of the Caldecott Tunnel. This deformation evidences the compressive forces that once prevailed along the boundary between the North American and Pacific plates.

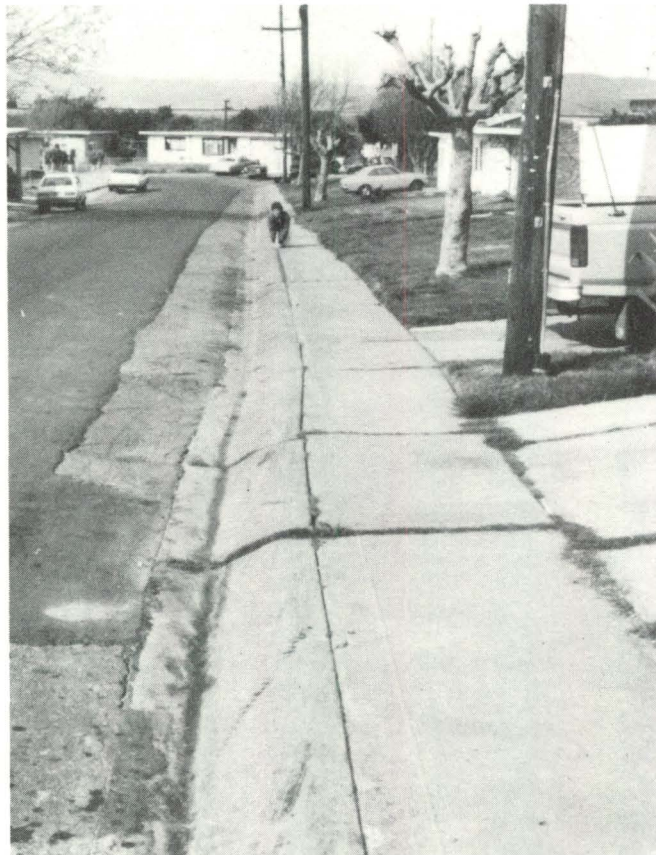
Fault creep totaling about 0.5 feet has occurred at this location on the Hayward fault in San Pablo since the sidewalk was constructed. Right-lateral movement is exemplified with the opposite side of the fault moving to the observer's right.

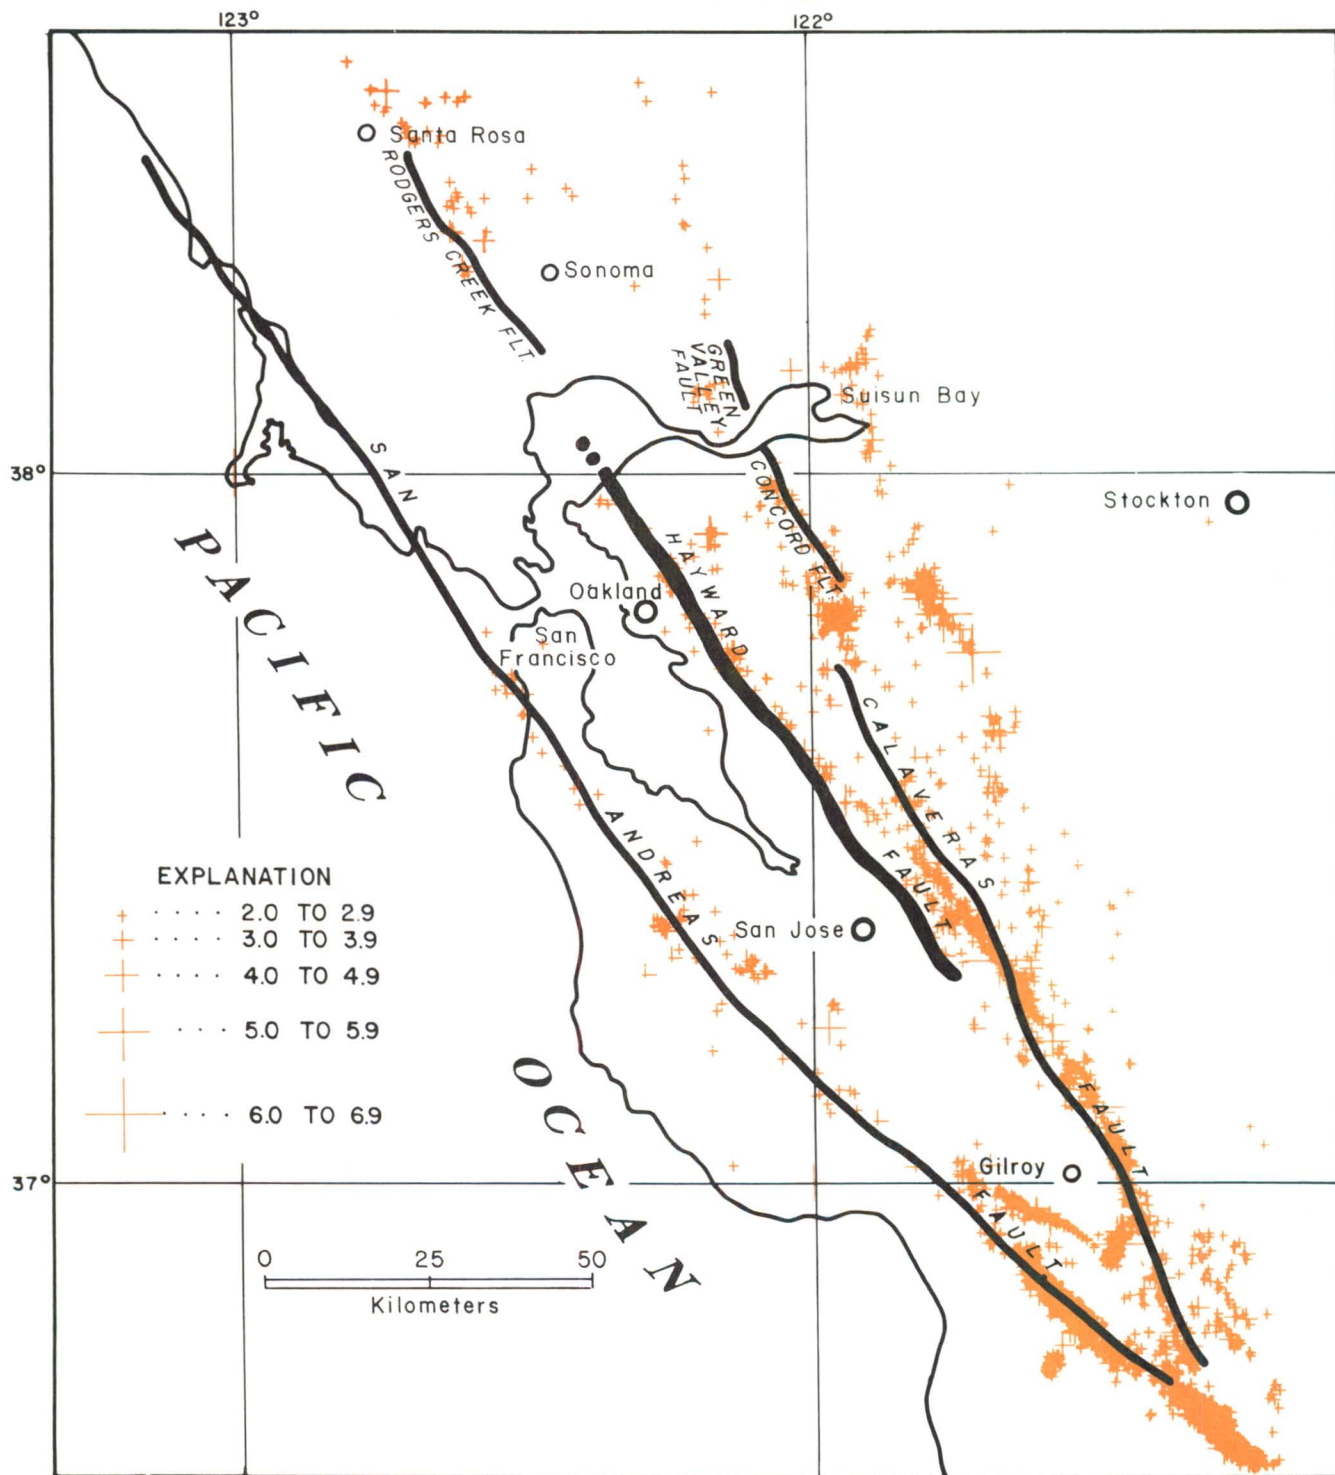
Figure 4. Epicenters of earthquakes of magnitude 2 and greater in the San Francisco Bay area from 1969 to 1984. Data from the U.S. Geological Survey central California seismograph network. Solid lines are the principal active faults.

Earthquakes in the San Francisco Bay area during the past 15 years are concentrated near the juncture of the San Andreas and Calaveras faults, and in the East Bay (Figure 4). Seismicity along the San Andreas fault on the San Francisco Peninsula is relatively low compared to the Calaveras-Hayward-Rodgers Creek fault zone. The April 1984 Morgan Hill earthquake occurred on the Calaveras fault near the southern end of the Hayward fault. This is the largest epicenter shown in Figure 4, and also appears in Figure 5. Other seismic trends east of San Francisco Bay are along the Concord fault and the Greenville fault. The latter is the easternmost trend shown in Figure 4 and was active in the January 1980 earthquakes that caused damage in Livermore Valley.

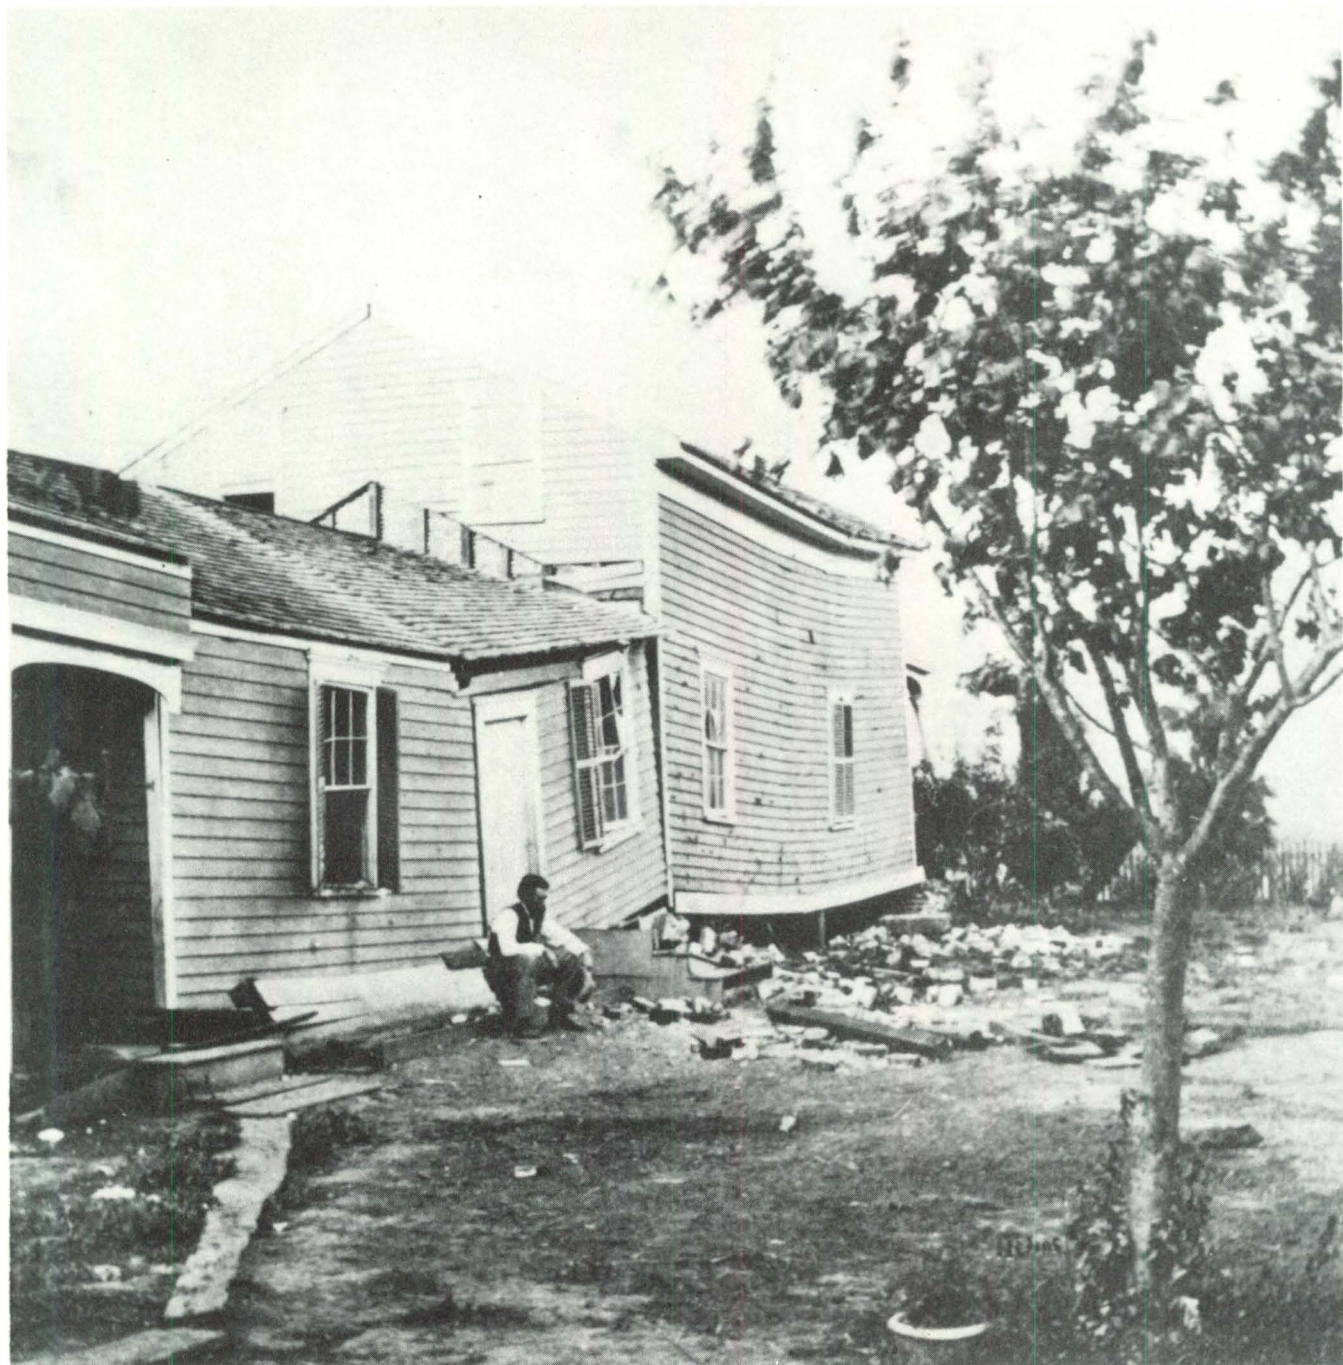
House at Hayward after the earthquake of 21 October 1868. Photo courtesy of the Bancroft Library, University of California, Berkeley.

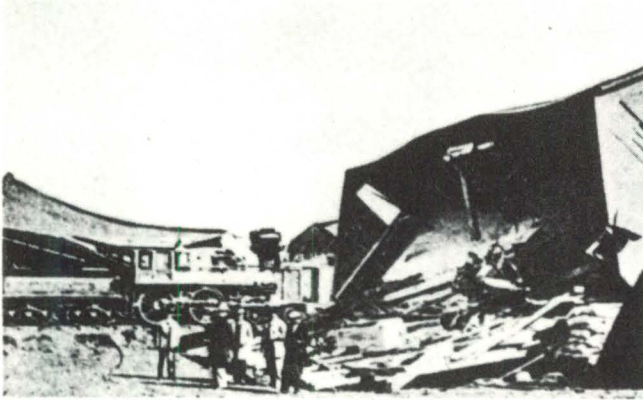
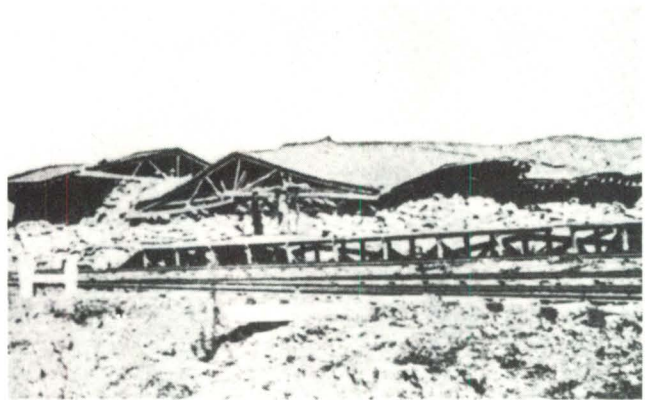
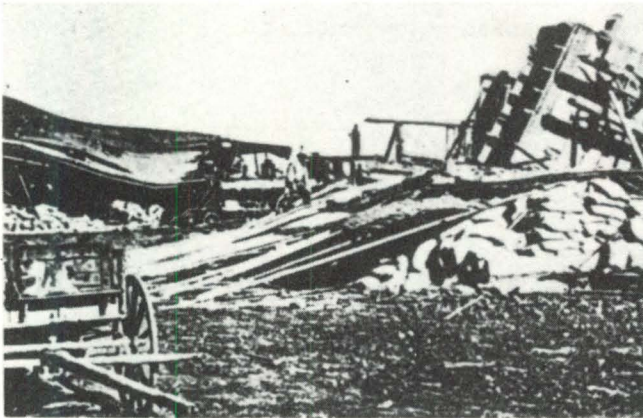
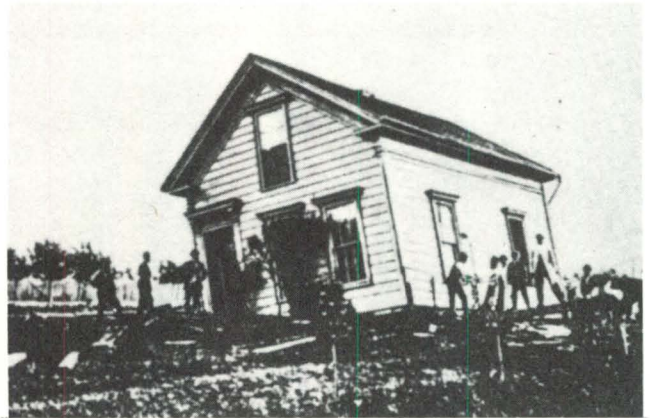
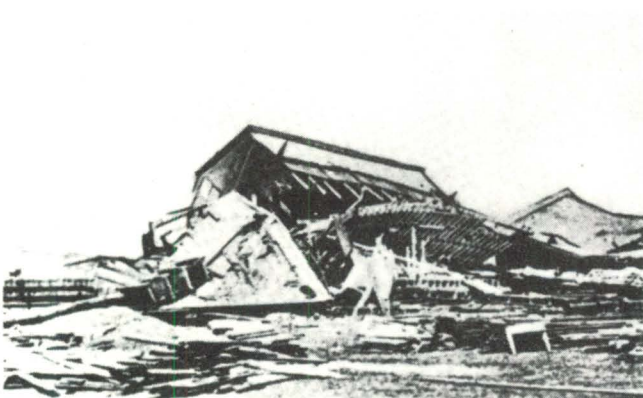
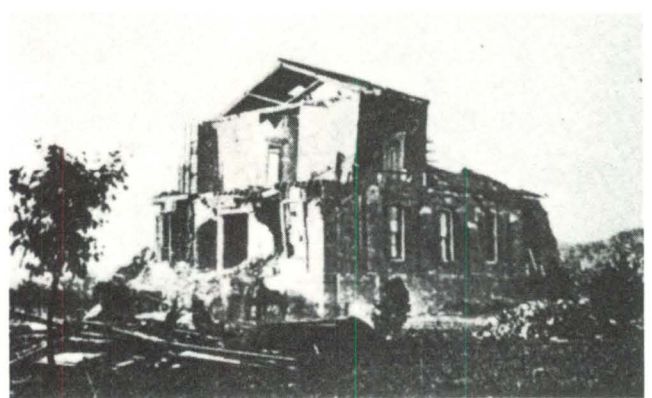
A. Flour mill, Haywards. Wrecked by earthquake of 1868.

B. Edmonson's warehouse, Haywards. Wrecked by earthquake of 1868.

C. Flour mill and warehouse, Haywards. Wrecked by earthquake of 1868.

E. Haywards. Wreck of buildings by earthquake of 1868.

F. Court-house, San Leandro. Wrecked by earthquake of 1868.

Figure 6. Earthquake damage near Hayward resulting from the 1868 Hayward Earthquake. (Reproduction of Plate 144 from Lawson, 1908).

The greatest damage was done at Haywards, where nearly every house was thrown off its foundations; while at San Leandro the shock was less severe. A house near old Blair Park, in the present Piedmont district of Oakland, was badly damaged. The only other town of that date in close proximity to the fault-trace was Mission San Jose, which lies in the hills a few hundred yards west of it. In this town were several adobe buildings, one of which, a church, was wrecked. Many chimneys were thrown, but the general effect was much less severe than at Haywards.

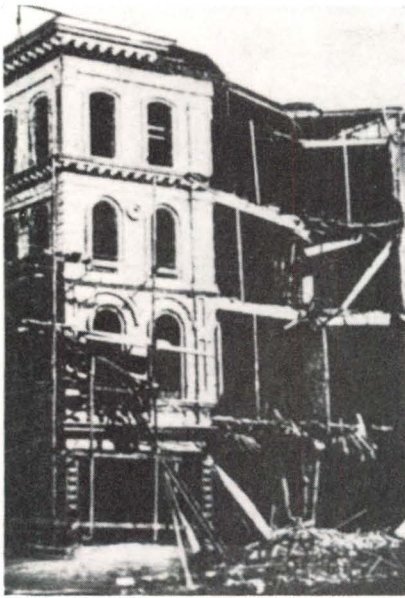
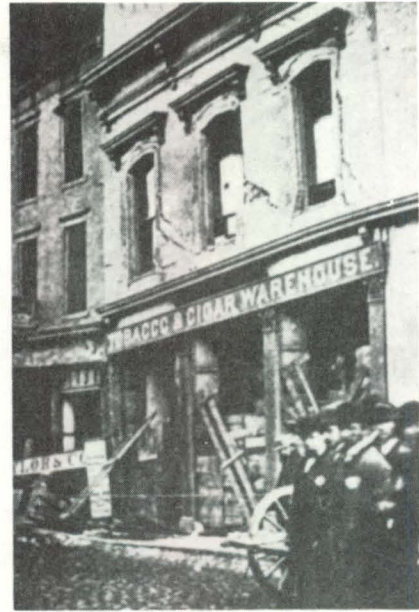
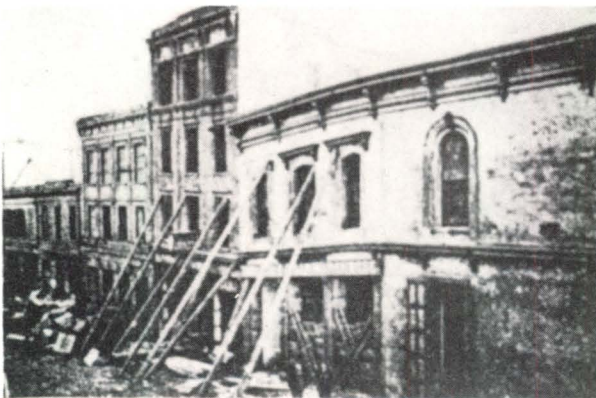
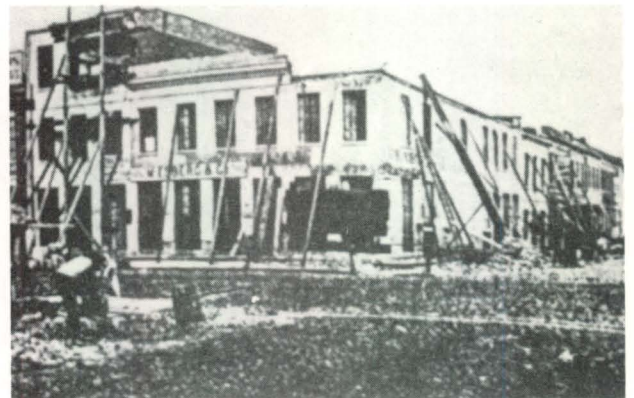
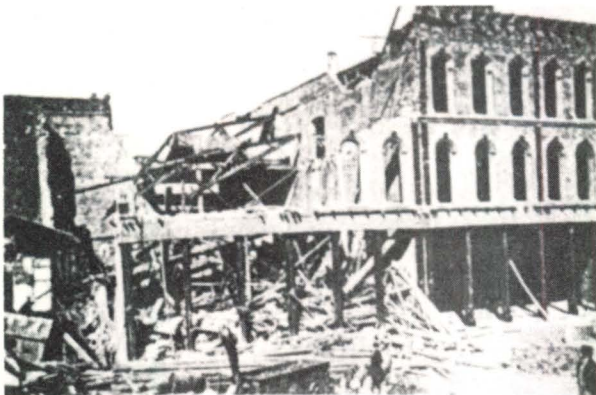
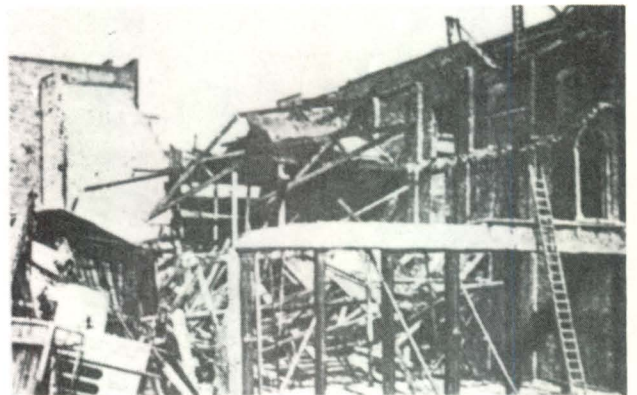
Effects of the earthquake of 1868 in San Francisco. From photographs preserved by Mr. H. Bendel.

Figure 7. Earthquake damage in San Francisco resulting from the 1868 Hayward earthquake (Reproduction of Plate 145 from Lawson, 1908).

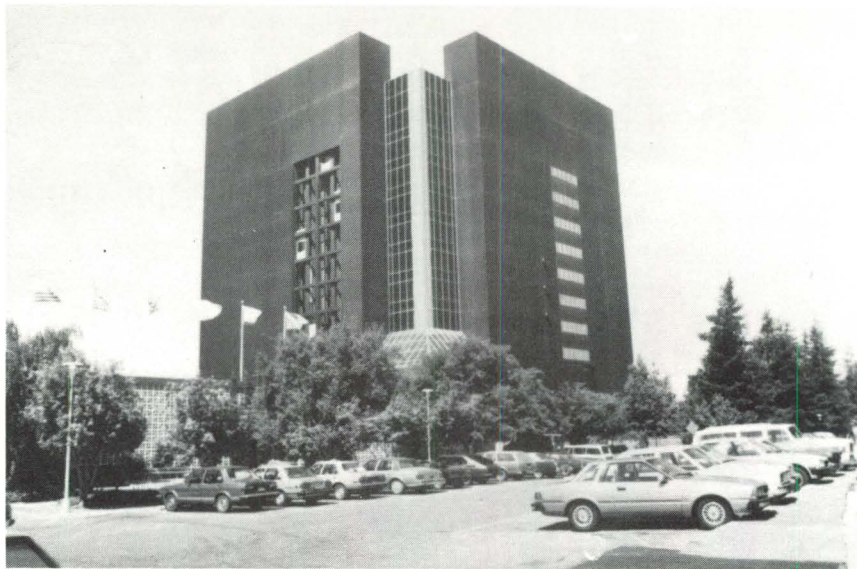
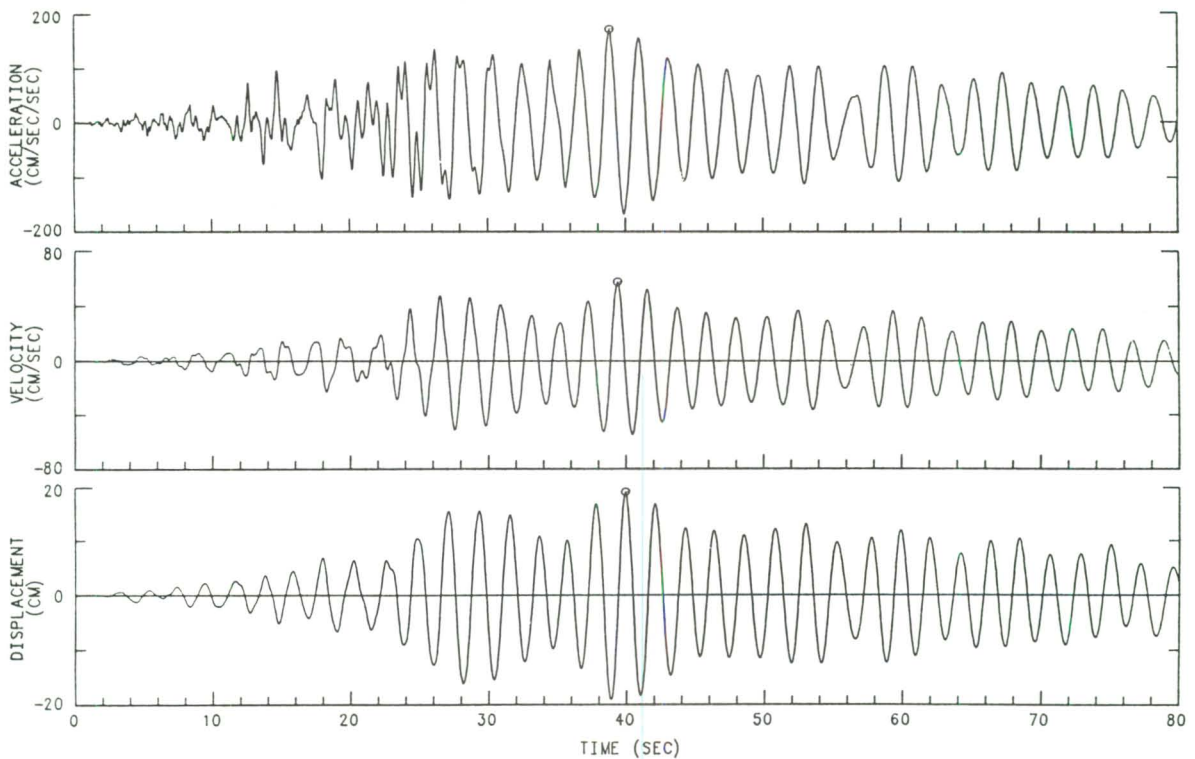
Strong motion accelerographs installed in various types of buildings, lifeline structures and on different geologic formations are providing structural engineers and seismologists with valuable new data concerning ground and structural response to earthquake shaking. The processed record shown indicates the characteristics of motion recorded on the roof of the Santa Clara County Administration Building during the 1984 Morgan Hill earthquake (M6.2). (Record and photo by California Strong Motion Instrumentation Program)

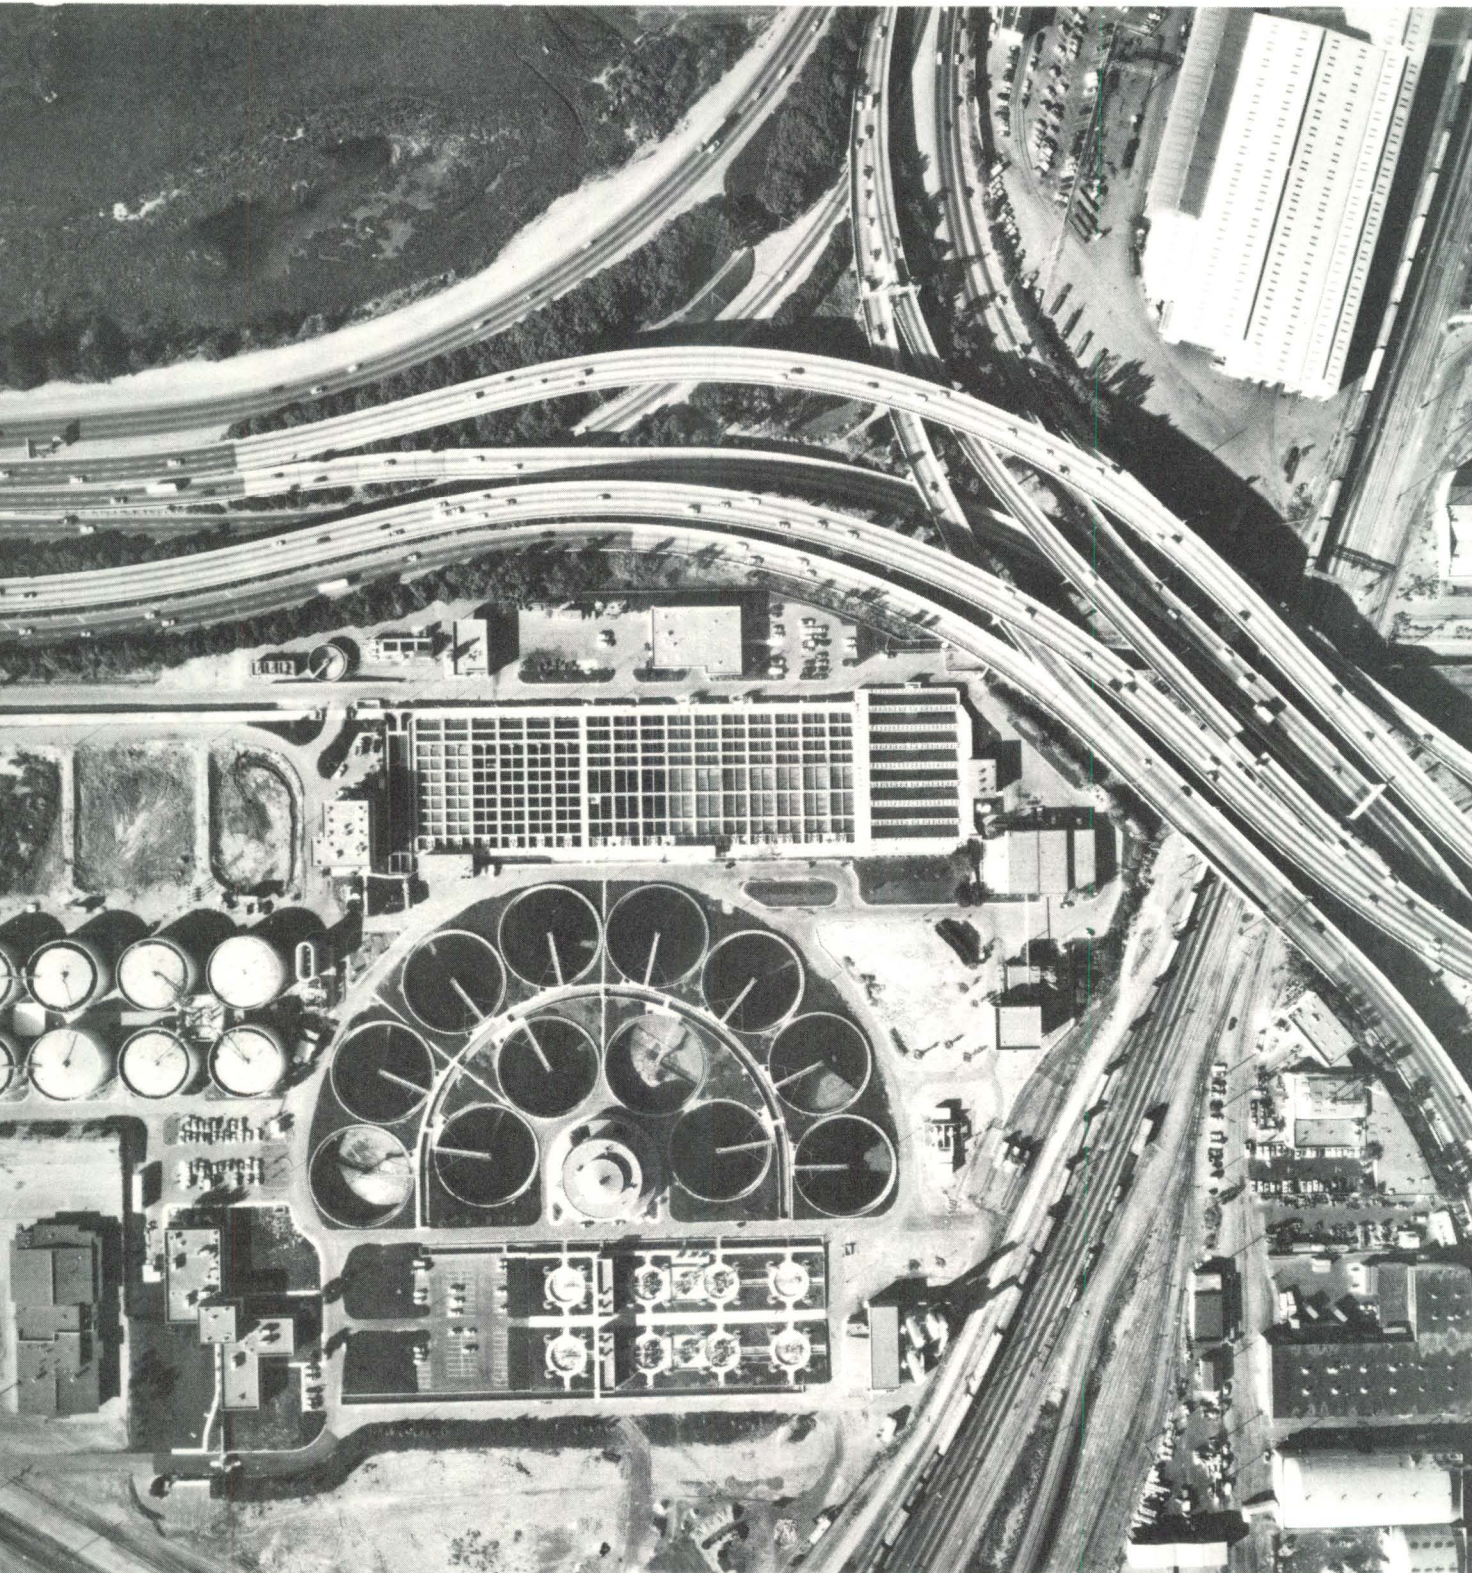
The Bay Bridge east approach interchange (I-80/580, S.R. 17), main line railroads, and EBMUD's Special District Number 1 waste water treatment plant.

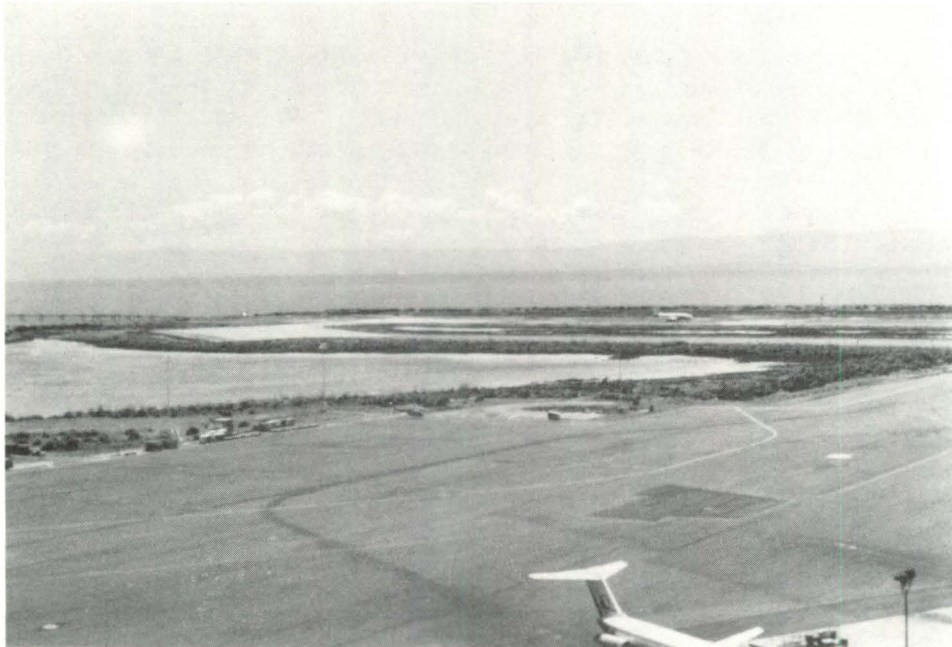
Typical Bay area airport runway constructed on fill overlying potentially unstable soils, including Bay mud.

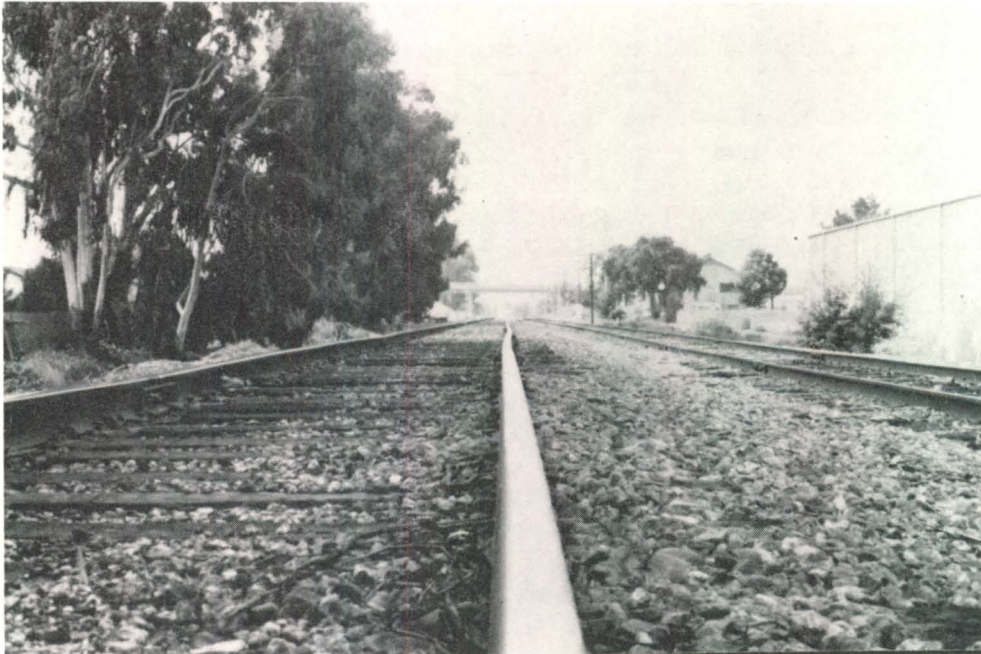
Deformation of railroad track at the crossing of the Hayward fault in Fremont.

Fault displacement disrupts the tracks at multiple crossings of the Hayward fault in this area. For the 1868 earthquake Lawson (1908,p. 443) reported the damage from fault rupture to the Southern Pacific tracks at Irvington, as follows: "Thru the north side of town a crack split the hillside, opening 7 or 8 inches and showing a fault of 8 or 10 inches. It crost (sic) the county road 500 feet north of the Southern Pacific Railway Depot. The railroad tracks north of the station were badly twisted for several hundred yards."

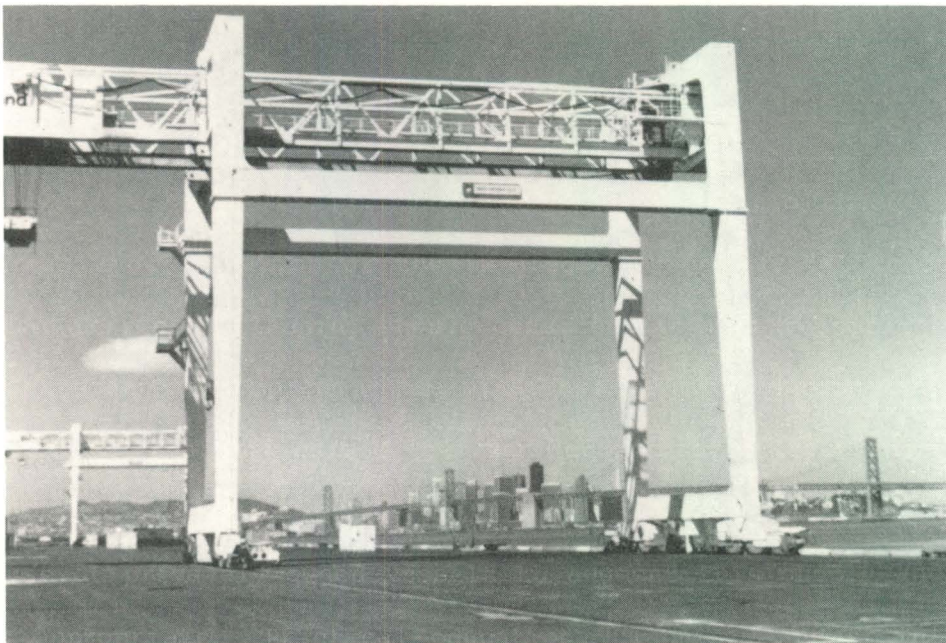
Rail mounted crane at the Port of Oakland.

Rail mounted cranes, such as those used for containers, are often dislodged from their rails during an earthquake, but they do not turn over unless the supporting dock fails. These derailed cranes can be remounted on their rails by the use of jacks and other means, but skilled labor and time are involved.

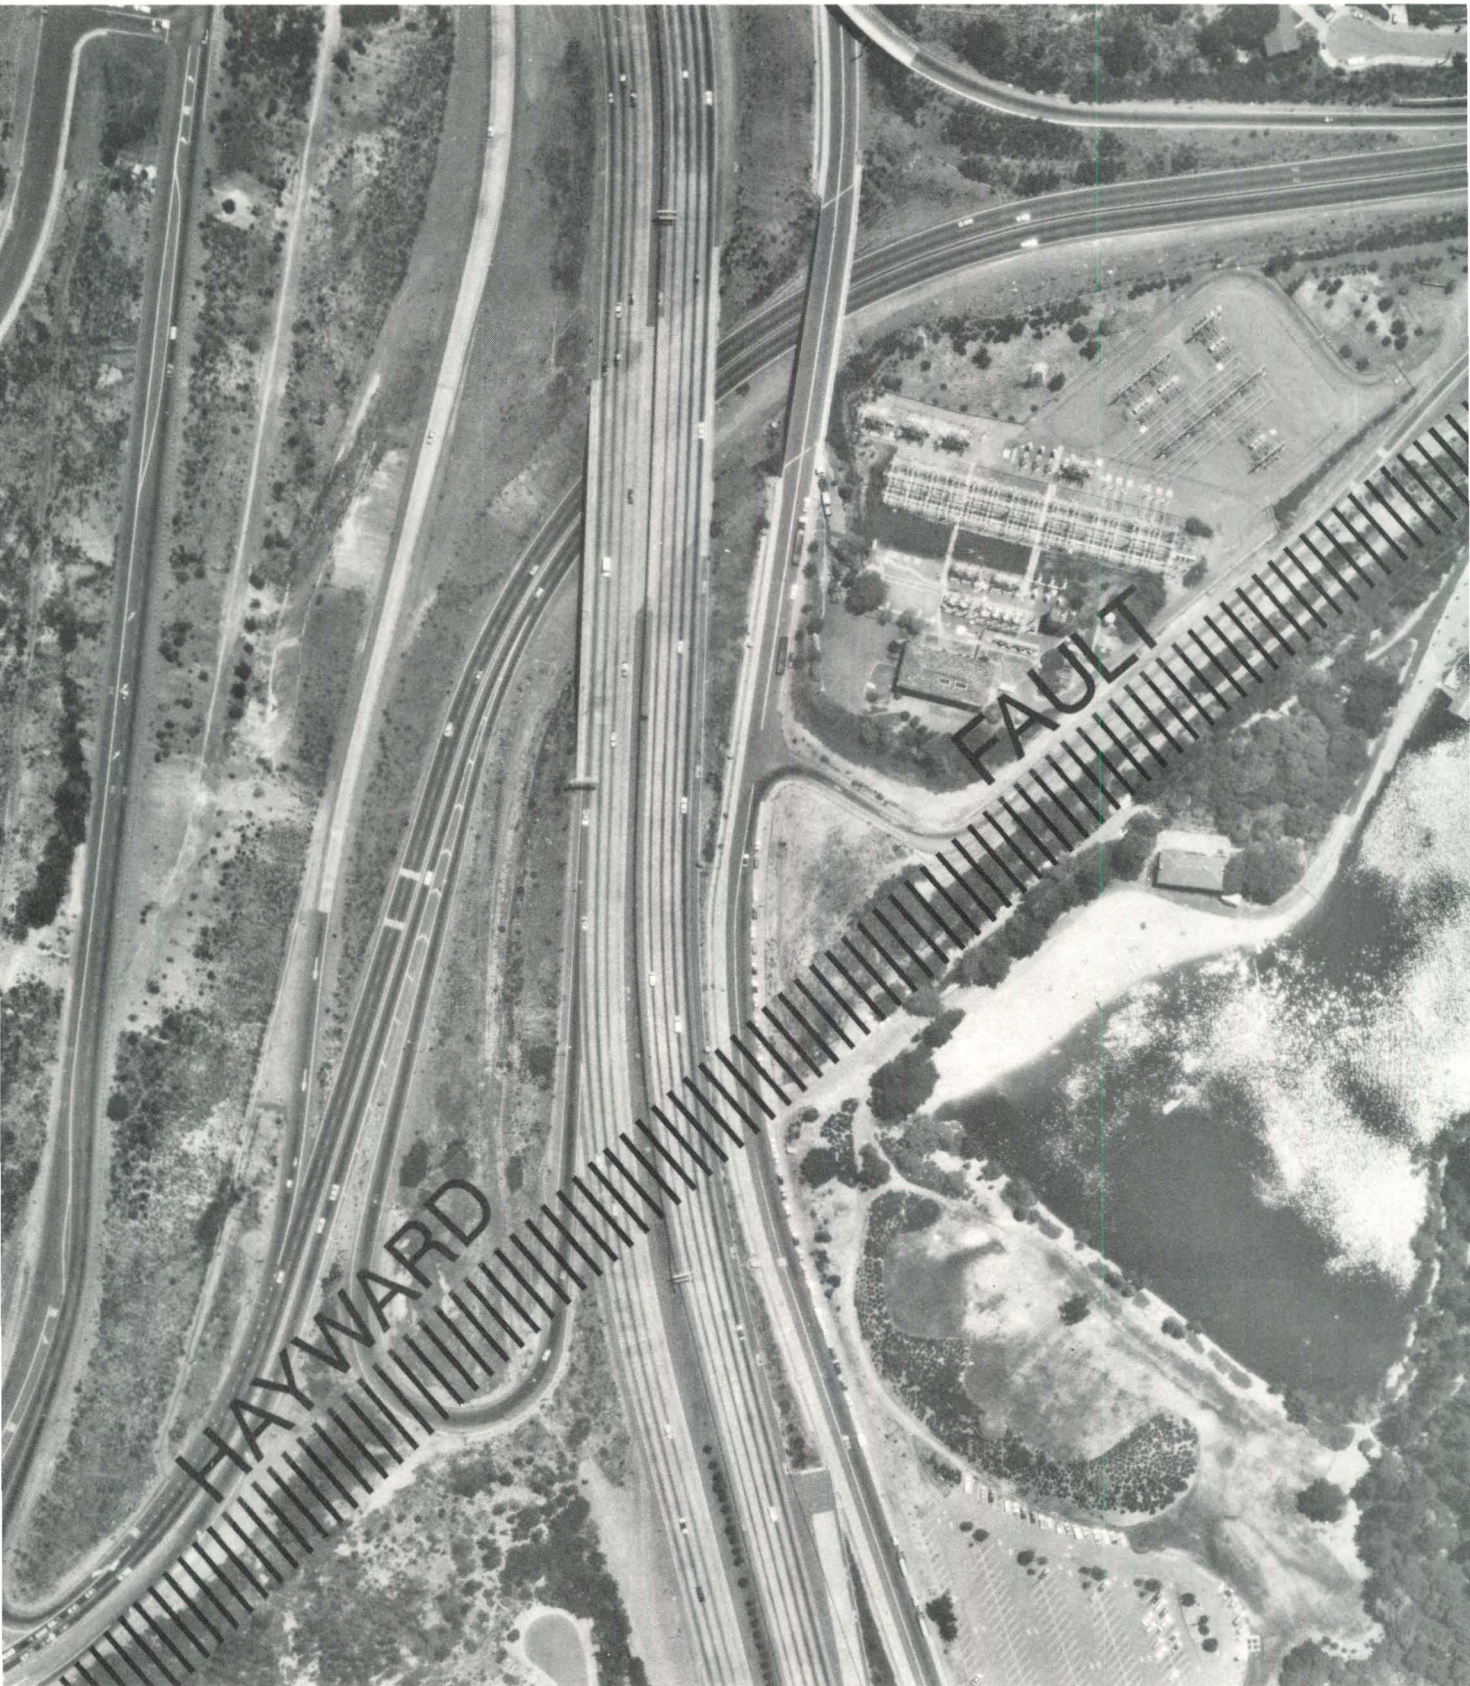
The Hayward fault crossing of Route 24 in the Route 13 interchange area near Lake Temescal and PG & E's Claremont substation.

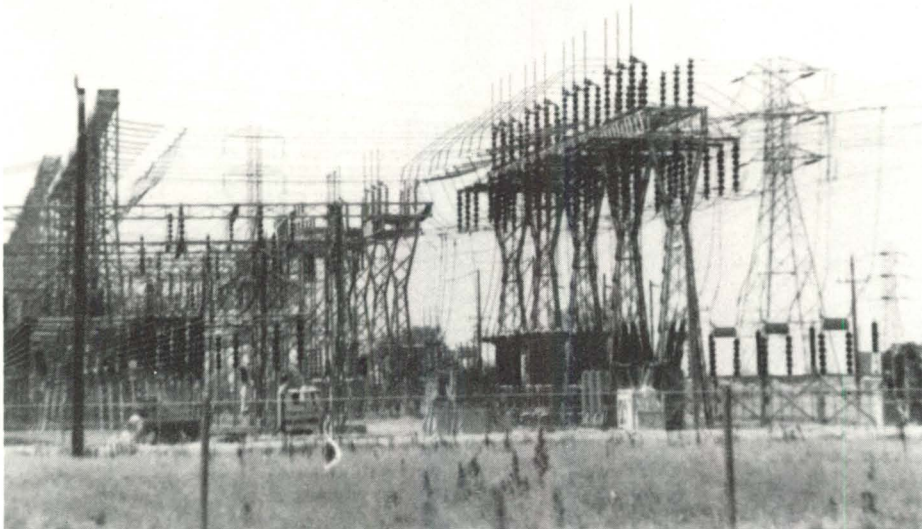
Elements of a major Bayside power transmission substation vulnerable to damage from high intensity shaking and potential ground failure.

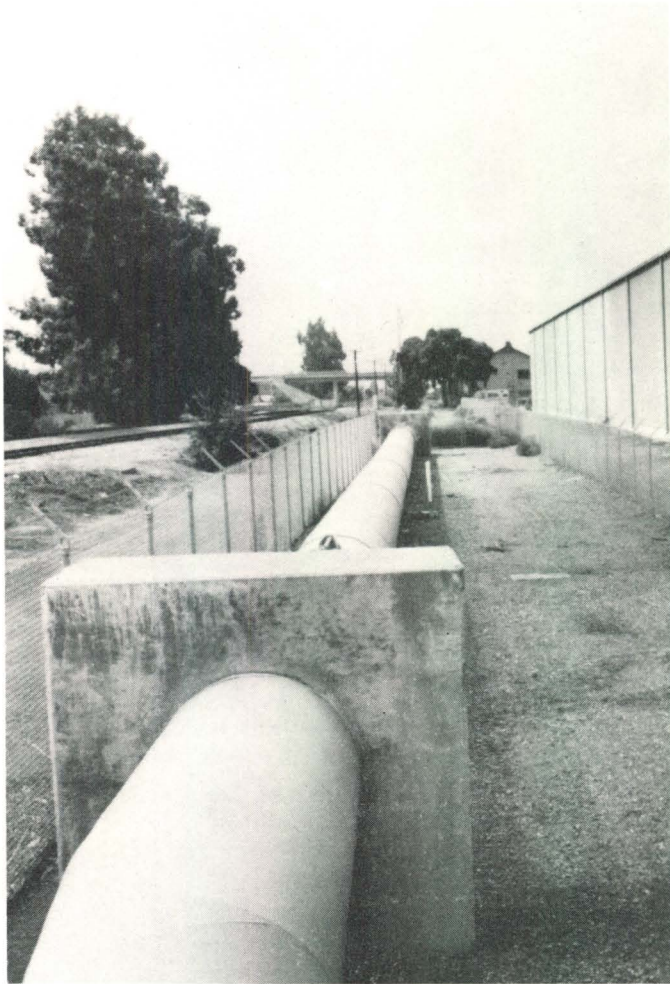
Major water transmission pipeline at a crossing of the Hayward fault in Fremont. This section of the pipeline has been constructed on the surface to accommodate fault creep and facilitate repairs necessitated by fault rupture.
