# EARTHQUAKE PLANNING SCENARIO

FOR A MAGNITUDE 7.5 EARTHQUAKE  
ON THE HAYWARD FAULT IN THE  
SAN FRANCISCO BAY AREA

CALIFORNIA DEPARTMENT  
OF CONSERVATION

SPECIAL PUBLICATION 78

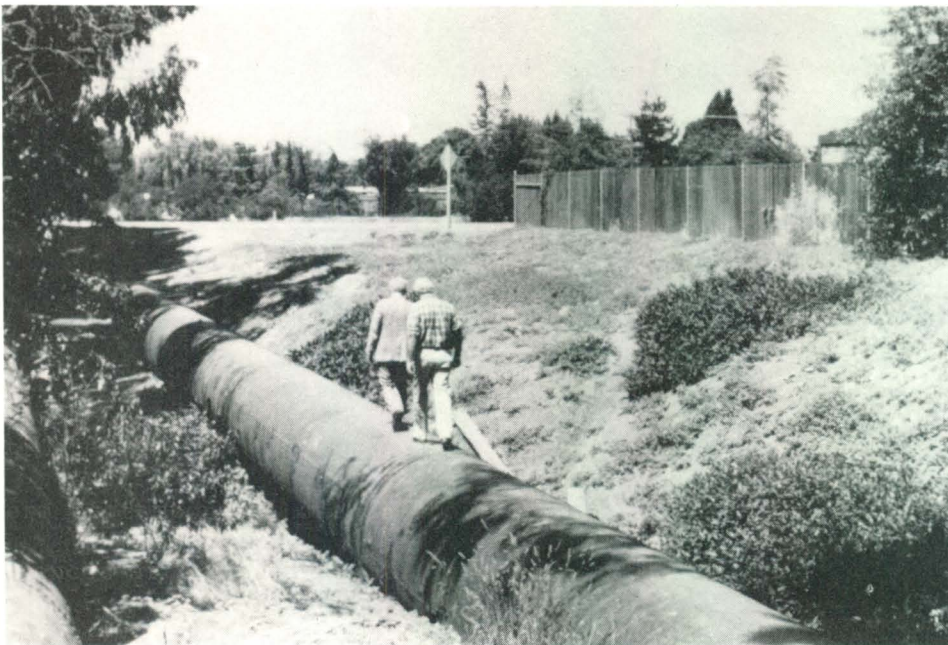
The two trans-Bay Hetch Hetchy pipelines at the Hayward fault crossing in Fremont.

1. Interstate 680 - Principal route east from the south Bay, through Mission Pass.
2. Hetch Hetchy Aqueduct pipelines (trans-Bay route).
3. Southern Pacific and Western Pacific rail lines.
4. A major electrical power transmission corridor with multiple tower lines routed to PG & E's Newark substation (2 miles west of the fault) The city of San Francisco's Hetch Hetchy power lines are also in this corridor..
5. PG & E's Fremont substation and two adjacent high-voltage electrical power transmission lines.
6. Three principal natural gas supply lines that cross the fault between Durham Road and Olive Avenue (routed to the Irvington terminal).
7. Two of the three petroleum product pipelines that provide fuel to distribution terminals in San Jose.
8. A major local water transmission pipeline that crosses the fault near the intersection of Washington Boulevard, Driscoll Road, and Osgood Road.

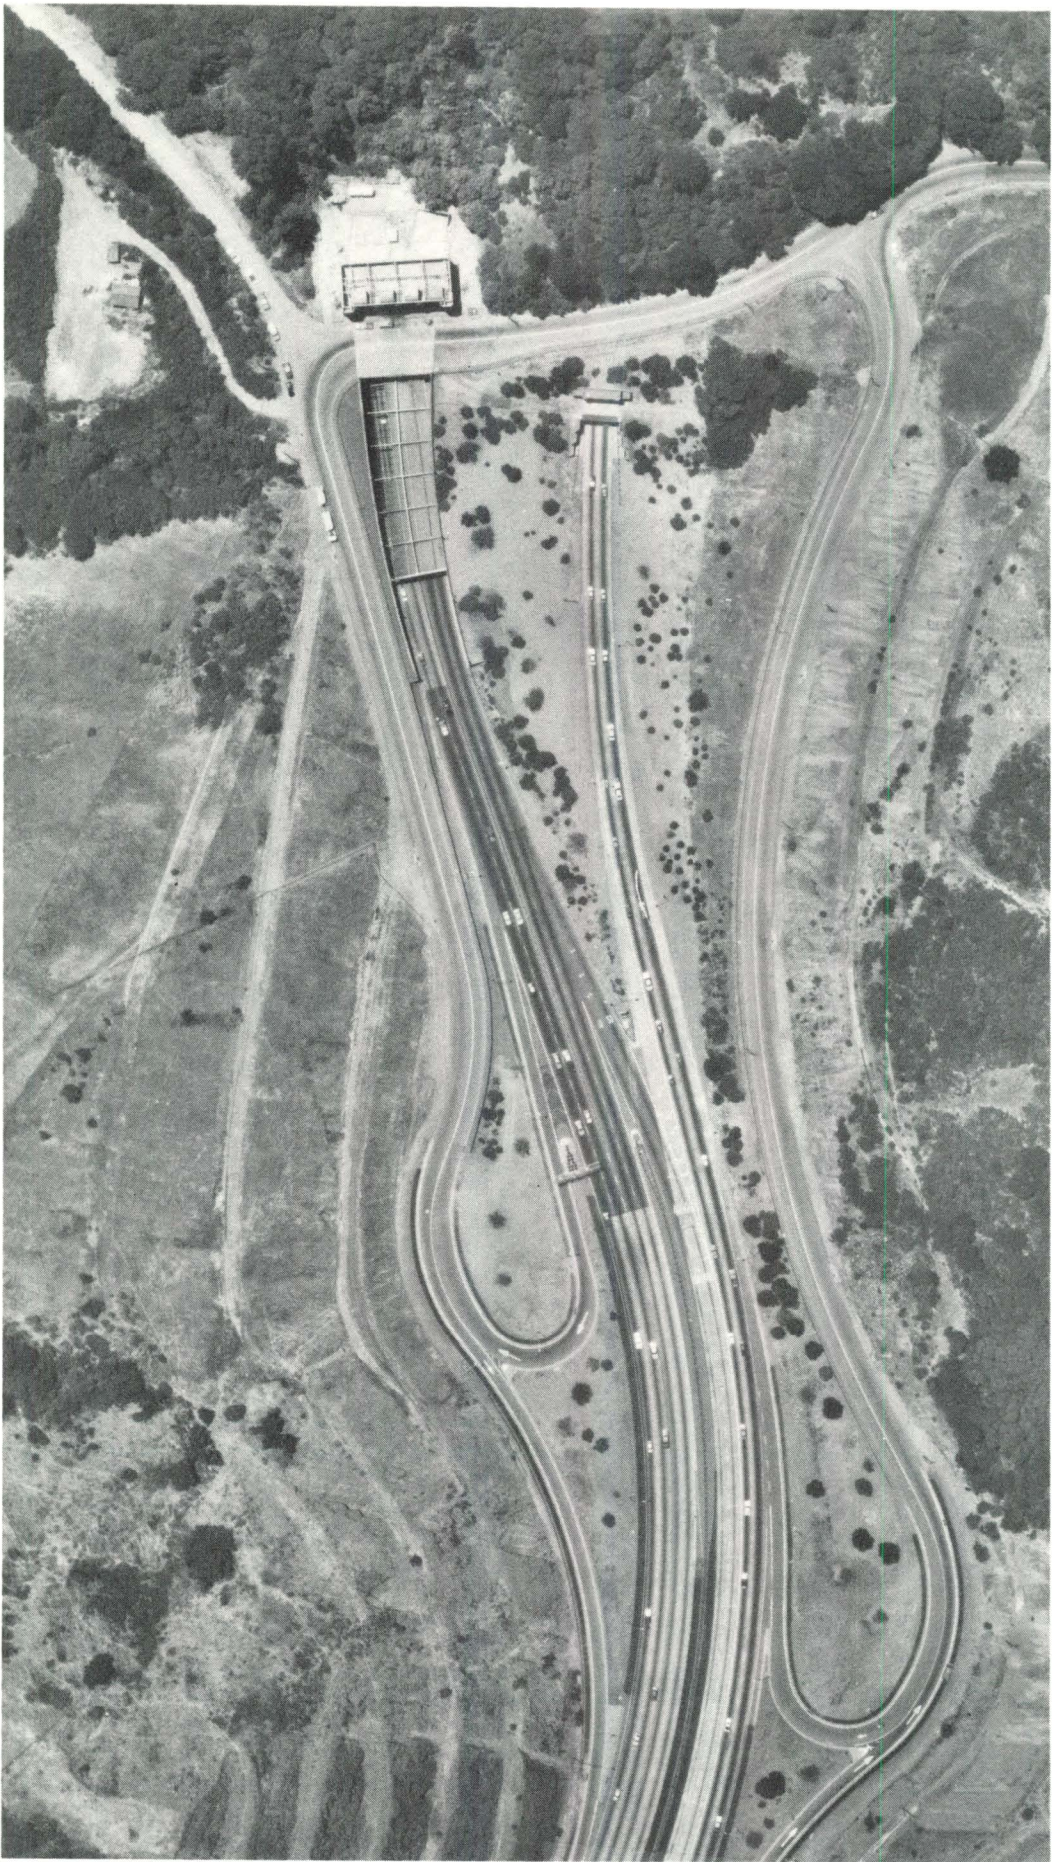
East portal of the Caldecott Tunnel.
