TORSIONAL RESPONSE OF THREE INSTRUMENTED BUILDINGS
DURING THE 1984 MORGAN HILL EARTHQUAKE

ABSTRACT

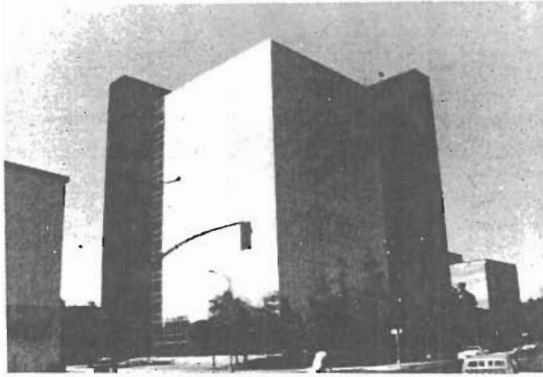
(a) Santa Clara County Office Bldg.
13-story steel frame

FIG. 1. Three instrumented buildings in San Jose, California.

The 13-story Santa Clara County Office building, shown in Fig. 1a, is 167 by 167 feet in plan and 187 feet in height. The exterior cores at the west and south ends of the building extend from the lower level to 24 feet above the roof. The lateral force-resisting system of the building is composed of moment-resisting steel frames. The vertical load-carrying system consists of concrete floor slabs overlying decks supported by the steel framing. The foundation is a concrete mat.

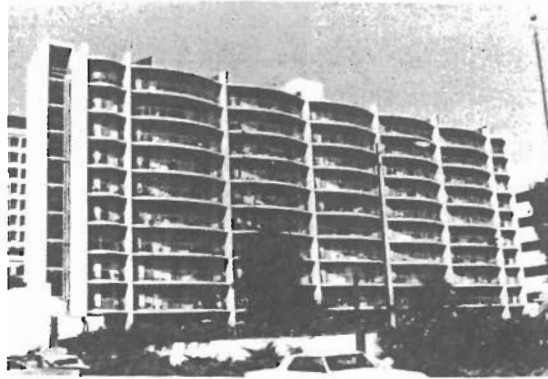
(b) Tower Park Towers Apartment Bldg.
17-story reinforced concrete
shear walls

The 10-story Town Park Towers Apartment building, shown in Fig. 1b, is 210 by 64 feet in plan and 96 feet in height. The lateral force-resisting system consists of reinforced concrete shear walls at regular intervals in the transverse direction and reinforced concrete shear walls along interior corridors in the longitudinal direction (stepped at the 6th floor). The typical floor system is a one-way post-tensioned flat slab on reinforced concrete bearing walls. The foundation consists of precast-prestressed concrete piles under all bearing walls.

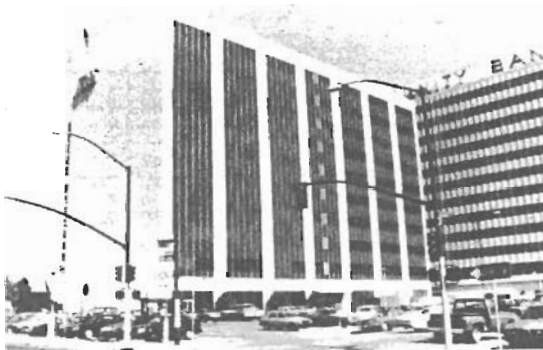
(c) Great Western Savings & Loan Bldg.
10-story reinforced concrete frame
and shear walls

The 10-story Great Western Savings building, shown in Fig. 1c, has a basement and is 124 feet in height relative to ground level. The typical floor dimension is 190 by 82 feet. The lateral force-resisting system consists of end concrete shear walls in the transverse direction and a moment-resistant concrete frame in the longitudinal direction. The vertical load carrying system consists of concrete floor slabs over pan joists supported by the concrete frame. The foundation is a concrete mat.

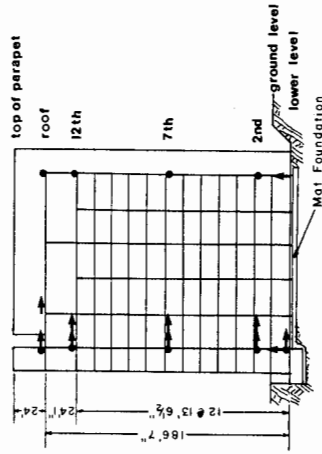
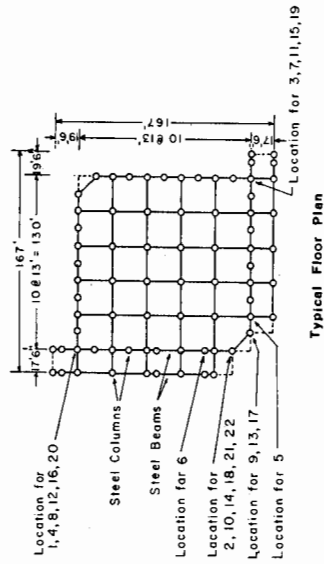
E-W Section

Fig. 2. Sensor layout in Santa Clara County Office Building.

A total of twenty-two accelerometers were installed at locations throughout the building; the sensor locations are shown in Fig. 2. Sensors 1 - 3, on the lower level, are mounted vertically to record the vertical motion at the base as well as to indicate the presence of any foundation rocking. Sensors 20 and 21 record the east-west translational motion of the foundation at the north and south ends. This east-west pair of sensors is repeated on the 2nd, 7th and 12th floors and on the roof. These sensor pairs allow analysis of the translational as well as torsional motions at these levels. These pairs are complemented by pairs sensing north-south motion on the same levels.

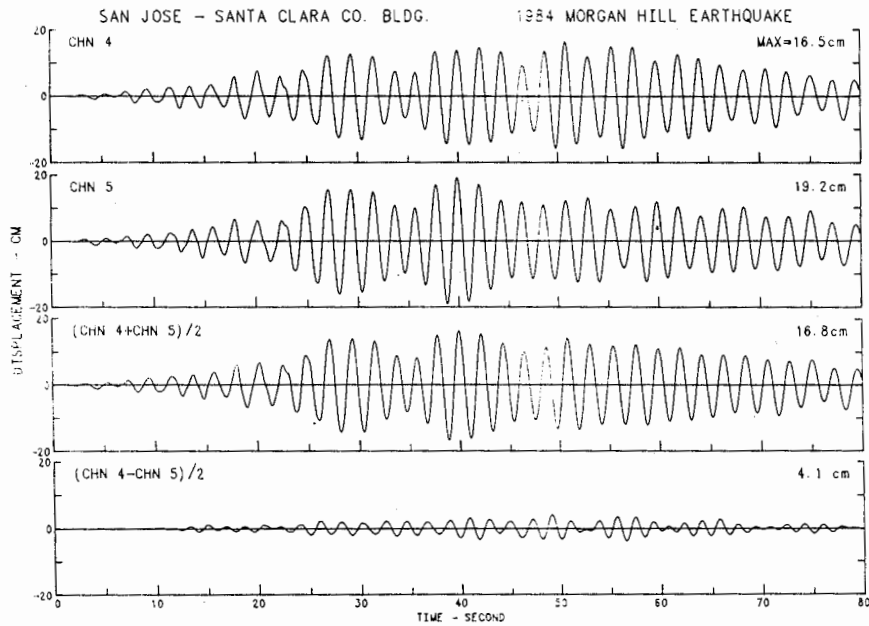
Fig. 3a. Top Traces: EW displacements from sensors at N (Chn 4) and S (Chn 5) edge of roof. 3rd Trace: Average EW displacement at roof, obtained from Chns 4 and 5. 4th Trace: Torsional displacement at roof.

To illustrate computation of the torsional motion from the motion recorded by a pair of sensors, Fig. 3a shows the displacements obtained from the accelerations recorded by sensors 4 and 5 on the roof, the average east-west translational displacement at the roof level $(Ch. 4 + Ch. 5)/2$, and the torsional displacement $(Ch. 4 - Ch. 5)/2$. The maximum amplitude of the

lateral displacement at the roof level is about 17 cm; the maximum amplitude of the displacement at the end wall due to torsional motion is about 4 cm. The predominant period of the torsional displacement is very close to that of the lateral displacement, which is about 2 seconds.

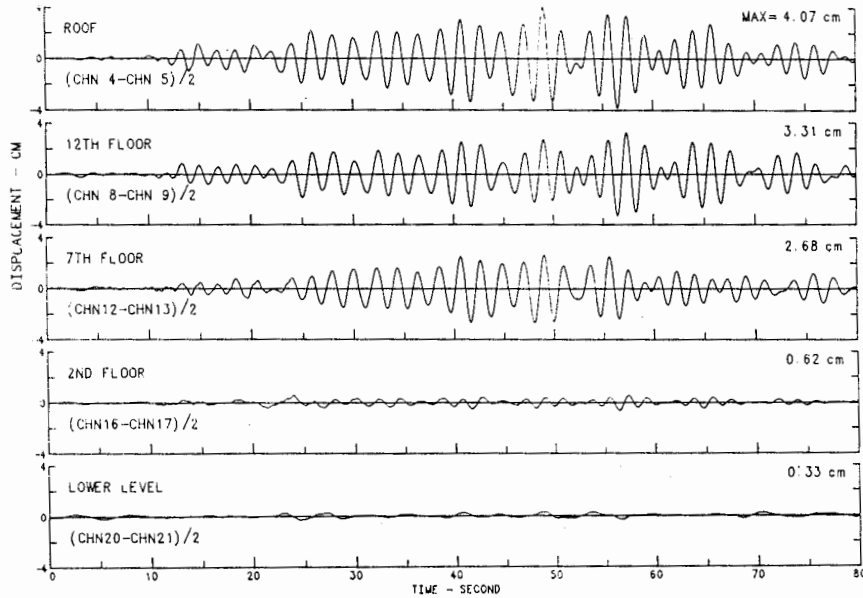
Fig. 3b. Torsional displacement profile, Santa Clara County Office Building, showing the torsional displacements obtained from EW sensors on the roof, 12th, 7th, and 2nd floor and lower level.

Fig. 3b shows the torsional displacements computed for the roof, 12th floor, 7th floor, 2nd floor and foundation level. The amplitude varies from about 0.3 cm at the base to 4.0 cm at the roof, an amplification factor of near 10. The torsional displacements obtained from the north-south sensor pairs on the roof, 12th, 7th, and 2nd floors are very similar to those obtained from the east-west pairs.

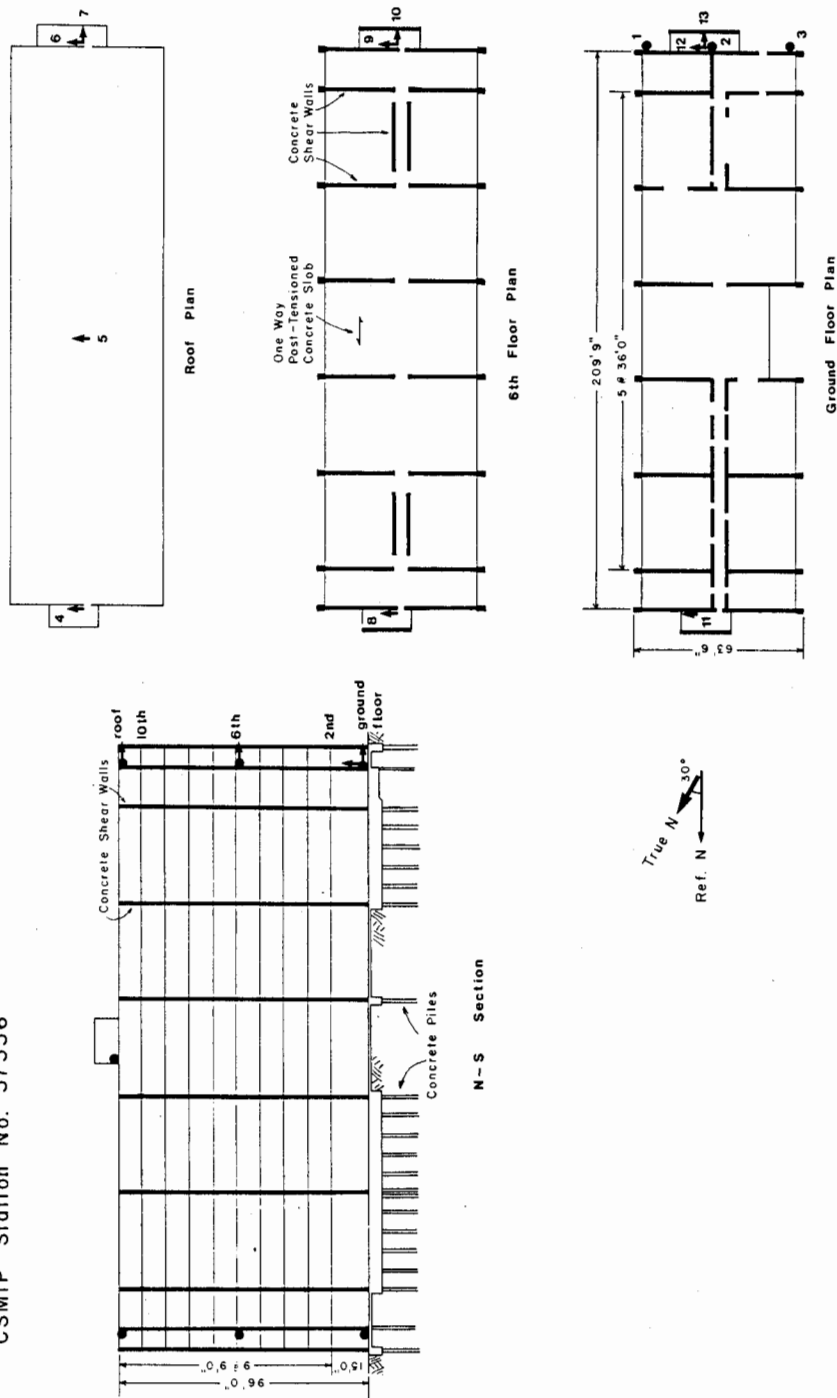
Fig. 4. Sensor layout in Town Park Towers Apartment Building.

Thirteen accelerometers were installed in this building. The locations of the accelerometers are shown in Fig. 4. Sensors 11 and 12 record the translational motion of the foundation in the transverse direction. This pair of sensors is repeated at the 6th floor and the roof. Sensor 5 is mounted at the center of the roof to detect any in-plane motion of the roof diaphragm. In the longitudinal direction, one sensor is placed at each end of the ground floor, the 6th floor and the roof.

The Great Western building is quite symmetrical, and the shear walls, only two per floor, are located at the opposing endwalls (Fig. 6). The Town Park Towers Apartment Building, though similar to the Great Western building in overall dimensions (64 x 210 feet for Town Park, 82 x 190 feet for Great Western), has a much more complex distribution of shear walls in the interior of the building (Fig. 4). In addition, the distribution of shear walls is vertically discontinuous at the sixth floor.

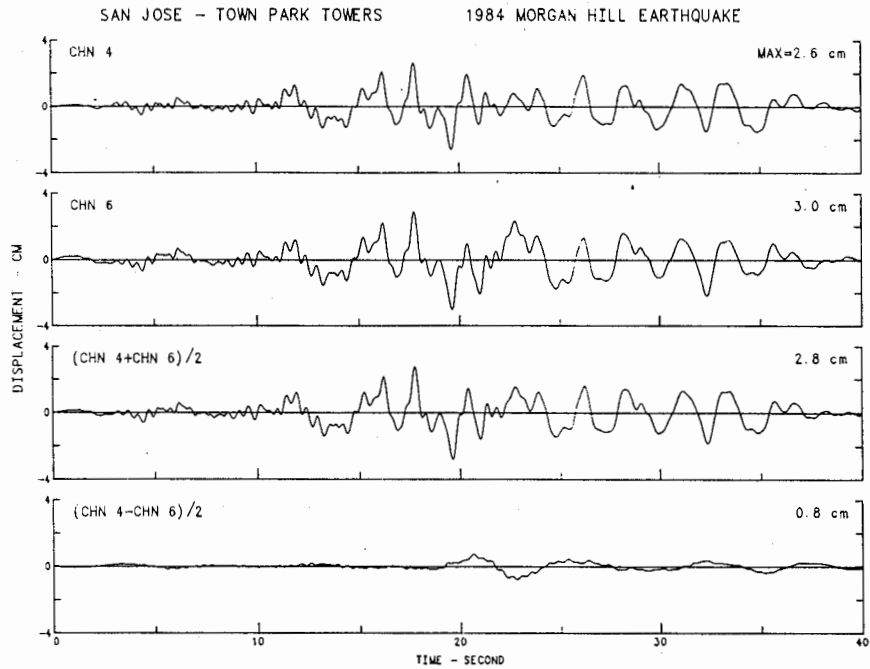
Fig. 5a. Top Traces: EW displacements from sensors at N (Chn 4) and S (Chn 6) edge of roof. 3rd Trace: Average EW displacement at roof, obtained from Chns 4 and 6. 4th Trace: Torsional displacement at roof.

The computed torsional displacement and average transverse displacement at the roof level is shown in Fig. 5a. These results indicate that the torsional motion was quite different from the lateral motion. The predominant period of the torsional displacement is approximately 5 seconds, while the response spectra indicate that the first translational mode of the structure in the transverse direction has a period of approximately 0.5 second. Fig. 5b shows the torsional displacements obtained for the roof, 6th floor and ground floor. Like the Santa Clara County Building, the roof to ground floor amplification is quite large, near 6.

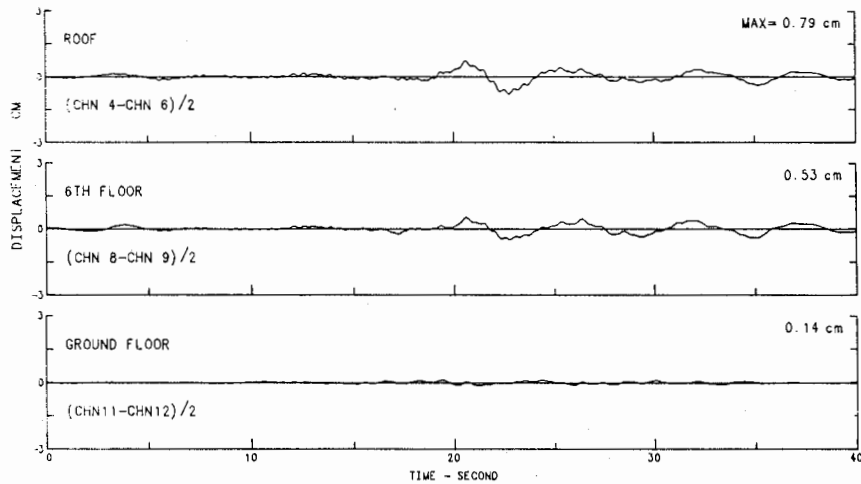
Fig. 5b. Torsional displacement profile, Town Park Towers Apartment Building, showing the torsional displacements obtained from EW sensors on the roof, 6th floor, and ground floor.

The torsional displacement profile for the Town Park Towers Apartment Building is shown in Fig. 8b, corresponding to the displacements plotted in Fig. 5b. The torsional displacement at the roof level, 0.8 cm, is much smaller than that at the County Building, although the roof-to-base amplification is similar to that of the County Building. As noted above, the predominant period of the torsional displacement is quite long, however. In terms of angular measure, the 0.8 cm torsional displacement is equivalent to 0.00025 radian (0.014 degree) maximum torsional rotation at the roof level.

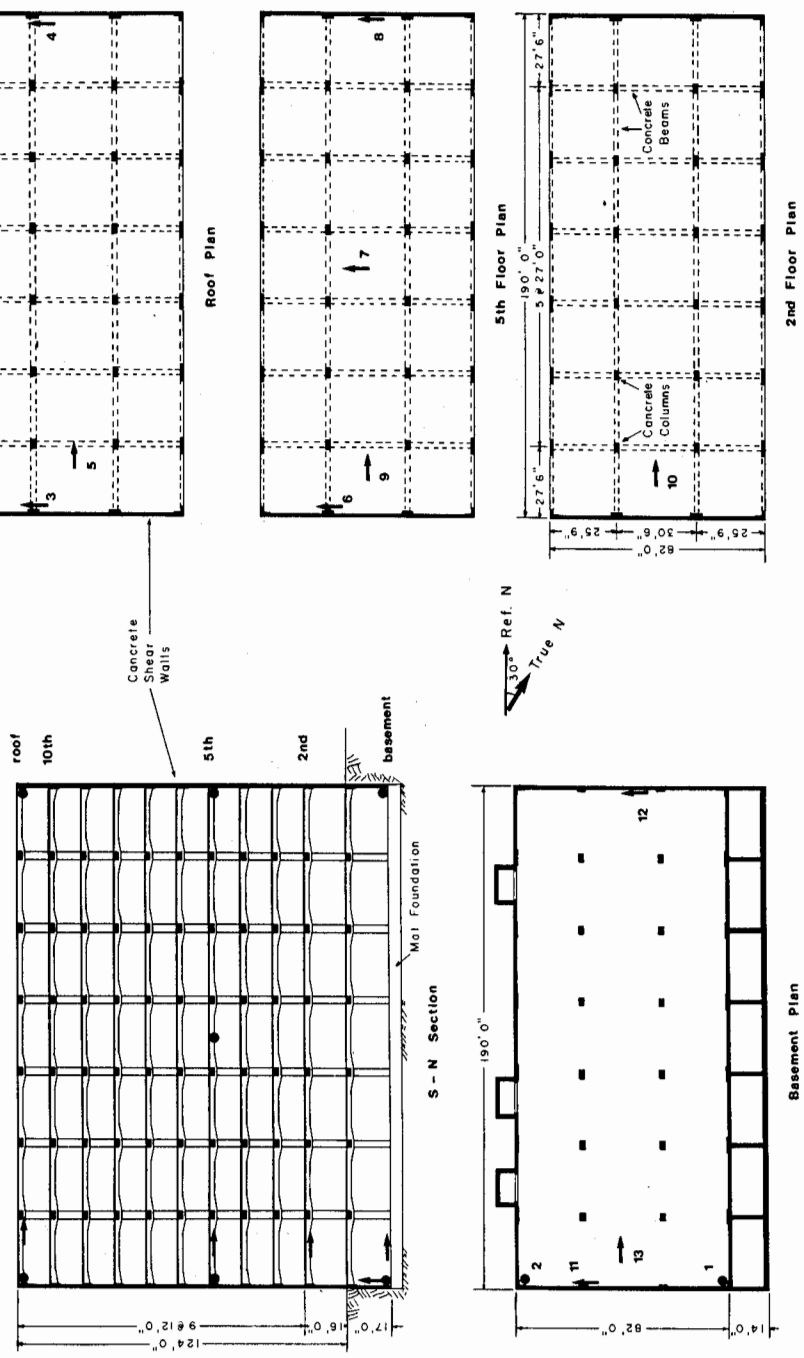
Fig. 6. Sensor layout in Great Western Savings and Loan Building.

Thirteen accelerometers were installed in this building. Their locations are shown in Fig. 6. Sensors 11 and 12 record the translational motion at opposite walls in the basement. This pair of sensors is repeated at the 5th

floor and the roof. Sensor 7 is mounted at the center of the 5th floor to detect any in-plane motion of the floor diaphragm. Sensors 13, 10, 9 and 5 in the longitudinal direction record the translational motion at the basement, 2nd floor, 5th floor and the roof, respectively.

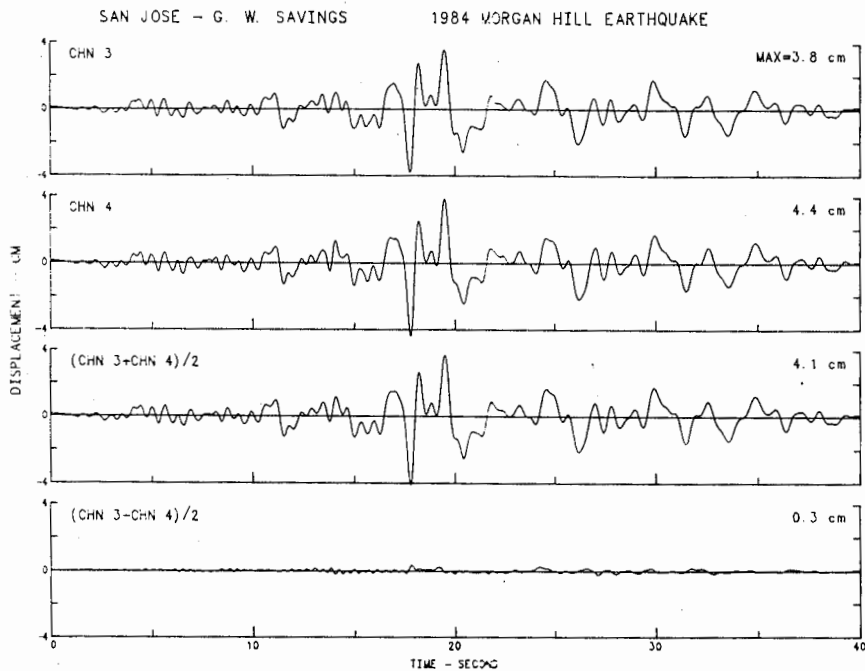
Fig. 7a. Top Traces: EW displacements from sensors at S (Chn 3) and N (Chn 4) edge of roof. 3rd Trace: Average EW displacement at roof, obtained from Chns 3 and 4. 4th Trace: Torsional displacement at roof.

The lateral and torsional displacement at the roof level are shown in Fig. 7a. In contrast with the two buildings considered previously, there is relatively little torsional motion indicated by the data from this building. The torsional displacements computed for the roof, 5th floor and base level are shown in Fig. 7b. These records do not show amplification of torsional motion at higher levels in the building. The sensor at the center of the 5th floor (no. 7) does indicate the presence of in-plane vibration of the floor slab, however.

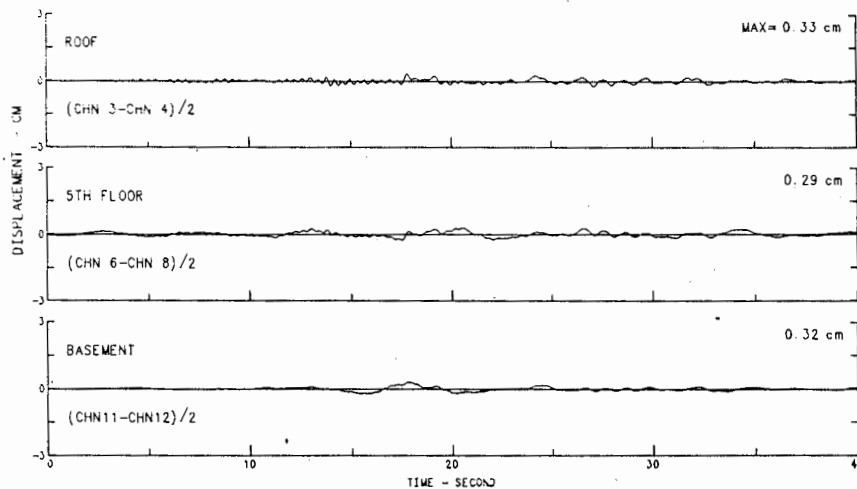
Fig. 7b. Torsional displacement profile, Great Western Savings Building, showing the torsional displacements obtained from EW sensors on the roof, 5th floor, and basement levels.

The torsional displacement profile for the Great Western Building in Fig. 8c and the torsional records in Fig. 7b indicate little torsional response of this building, and little or no torsional amplification.

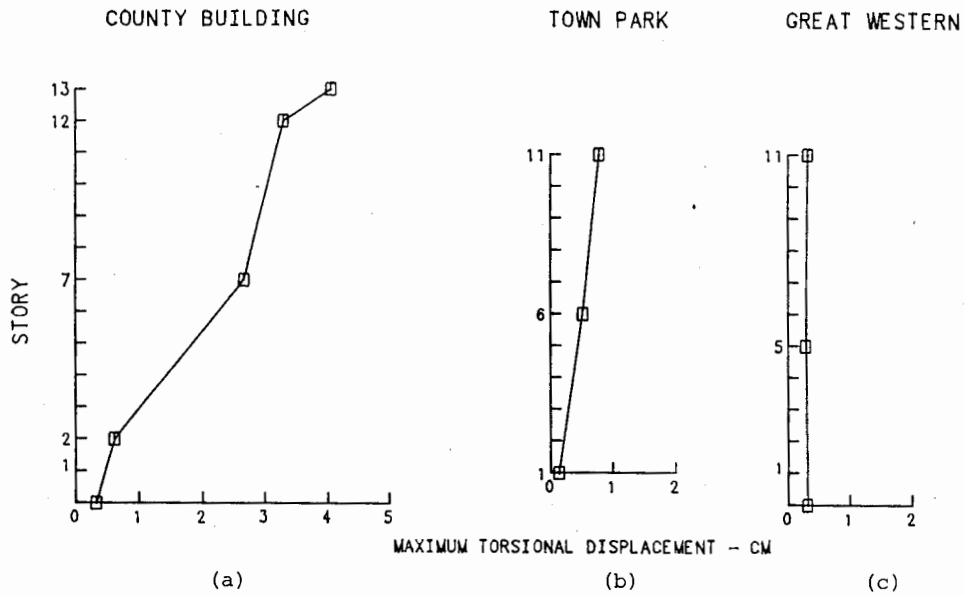
Fig. 8. Profile of torsional displacement in a) Santa Clara County Building, b) Town Park Towers Apartment Building, and c) Great Western Savings Building.

The maximum torsional displacement at each floor level for the three San Jose buildings considered in this study have been plotted against floor level in Fig. 8. The torsional displacement profile for the Santa Clara County Office Building, obtained from the displacements shown in Fig. 3, is shown in Fig. 8a. The profile indicates significant amplification at the roof level relative to the base. Most of the amplification occurs between the 2nd and 7th floors. The torsional displacement at the roof is about 4 cm. In terms of angular measure, this converts to a maximum torsional rotation of the building at the roof level of approximately 0.002 radian (0.12 degree).
