AN EVALUATION OF UNREINFORCED MASONRY WALL PERFORMANCE

JON D. RAGGETT AND CHRISTOPHER ROJAHN

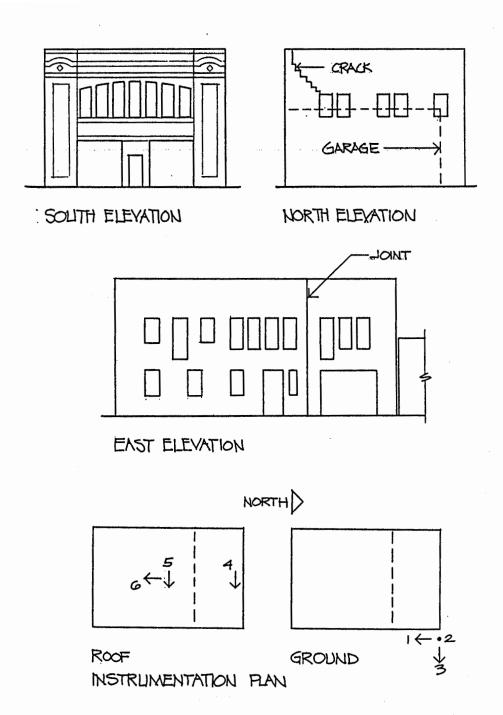
FIGURE 4.1 ELEVATIONS AND INSTRUMENTATION PLANS - OLD GILROY FIREHOUSE

The first, and obvious, building selected was the Old Gilroy Firehouse, the only unreinforced masonry building for which detailed strong-motion records are available. The building is shown with instrument location, in Figure 4.1. In-plane instrumentation does exist, at the top and bottom of the north wall, for this structure. Strong-motion records are available for this building from the Loma Prieta Earthquake 10/17/89.

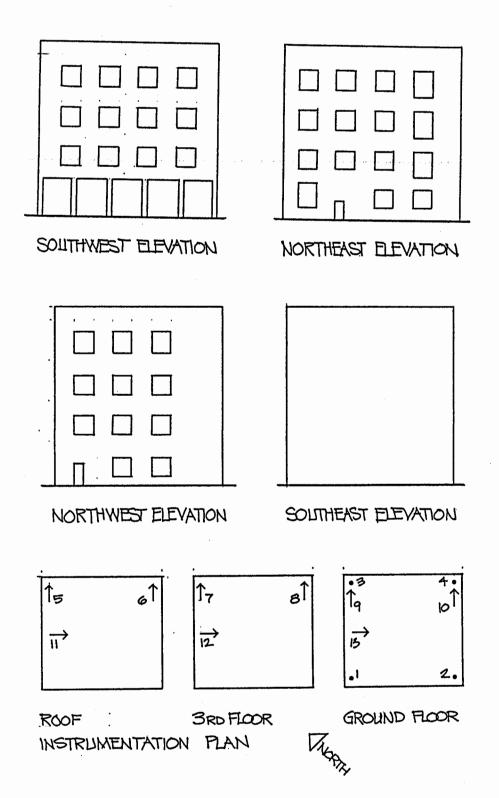
FIGURE 4.2 ELEVATIONS AND INSTRUMENTATION PLANS
PACIFIC TELEPHONE BUILDING

Other buildings studied included the following: Second, the four-story Pacific Telephone Building in Watsonville, again, for the Loma Prieta Earthquake, 10/17/89, was studied. By its proportions, the building is a bit too "high rise" but it does have perimeter shear walls (of reinforced concrete) with many openings. It also has, which is not great for this study, rigid concrete floor diaphragms. It is hoped something can be learned about in-plane deformations of shear walls with openings. See Figure 4.2.

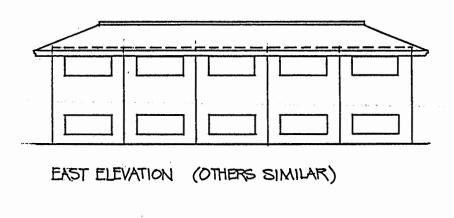
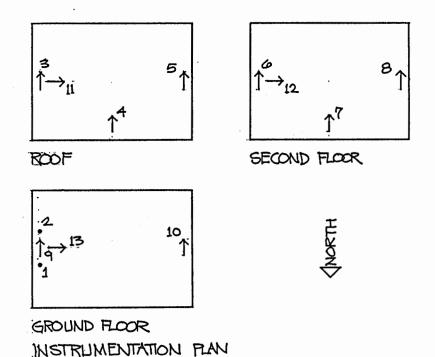
FIGURE 4.3
ELEVATIONS AND
INSTRUMENTATION PLANS
MARSHALL ELECTRONICS
GROUP BUILDING

Third, the Marshall Electronics Group Building in Milpitas was included. Strong-motion records exist for this building for the Loma Prieta earthquake, 10/17/89, as well, and were analyzed. This building is a two-story reinforced concrete tilt-up structure with large openings around the entire perimeter. It has a plywood, on wood frame, roof diaphragm. The second floor structure consists of concrete fill on metal deck on open-web steel joists. This second floor diaphragm is perhaps stiffer than desired compared to a wood diaphragm, but it is still far more flexible than a cast-in-place concrete diaphragm. Again, this structure was selected because the analysis of in-plane deformations of shear walls with openings would hopefully be rewarding. See Figure 4.3 for a simple description of the building and the instrumentation plan.

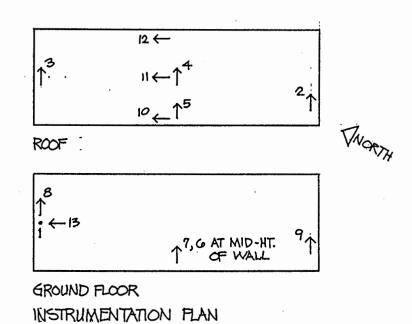
FIGURE 4.4
ELEVATIONS AND
INSTRUMENTATION PLANS
GLORIETTA K WAREHOUSE

Fourth, the Glorietta K Warehouse in Hollister was selected to be studied. Strong-motion records for the Loma Prieta earthquake 10/17/89, the Morgan Hill Earthquake 4/24/84, and the Hollister earthquake 1/26/86 were studied. The Glorietta K Warehouse is a typical, one-story concrete tilt-up warehouse with a wooden panelized roof structure. There are very few openings in the entire building. See Figure 4.4 for a simple description of the building and the instrumentation plan.

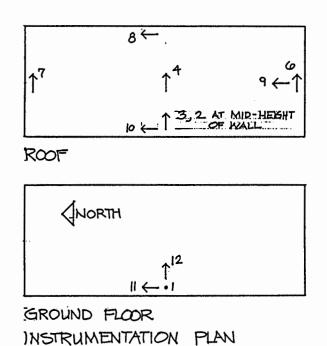
FIGURE 4.5
ELEVATIONS AND
INSTRUMENTATION PLANS
INTERSTATE VAN LINES
BUILDING

And fifth, the Interstate Van Lines building in Redlands was studied. Records for this building from the Palm Springs Earthquake 7/8/86 were studied. This is another warehouse, very similar to the Glorietta K Warehouse. See Figure 4.5 for a simple description of the building and the instrumentation plan.
