RECOVERY OF RECORDS FROM CODE-REQUIRED ACCELEROGRAPHS
AFTER THE NORTHRIDGE EARTHQUAKE

A. Shakal, C. Petersen, R. Darragh, M. Huang
California Division of Mines and Geology
Department of Conservation, Sacramento, CA

ABSTRACT

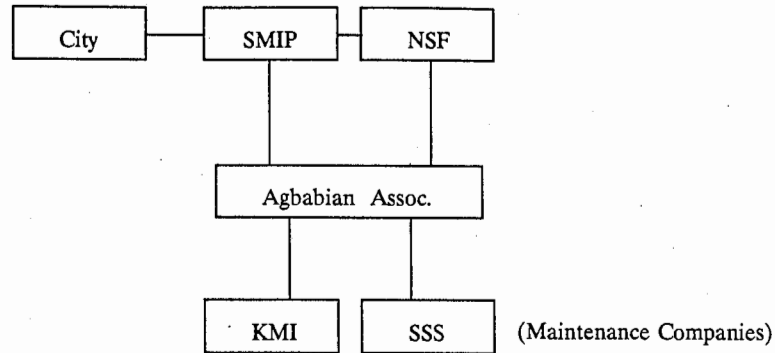
Figure 3. Relationships between The City of Los Angeles, CDMG, NSF, Agbabian Assoc. and accelerograph maintenance companies for the recovery of the Northridge accelerograms.

This model is much more effective. Of course, significant funding may be required for the State to contract for record recovery by the Maintenance Companies. After the Northridge earthquake, the National Science Foundation (NSF) shared this cost. To make the record recovery as effective as possible, NSF and CDMG jointly funded record recovery, in two separate contracts with Agbabian Associates to direct the activities of the individual Maintenance Companies, and to collect instrument and building information. This relationship is illustrated in Figure 3.

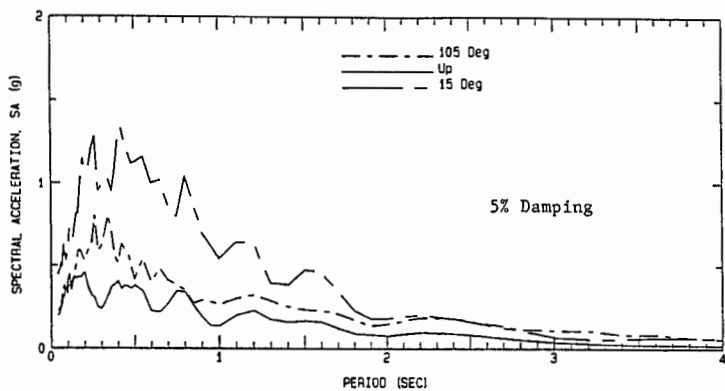
Northridge - Roscoe Blvd (CSMIP Sta. C130)
Ground Floor of 7-story Bldg.

Woodland Hills - Oxnard Blvd. #4 (CSMIP Sta. C246)
Basement of 12-story Bldg.

North Hollywood - Lankershim Blvd. #2 (CSMIP Sta. C083)
Basement of 8-story Bldg.

Sherman Oaks - 13-story Commercial Bldg. (CSMIP Sta. 322)
Basement of 13-story Bldg.

Figure 7. Spectral acceleration (5% damped, all three components) from the accelerograph located at the base of four buildings, one located near the epicenter and three on the south side of San Fernando Valley. Records from the top three are from code-required accelerographs.

Examples of spectra are shown in Figure 7. This figure shows the spectral acceleration (5% damping) at the base of four buildings located in the epicentral area, Woodland Hills, Sherman Oaks and North Hollywood. The spectral acceleration for these areas is similar to or smaller than the UBC spectra. These spectra have been used in the Seismic Safety Commission Case Studies Project (SSC, 1996) as discussed in Turner (1996).

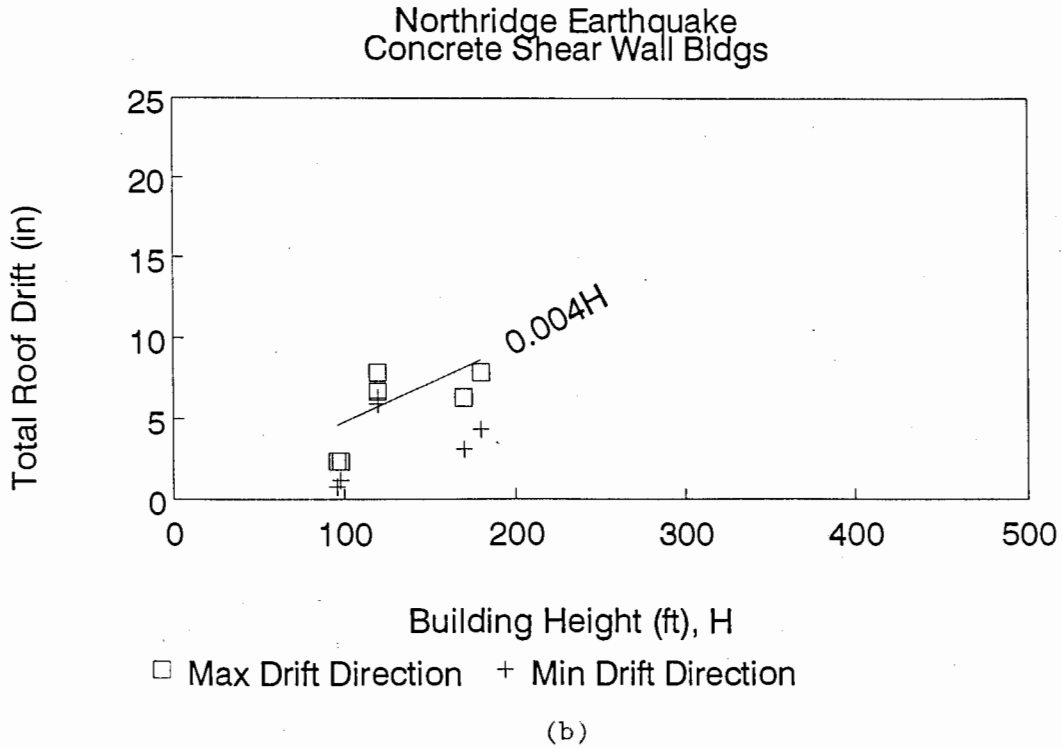
Figure 8. Total drifts at roof versus building height for (a) moment-frame buildings, and (b) concrete shear wall buildings in the Northridge earthquake. The line corresponding to the code drift limit of 0.004 H is also shown.

As an example of the value of strong motion data in the assessment of a building's response after an earthquake, Figure 8 shows a plot of total drift at the roof level calculated or estimated from the records for 23 moment-frame buildings of different heights (Huang and Shakal, 1995). The drift limit in the building code is about $0.004 H$ for these buildings. Total drift in many of the buildings was over this value. Since the designs of moment-frame buildings were mostly controlled by drift, structural members in some of these moment-frame buildings with large drifts may have yielded during the earthquake. If a building owner or response official knew, for example, that the total drift in a building was less than the code drift limit they may concern themselves first with other buildings, unless there are other symptoms of damage. Of course, to provide an accurate measurement of total drift, or allow the determination of base shear, there must be an instrument at the base of the building as well as at the roof level, rather than a single instrument at the roof.
