SMIP96 SEMINAR ON SEISMOLOGICAL AND ENGINEERING IMPLICATIONS OF RECENT STRONG-MOTION DATA

Sacramento, California
May 14, 1996

PROCEEDINGS

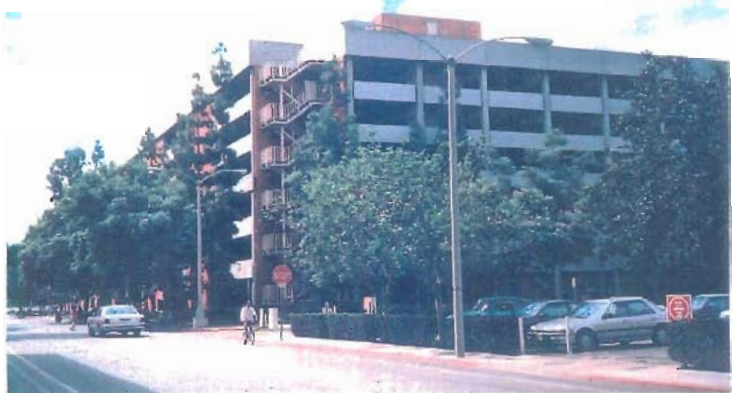
Photo #1 shows a view of the structure. One important characteristics of the parking structure is that the interior prestressed beams are seated on neoprene bearing pads at the columns corbels, with no positive ties between the beams and columns. The slabs are connected to the columns with $\frac{3}{4}$ inch diameter coil inserts that are embedded 6 inches into the columns and are connected to $\frac{3}{4}$ inch diameter threaded rods that are embedded three feet into the slab; the typical connection between the precast concrete columns and cast-in-place walls is provided through steel dowels and shear keys.

Photo 1. View looking northeast

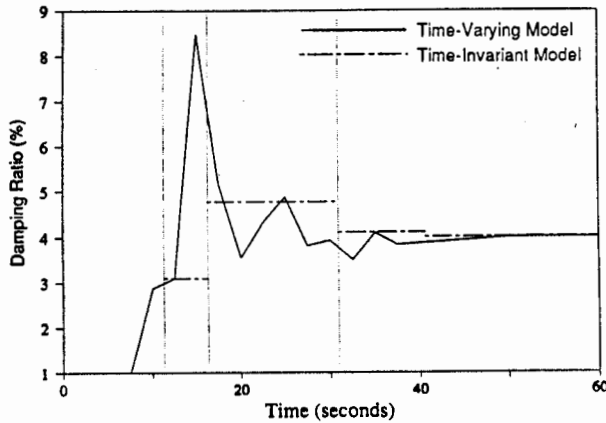
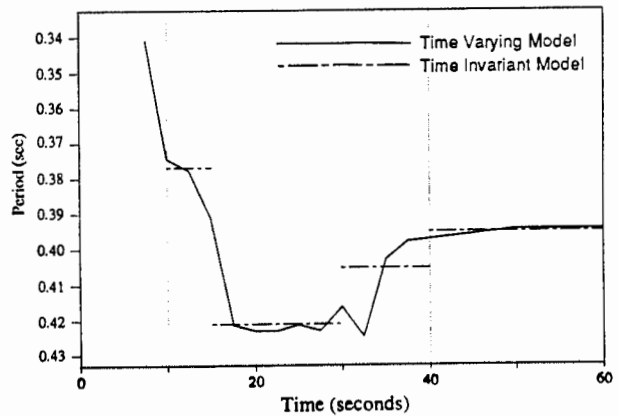
Fig. 6 shows how the period of vibration and the damping ratio for mode 1 and 2 vary over time, at different time windows. The rather small differences between these natural period and damping ratio values among all of the various time windows suggests that the parking structure did not undergo significant nonlinear response during the Northridge Earthquake.

a) Mode 1: First North-South

b) Mode 2: First East-West

Figure 6. Variation of Natural Periods and Damping Ratios of the Parking Structure Over Time

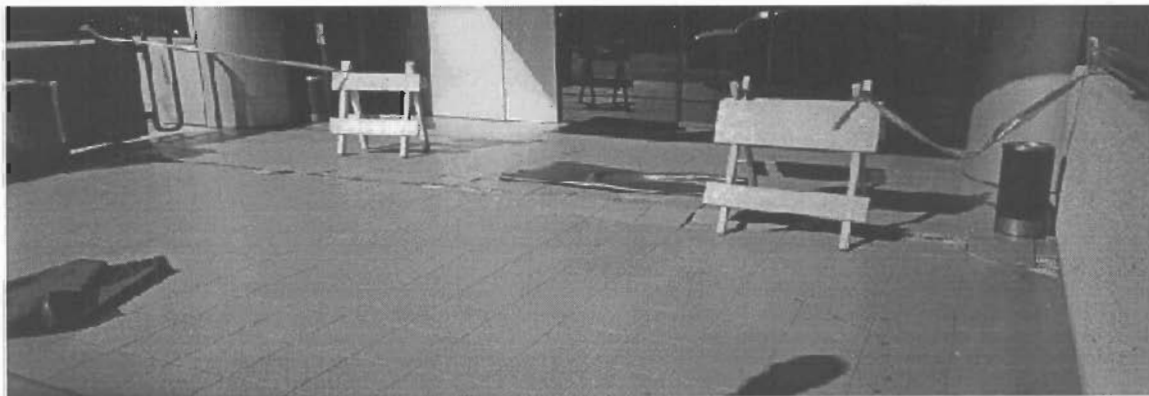
Figure 4. Tiles over isolation pit of the LACC 2 bldg. after the earthquake (photo courtesy of Robert Bachman).

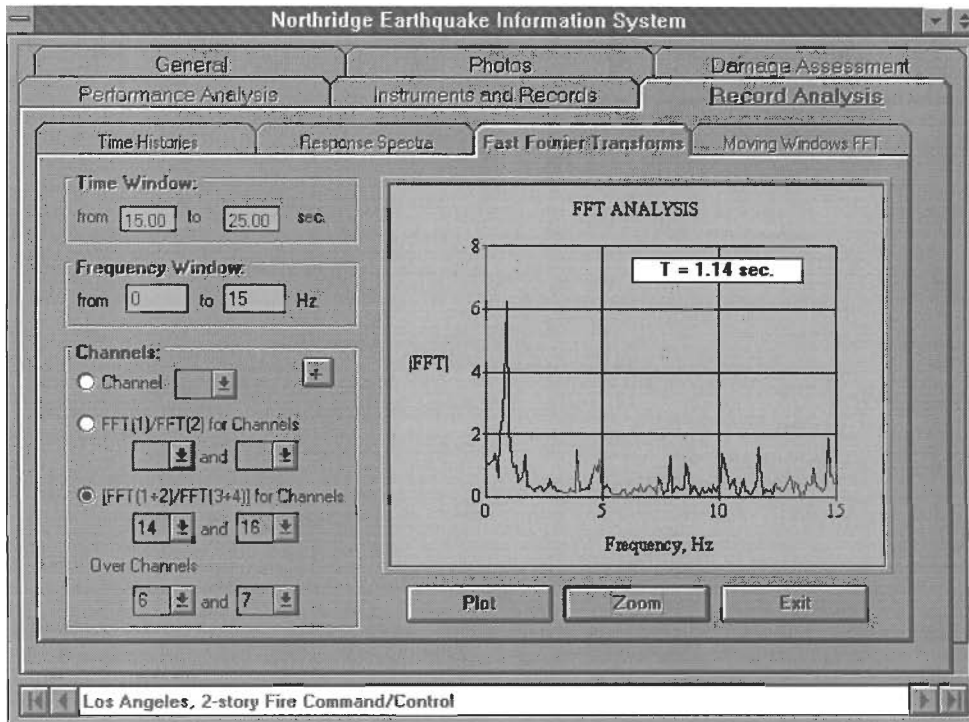
(a) time = 0 to 15 seconds

(b) time = 15 to 25 seconds

Figure 5. Fast Fourier Transform of E-W response of LACC 2 building shows that the pit separation shown in Figure 4 has permitted the building to behave as an isolated system after 15 seconds into the ground motion.

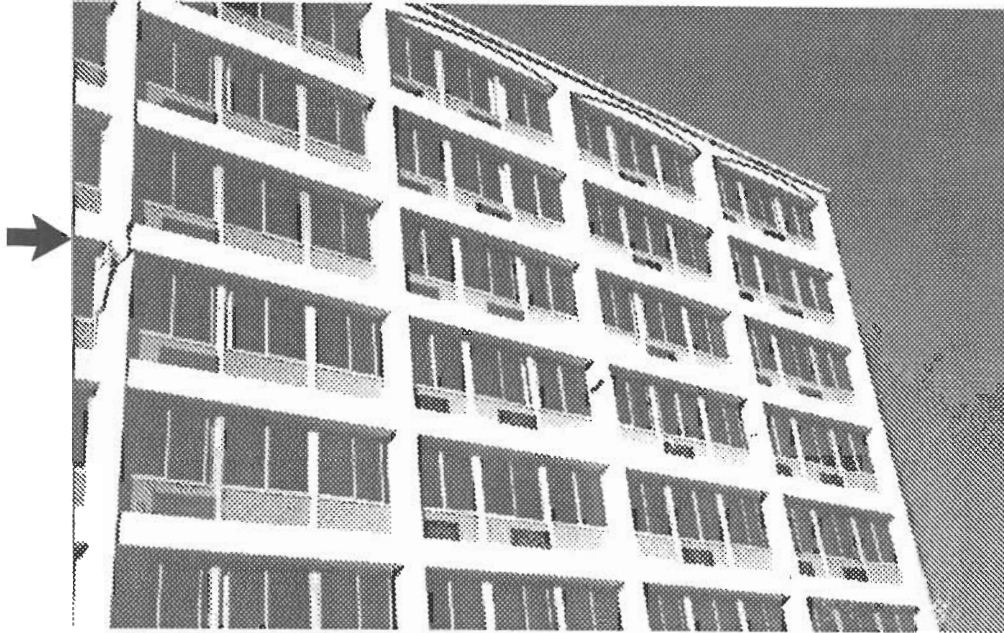
Fig. 5. Partial south elevation of Van Nuys 7-story Hotel showing damage to columns (indicated by an arrow) below fifth floor spandrel beams during the 1994 Northridge earthquake.
