INVESTIGATION OF DESIGN AND ANALYSIS METHODS
FOR STEEL FRAMED BUILDINGS

A. Astaneh, S. A. Mahin, J-H. Shen and R. Boroschek

Department of Civil Engineering
University of California at Berkeley

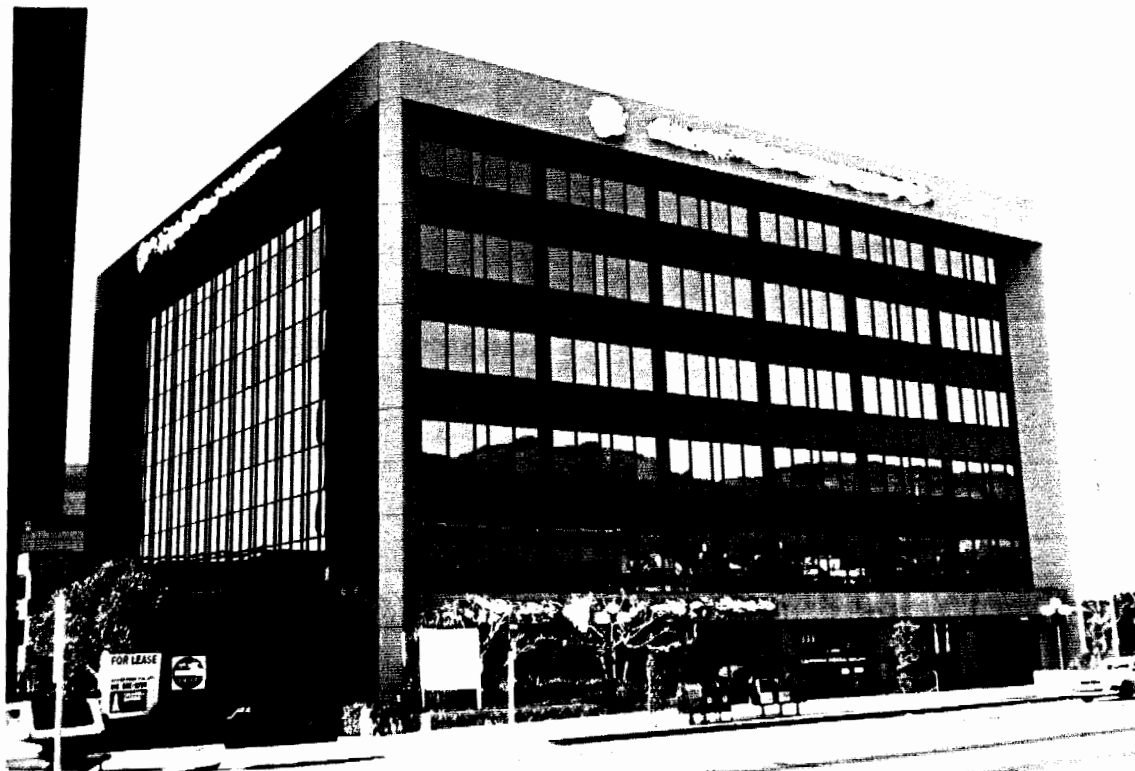
RIGID FRAME MOMENT CONNECTION

CONNECTION TO
COLUMN FLANGE

CONNECTION TO
COLUMN WEB

SHEAR CONNECTIONS

Figure 4. Office Building in Burbank and its Connection Details

The Burbank Building is a six story building with almost symmetric geometry. The building was excited during the 1987 Whittier Narrows earthquake [5]. Details of the steel structure of the building are shown in Figures 3 and 4. The structure of the building consists of hot rolled wide flange columns and beams supporting the floor steel deck and concrete slabs. The structure has a perimeter moment frame to resist the tributary gravity and total lateral load while the internal columns are designed to carry only their tributary gravity load. The beam-to-column connections in the perimeter frame are rigid, and all other connections are designed to act as simple connections and to carry shear only. During the Whittier Narrows earthquake the building was subjected to ground motions with 22% peak acceleration.

connected to the girder by limited number of shear studs resulting in partial composite action. Connections that were assumed to be simple, actually were more or less semi-rigid.

Column base connections are conventionally modeled as fixed or pin, however, the actual base connections were either close to fixed or close to semi-rigid joints. In the refined model of the structure, the realistic conditions were modeled properly.
