**ANALYSES OF STRONG-MOTION RECORDS
FROM A PARKING STRUCTURE
DURING THE 17 JANUARY 1994
NORTHRIDGE EARTHQUAKE**

Said Hilmy, Stuart Werner, Ahmed Nisar and James Beck

Dames and Moore
Santa Ana, California

Data Utilization Report CSMIP/00-04 (OSMS 00-06)

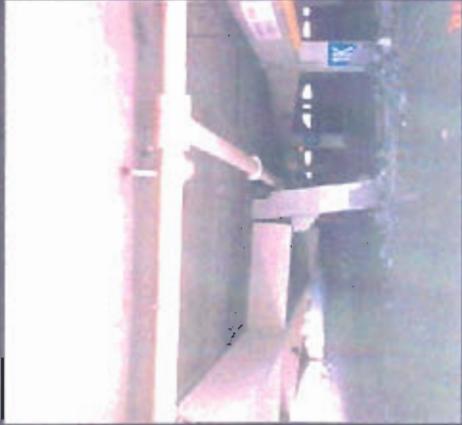
COLUMN HINGING AT BASE

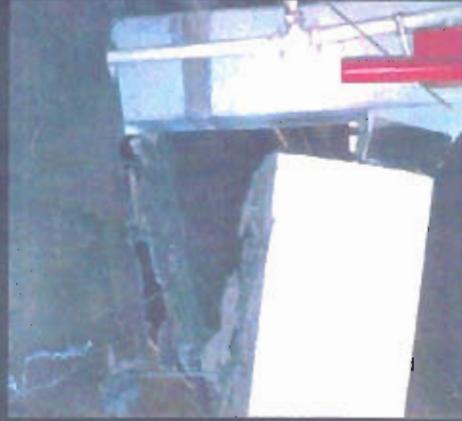
BEAM SLIPPAGE

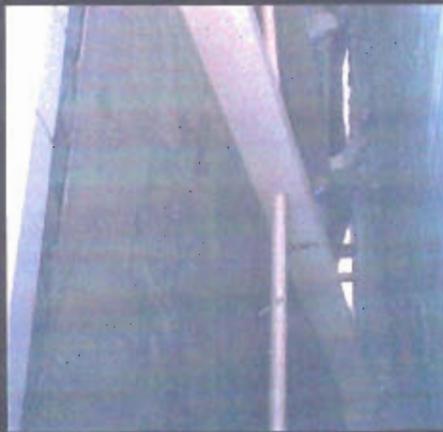
DECK COLLAPSE

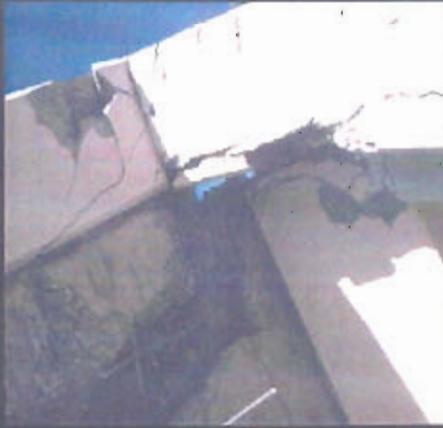
DECK SEPARATION

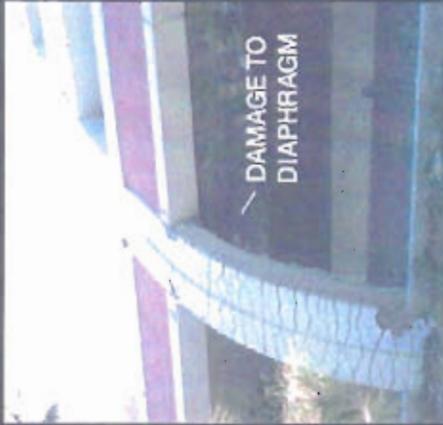
EXTERIOR COLUMN BENDING
